## **Treatment of Bottled Liquid Waste During Remediation of the Hanford 618-10 Burial Ground - 13001**

Darrin E. Faulk, Chris M. Pearson, Barry L. Vedder, David W. Martin  
Washington Closure Hanford, LLC, Richland, WA 99354

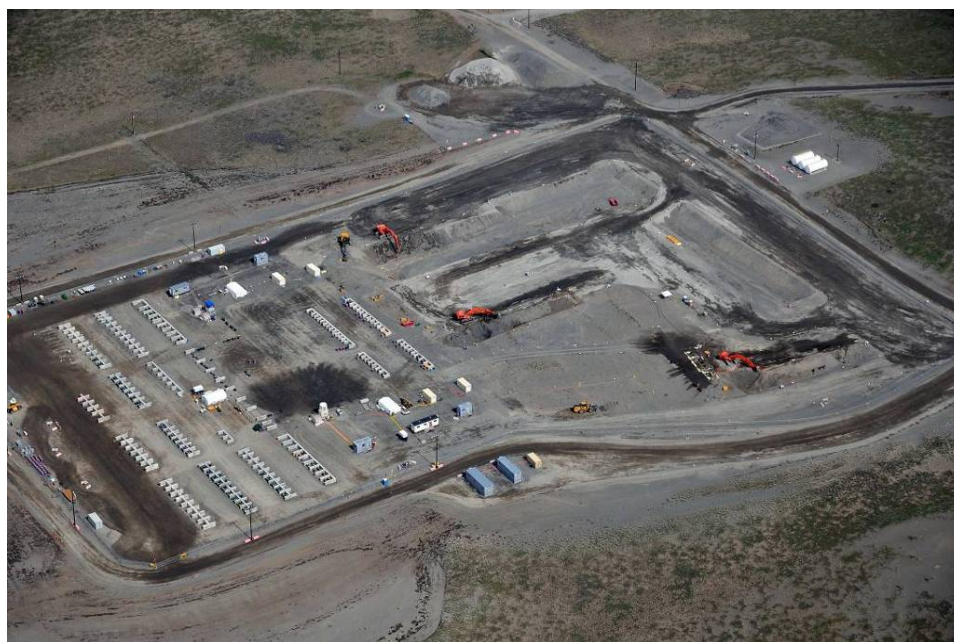
Figure 1. 618-10 Burial Ground Remediation, April 2012.

The 618-10 Burial Ground (Figure 1) is located approximately 9.6 kilometers north of the city of Richland and approximately 400 meters upwind of the primary Hanford highway. It was activated in March 1954 and closed in September 1963. The 618-10 burial contains waste generated primarily from Hanford's 300 Area, where fuel metallurgical analysis was performed and new methods were developed to separate plutonium from nuclear fuel. These wastes consisted of metallurgical sample residues, samples from experiments, and other very highly radioactive wastes [3]. Also, there are records indicating that some of the waste disposed in 618-10 may be shock sensitive.

The burial ground includes 12 trenches of various sizes which are up to 23 meters wide and 92 meters long by up to 7.6 meters deep. It also contains 94 vertical pipe units (VPUs), which are bottomless 108 liter drums that were welded together and buried vertically. The VPUs are planned to be remediated at a

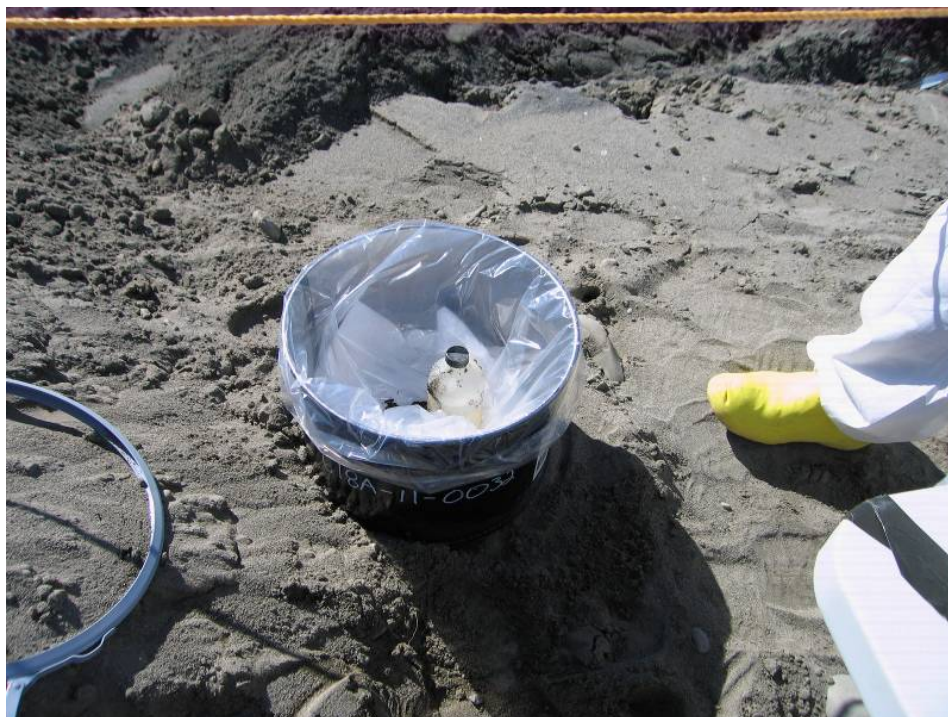
Figure 2. Prior bottle handling process

The past practice of handling bottle waste at WCH Field Remediation sites involved segregation of the bottles followed by individual characterization of bottle contents (Figure 2). During remediation of the 618-10 Burial Ground, hundreds of small laboratory-type containers have been encountered in the area of contamination during the initial months of excavation. It is not unreasonable to expect thousands of individual bottles could be encountered during the whole trench remediation activity (Figure 3). Process improvements are needed in the management of bottle waste from this burial ground, which contains highly radioactive, alpha containing waste. Standard remediation practices are adequate for handling soil and debris, however, there are records that indicate the potential for reactive chemical within bottles (e.g., picric acid).

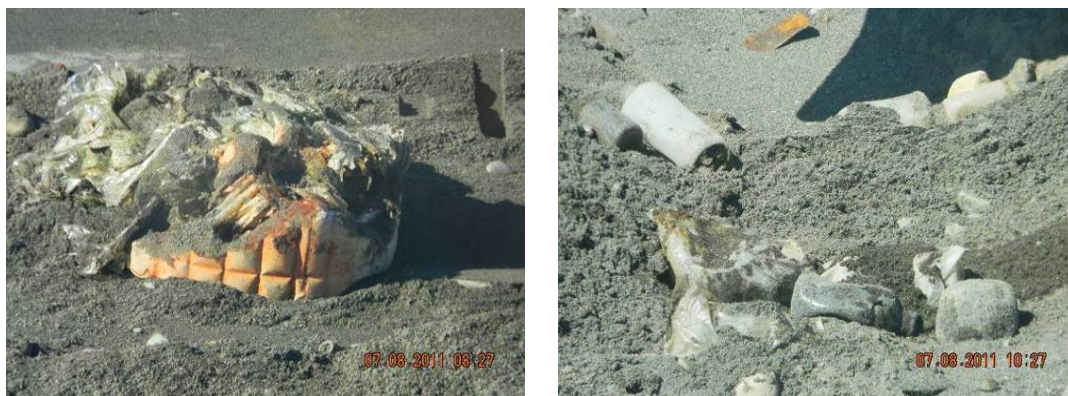
Figure 3. Bottles unearthed during remediation of Hanford's 618-10 Burial Ground.

The problematic waste consists of glass and plastic bottles in varying dimensions and composition potentially contaminated with barium, cadmium, or lead, and possibly other regulated metals. All of these metals could be at levels rendering the waste above Toxicity Characteristic Leaching Procedure (TCLP) limits that are subject to Land Disposal Restrictions (LDRs) prior to disposal [4]. The waste requires stabilization of the TCLP metals prior to disposal in the Environmental Restoration Disposal Facility (ERDF). Due to the highly dispersible characteristics of alpha contamination, and the potential for shock sensitive chemicals, a different method for bottle processing was needed at the 618-10 Burial Ground.

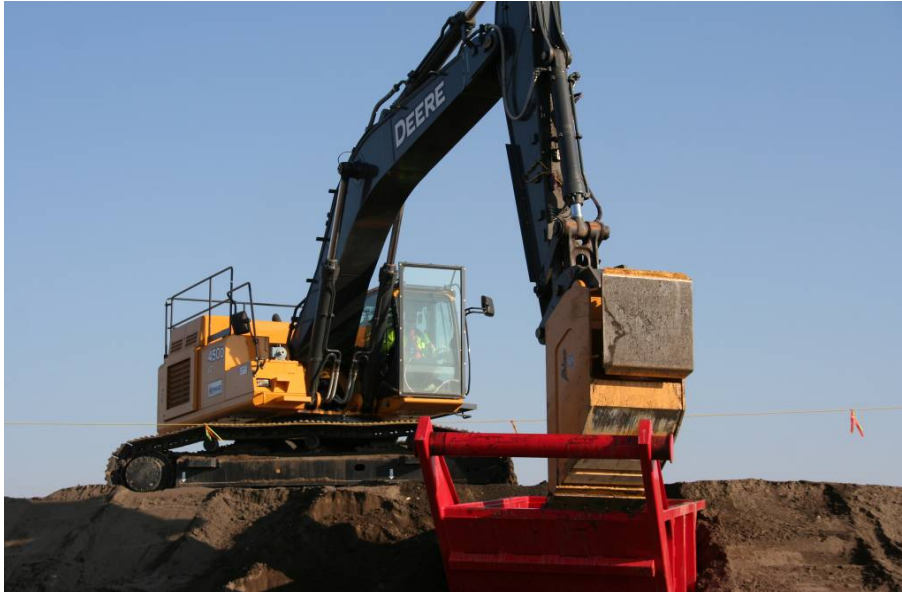
Figure 4. Crushing and mixing test bottles with grout within a mix box.

The grout mix is first added to a mix box and then bottles are added to the slurry. The excavator bucket is outfitted with a tamper plate. The tamper plate is positioned over the bottles and then lowered, crushing them (figure 4). The material is then mixed with the excavator bucket to reveal any unbroken bottles. If unbroken bottles are seen, the tamper is used to crush again. Mixing and crushing continues until no unbroken bottles are seen.

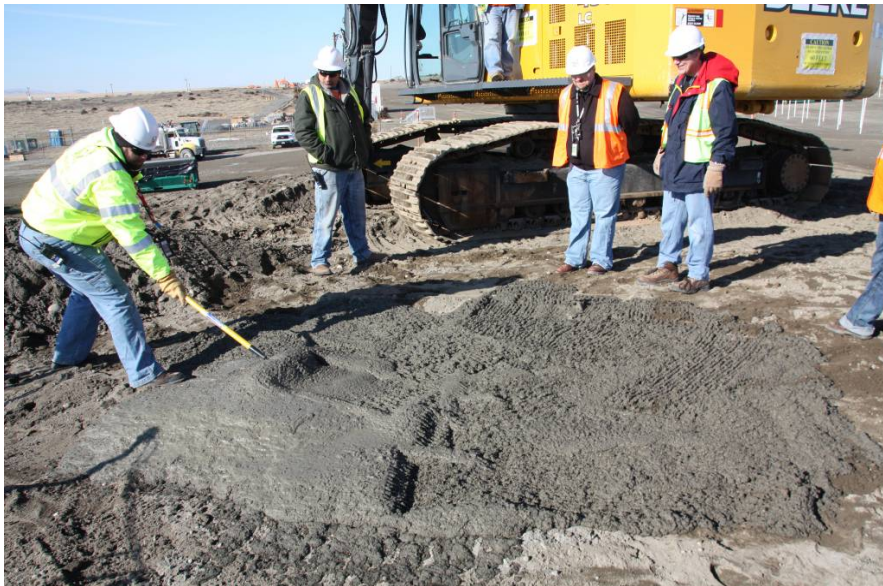
Figure 5. Examination of finished test batch.

During testing, the stabilized material was placed on the ground and raked out to facilitate examination for complete breakage (Figure 5). In practice, the remainder of the material is placed into a metal box to cure for later disposal (Figure 6). Reprocessing may be necessary if sample results show metals above land disposal restriction levels.

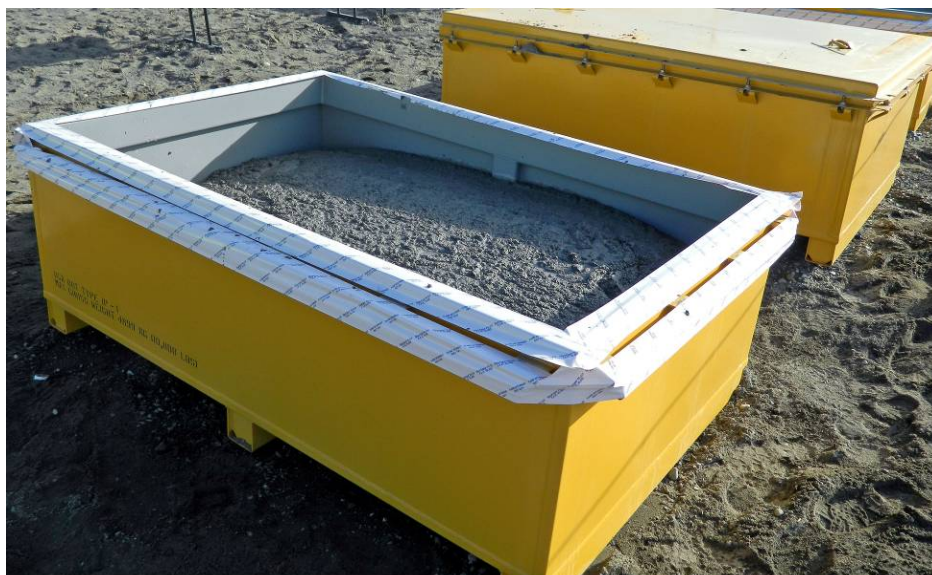
Figure 6. Final treated test batch packaged “for disposal”.
