Removal of the Plutonium Recycle Test Reactor – 13031

C. Brad Herzog, CH2M HILL, Inc., cherzog@ch2m.com
Rudolph Guercia, DOE, rudolph.guercia@rl.doe.gov
Matt LaCome, Meier Engineering Inc., mllacome@meierinc.com

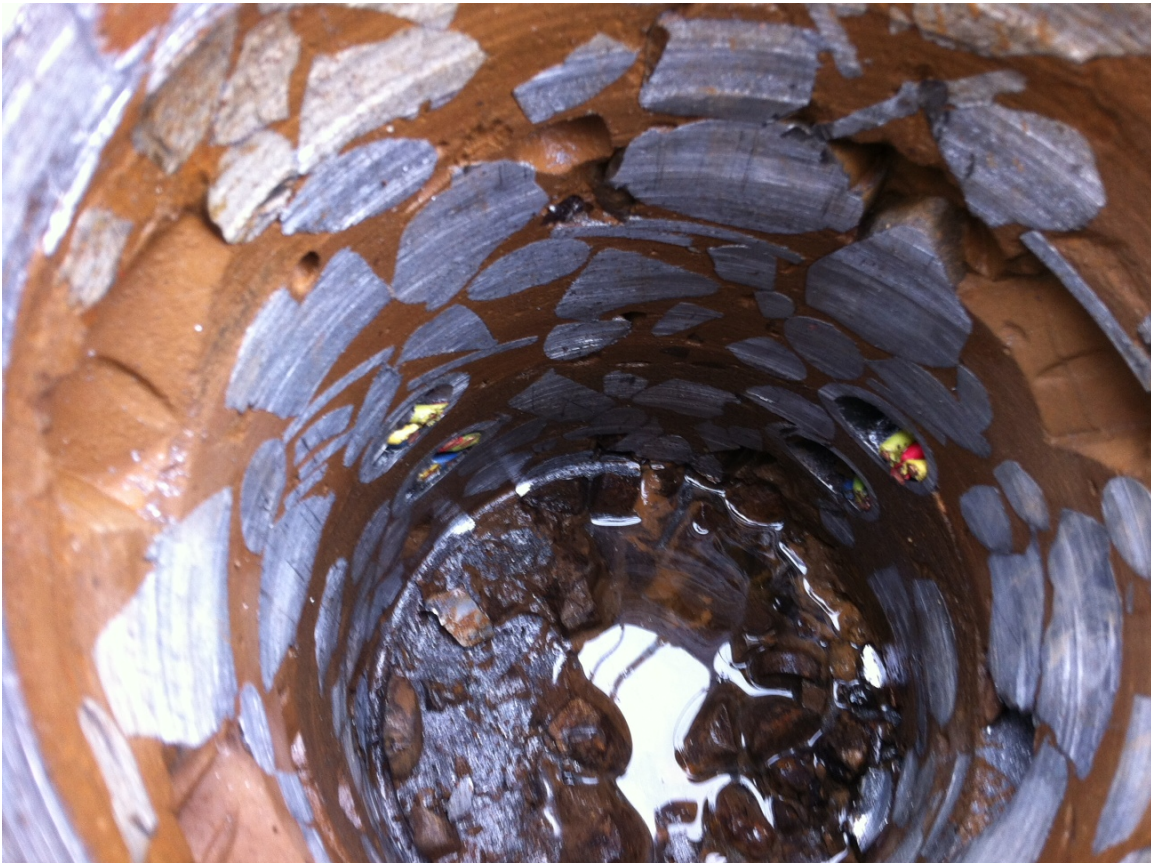
Photograph 2: Thermally Degraded Biological Shield

Initial 2011 sample core drilling at -3.4m (-11LF) from deck level in the Bio-Shield for radiological survey showed evidence that the Bio-Shield was of sound structure. In 2012, core drills for the separation process of the PRTR from the 309 structure began at the deck level and revealed substantial thermal degradation of at least the top 1.2m (4LF) of Bio-Shield structure. The degraded structure combined with the original materials used in the Bio-Shield would not allow for a stable structure to be extracted. The water used in the core drilling process proved to erode the sand mixture of the Bio-Shield leaving the steel aggregate to act as ball bearings against the core drill bit. The biological shield concrete sustained extended exposure to heat generated by the reactor producing thermal degradation which is evidenced in Photograph 2: Thermally Degraded Biological Shield. The characteristic color change from grey to orange of the cementitious matrix is easily identified in this Photograph 2.

While drilling the holes in the biological shield necessary to cut out the 309 reactor from its foundation, the progress of drilling was essentially stopped as the concrete self-destructed under the drill bits, (instead of being cored out). Drilling at a lower portion of 309 performed by WCH as part of its due diligence evaluation of radiological control issues, provided useable, solid cores. It should be noted that these radiological control samples were only visually inspected by civil engineers for soundness and actual compression tests were not performed. The 50mm (2 in) diameter core was drilled at an average of 250mm (10 in) per 8 hour work day over the course of 8 days at a depth of almost 5m (-16.0 LF) below the deck. Therefore the bioshield appeared to be of sound heavy aggregate concrete.

Since the top of the reactor is where the Type A accident occurred, the thermal degradation was only found to be in the top portion of the bioshield. A known depth of degradation is not known since coring was cancelled. A more thorough core sampling regiment would have uncovered significant change conditions from the originally assumed sound conditions.
