Reassessment of True Core Collapse Differential Pressure Values for Filter Elements in Safety Critical Environments - 13076

Adam Swain
Porvair Filtration Group, 1 Concorde Close, Segensworth,
Hampshire, PO15 5RT, England
Adam.swain@porvairfiltration.com

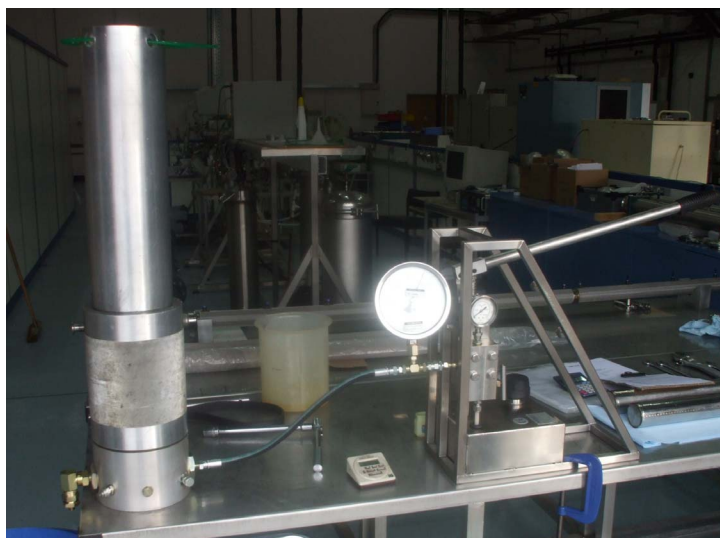
Figure 5- Collapse test rig set up

In order to make it possible to apply a differential pressure across the filter element carcass, a .010" shim was welded around the outside of the carcasses to simulate them in the fully blocked condition. Once welded the test carcasses were then bubble tested, by submerging them in an isopropanol tank, fitting them with a suitable bung fixture and pressurising them to check the welded joints for leaks. All test equipment used is calibrated and controlled in accordance with Porvair Filtration Groups internal control procedures.

The filter carcasses were then loaded into a suitable water test housing. The upstream port of the housing was connected to a manual hand pump, containing a pressure gauge to indicate the internal pump pressure. The housing was then filled with clean demineralised water, and bled of any air prior to pressurisation. Once bled the pressure inside the housing is raised in 5 bar increments and held for 2 minute intervals, until a drop in pressure signifying a collapse was detected. The water was then drained and the collapsed carcass removed, and inspected to ensure that a collapse has taken place.
