## **Cleanup and Dismantling of Highly Contaminated Ventilation Systems Using Robotic Tools – 13162**

The paragraphs below illustrate two examples of remote controlled tools developed for the decontamination and dismantling operations of the old ventilation system of the MAR 200 facility.

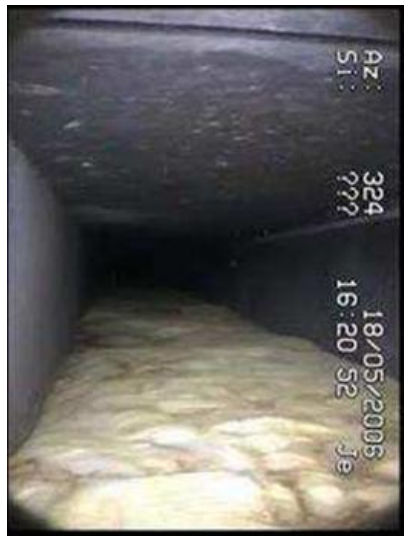
A picture of the powder deposits observed inside the duct using CCTV examination is given in Fig. 1.

Fig. 1. Powder deposits inside the ventilation duct

- The solution had spread inside the ventilation duct over a distance of 14 meters (46') and then dried and crystallized, resulting in powder formation,
- Approximately 15 cm (6") of powdery deposit were observed inside in the ventilation duct,
- There was an estimated 700 kg (1543 lb) of powder deposited inside the duct,
- According to the chemical and radiological analysis, the powder contained mostly uranium nitrate, and traces of plutonium,
- The initial dose rate ranged from 0.14 to 1 Gy/h (14 to 100 rad/h) inside the duct.

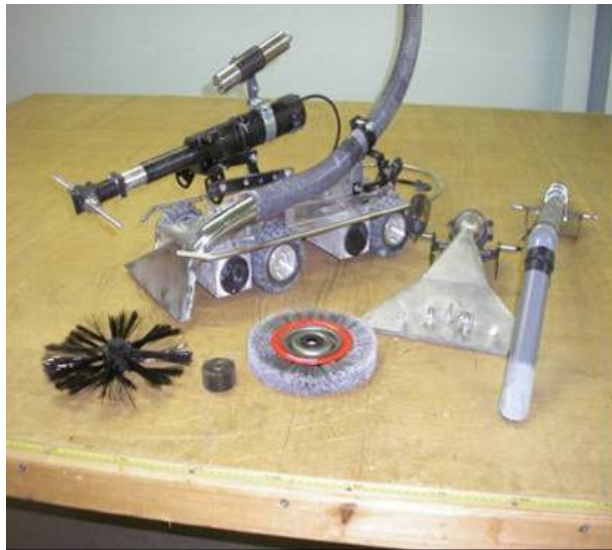
The tool carrier was designed to be inserted through specially created openings and to carry various cleanup and inspection tools (see Fig. 2). Each robot was equipped with a suction nozzle connected to a nitric acid dissolution unit via a hose and reel assembly.

Fig. 2. Remote-controlled tool carrier equipped for intervention inside the ventilation duct

For the retrieval of the powder, a dedicated small robot was designed from scratch and totally adapted to the environmental constraints. Indeed, preliminary analysis and inactive tests (full scale) with simulants have shown that the powder could be sucked up using a remote-controlled tool carrier throughout the length of the horizontal duct. The results from these tests were also used to define hose materials and hose reel control methods to minimize deposits inside the hose during suction operation.

The modular design of the tool carrier made it possible to rapidly install two cutting wheels on the front end to deal with the solid crust layer. The clogging of the hose reel was due to the adhesion properties of the powder associated with changes in atmospheric humidity. This phenomenon (not taken into account during the design and testing) was solved using an air dryer and a hydrometer installed in the glove box inlet.

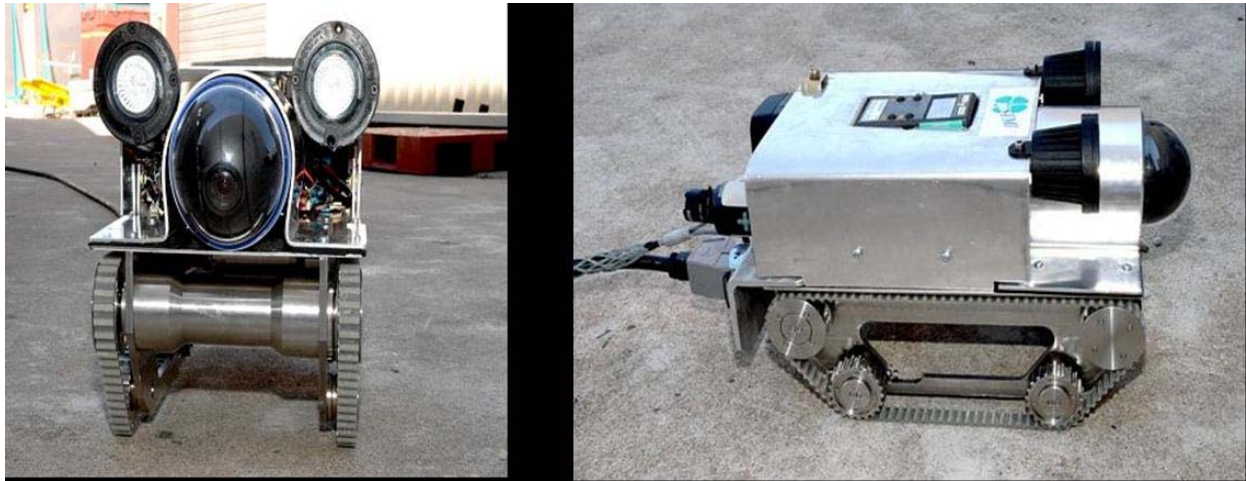
To increase the knowledge of the initial condition in the duct gallery, more investigation work was carried out using a remote controlled robot called EDI (Engin D'Intervention, see fig. 6). EDI is a lightweight carrier vehicle equipped with a measurement probe (with remote transmission to the control station), and also with a dome camera at the front, a fixed camera at the rear and two lights. It was also used later to assist remote-controlled devices in cutting operations (providing extra lighting and transmitting video images to the control room).

Fig. 6. The EDI robot

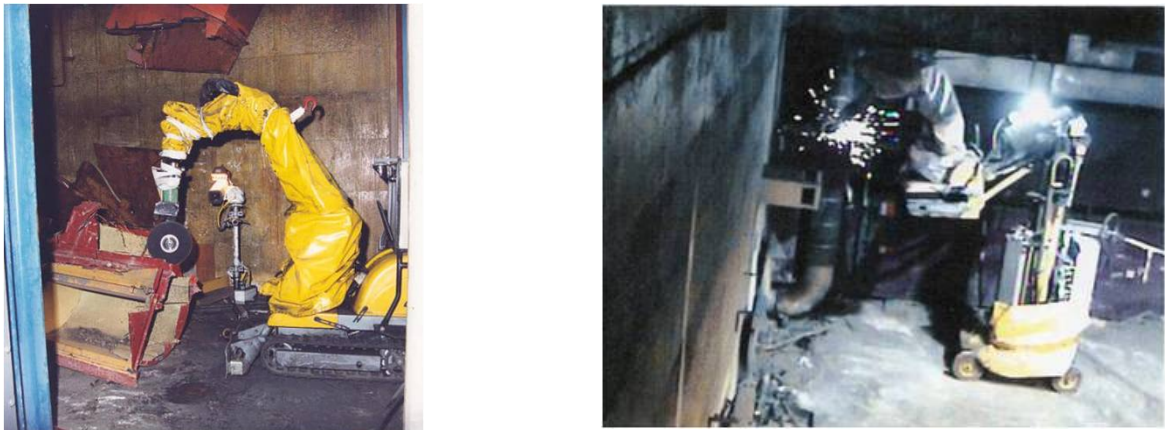
Filter room (see Fig. 8):

- Remove filters and transfer them to Marcoule Decontamination Facility
- Cut out and reduce the size of the filter chamber, ventilation duct and exhaust plenum
- Decontaminate metal sheet debris with a HP water jet washing machine

Fig. 8. Duct cutting in the filter room using EDA (left) and EDD (right)

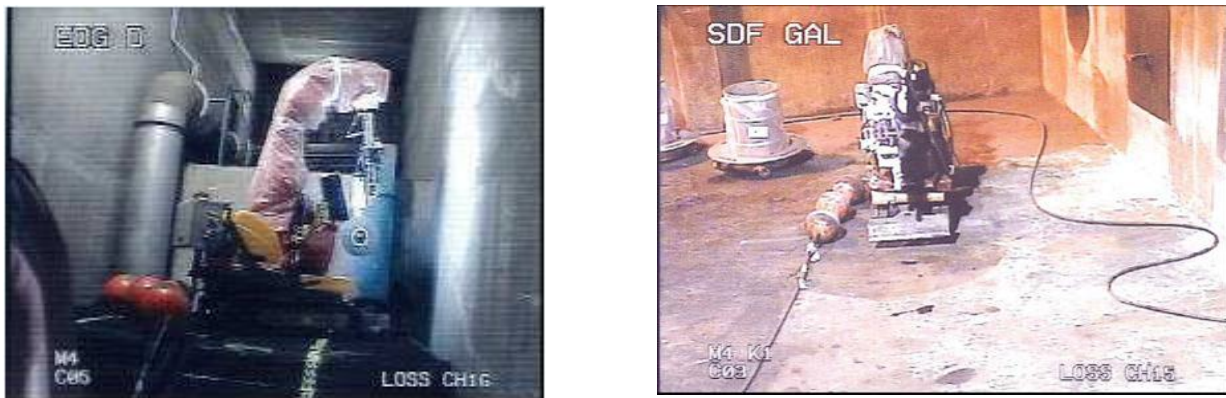
Duct gallery (see Fig. 9):

- Open ducts using disk cutter
- Vacuum dust and powder and spray fixatives on metal surfaces inside the duct
- Cut out ducts using disk cutter
- Transfer metal sheet debris to the ventilation filter room for further size reduction

Fig. 9. MD duct cutting (left) and duct gallery vacuuming (right) using EDM

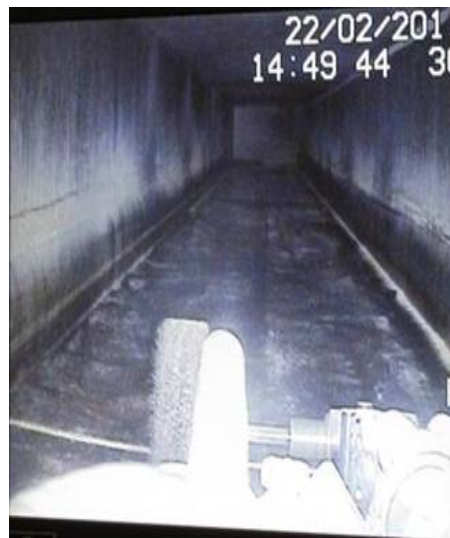
The powder retrieval objectives were achieved. A total of 452 kg (996 lb) of powder was collected in 59 batches, corresponding to a total radioactivity of 155 TBq (4185 Ci). The final dose rate ranged from 0 to 37 mGy/h (0 to 3.7 rad/h), corresponding to a decontamination factor of approximately 770. On the Fig.10 you can see the final condition of the ventilation duct after brushing the floor.

Fig. 10. Duct floor after brushing

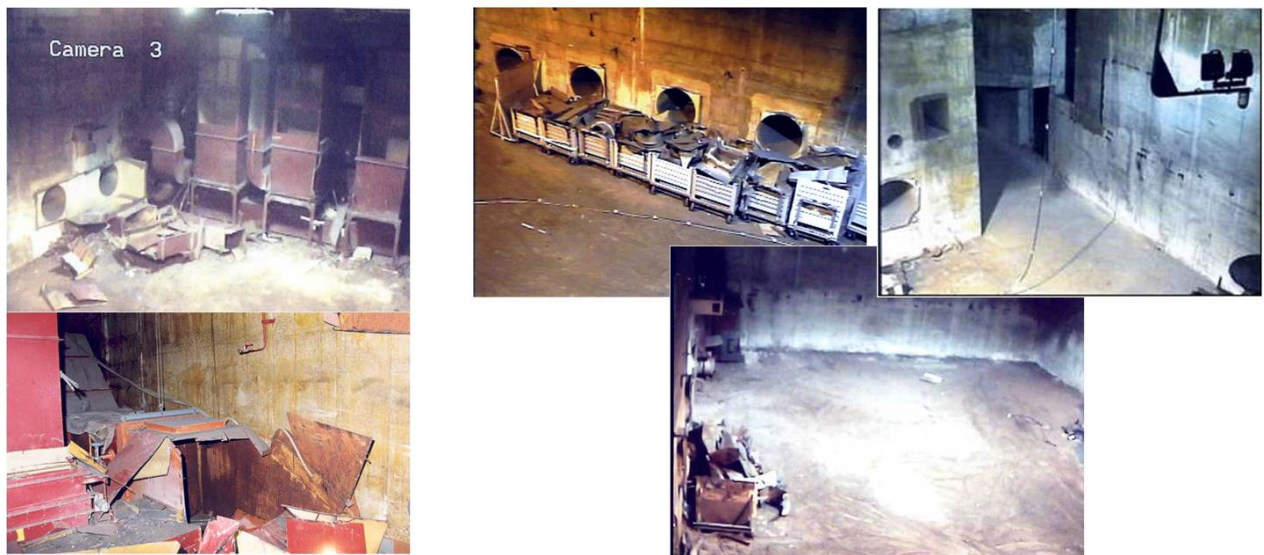
An overview of the rooms before and after the D&D operations is given on Fig.11.

Fig.11. The space between filter room and the duct gallery before and after D&D operations

The contractual final ambient dose rate of lower than 2 mGy/h (20 mR/h) and no hot point above 10 mGy/h (1 R/h) was reached. In spite of pneumatic drilling down to the first layer of reinforcement, some hot spots remained in certain limited zones which had been covered with lead plates.

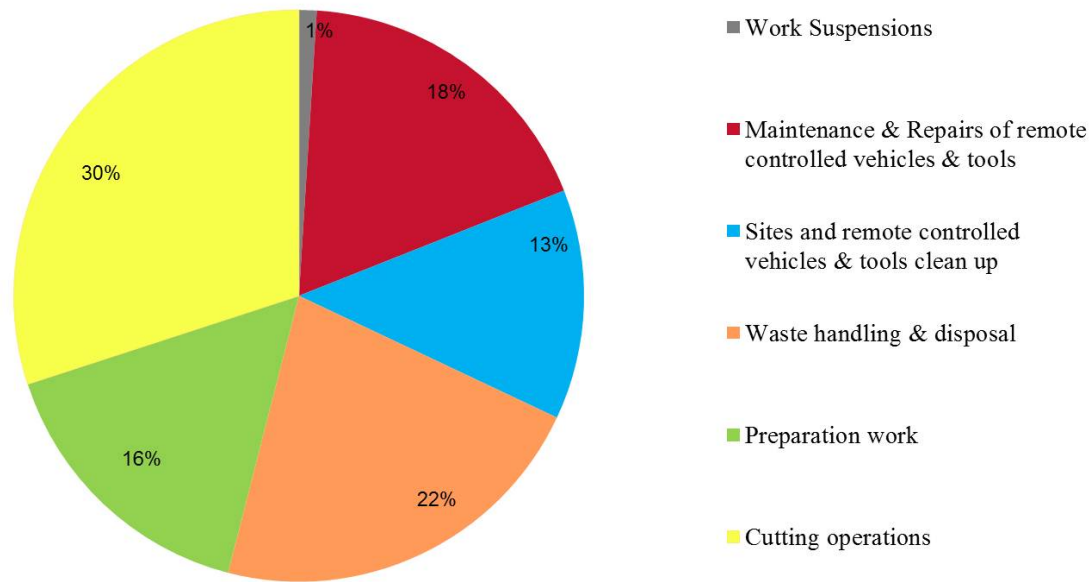
The work time organization for remote controlled cutting operation is given below on Fig. 12.

Fig. 12. Work time organization for remote controlled cutting operation

Regarding cutting efficiency, an average of 4.6 linear meters cut per disk grinder operating hour was reached throughout the duration of work and there were about 2 hours of cutting operations a day.
