Completion of the Operational Closure of Tank 18F and Tank 19F at the Savannah River Site by Grouting -13236

Andrew J. Tisler
Savannah River Remediation, LLC
Aiken, SC 29808

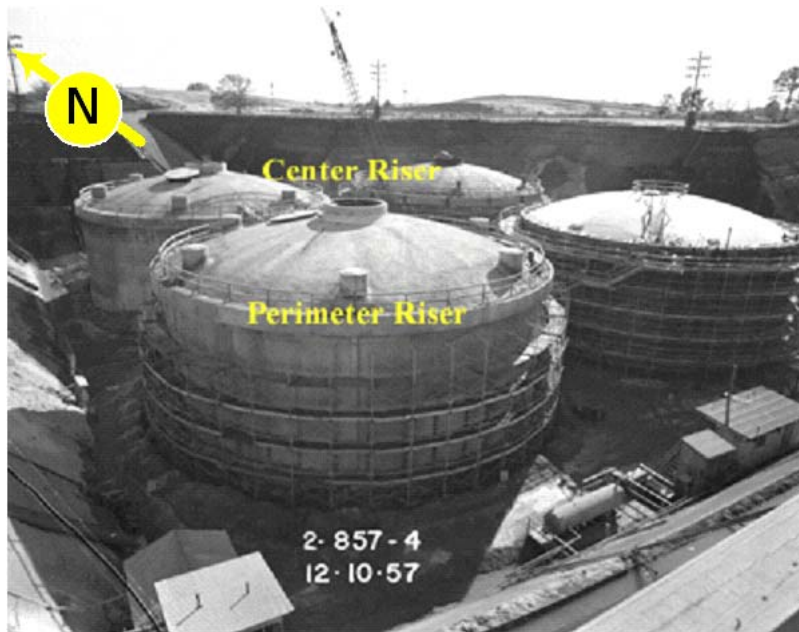
Figure 1. Tanks during construction

The single shell High Level Waste tanks targeted for closure were constructed from commercial grade carbon steel in the mid-1950's to the early 1960's. In general, their dimensions range from 23 to 26 meters in diameter, 7 to 10 meters in height, and the volumetric capacity ranges from 2.8 to 4.9 million liters. Access to these tanks is restricted to a few openings, typically 8 of approximately 0.6 meters in diameter.

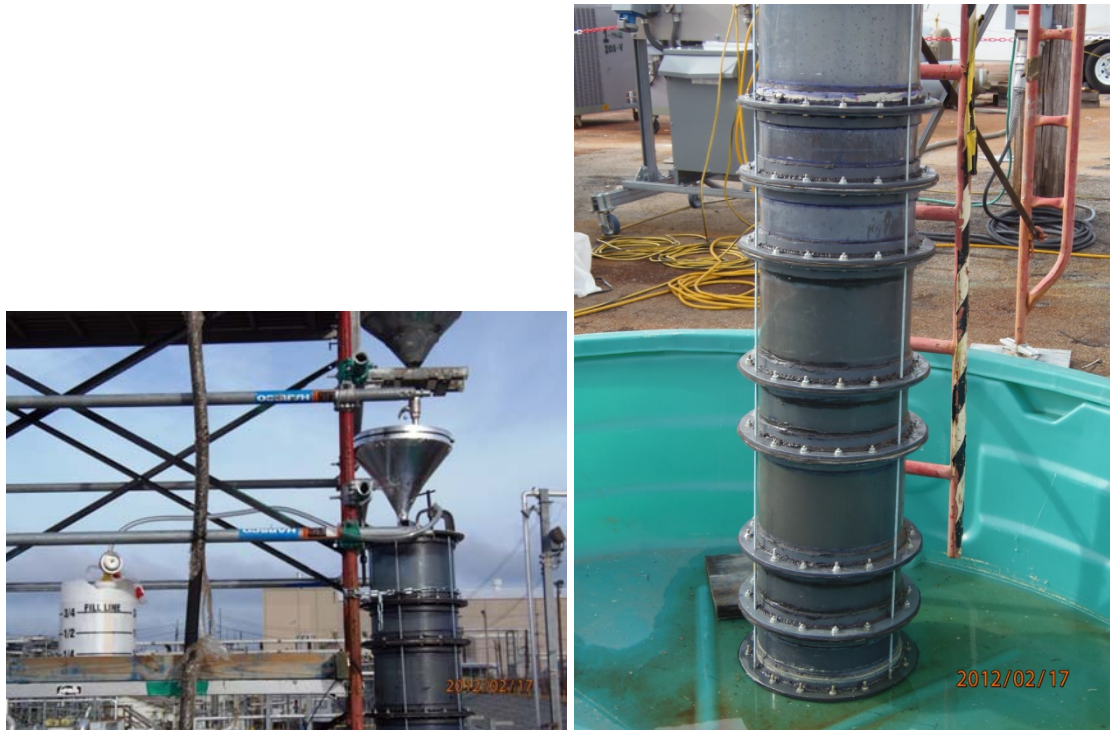
In order to provide the personnel filling the equipment practice time, and to verify that the techniques to be used will be appropriate, a mock-up was developed. This mock-up was constructed out of PVC material with sections that had small openings that would mimic a flow path representative of the interior of the equipment. The grout was mixed and the mock-up column was filled to demonstrate that the grout would flow to the bottom of the equipment when pumped into the top of the equipment. The grout flowed into the mock-up well, and the personnel gained experience with filling the equipment.

Figure 2. Equipment fill grout mock-up.

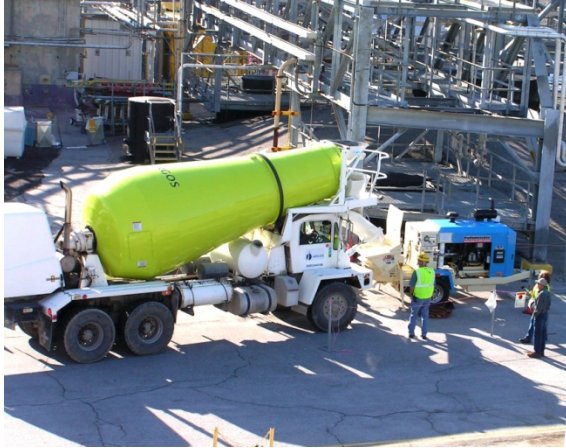
Figure 3. Grout Truck emptying bulk fill grout into Tank 19F

Once the material was accepted, the truck proceeded to the unloading station. This station consisted of a commercial concrete pump, and the truck unloaded the grout into this pump. The material was pumped through piping (slick line) to the center of the tank. Use of the center of the tank as the only pour point was made possible by the formula, a flowable, self-leveling grout.

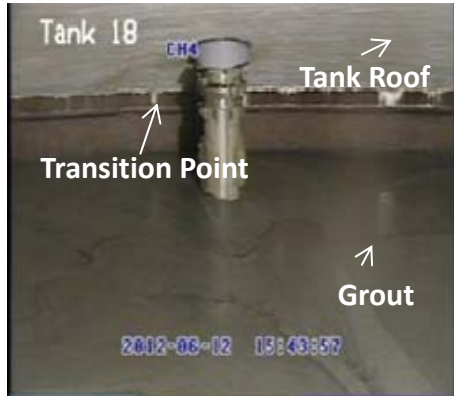
As part of the Safety Basis development that allowed the grouting, the bulk filling of tank would have to be filled in two discrete evolutions. The first evolution would fill the tank to just below the transition between the walls and the roof. At this point, the Safety Basis would be changed so the tank could continue to be filled. This transition point was above the highest known fill height when the tank was in radioactive waste service.

Figure 4. Tank filling.

After reaching this transition point, the fill could continue for an additional 61 cm in height. This height protected the roof from lifting off the wall due to the design of the roof structure. Once this amount of grout was set, then there was no additional risk for a roof lift, and the complete filling of the tank could occur. As the level of the grout reached the bottom of the tank top openings (risers), another pause occurred to allow the grout to set. This ensured that the grout would not flow out of the tank openings onto the tank top. Once this grout set up, the filling of the riser opening could occur. These openings were filled to grade, then any equipment extending above grade was entombed (riser capping).
