Cleanup under Airlock of an Old Uranium Foundry – 13273

Daniel Thuillier*, Jean-Marie Houee* and Frederic Chambon**

ABSTRACT

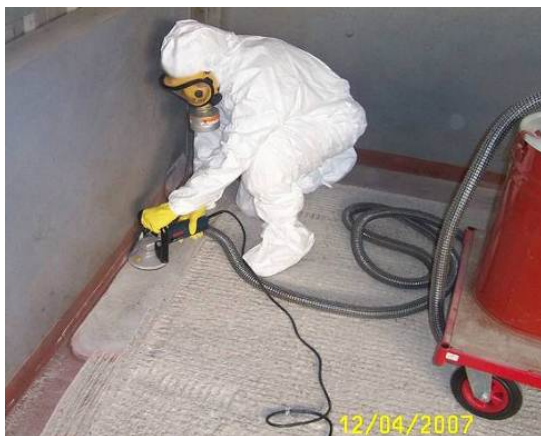
Fig. 2. Operator using sander

A variety of tools and machinery (see example in Fig. 2 and 3) was used to remove contamination from the concrete walls, floor and buried pipe galleries in the contaminated areas, such as power shovels (necessary for containment enclosures), bush hammers, grinders, sanders and pneumatic drills.

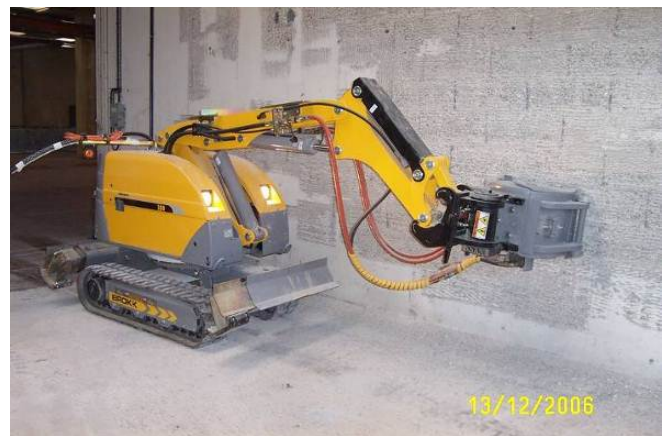
Fig. 3. Concrete scabbling using a Nuclearized Brokk

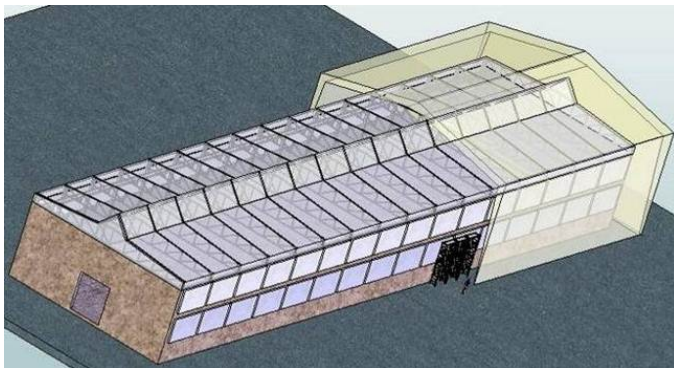
Fig. 4. Three-dimensional sketch of the building and airlock

In view of the plant's location in the downtown area of the city, and to prevent the dispersion of any dust during the processing of flooring and non-flooring surfaces as well as during the building's deconstruction, the building was enveloped in a rolling airlock with a metal framework capable of withstanding both wind and snow, both of which are frequent in this region. The building was more than 100 meters long, so it was decided not to procure an airlock to cover the entire edifice for reasons of cost and ventilation equipment design. A solution based on a rolling airlock that could cover one third of the building at a time was therefore chosen (see Fig. 4, 5 and 6).

The metal frame of the airlock was 33 meters long, 25 meters wide and 13 meters high, giving a total volume of 10,000 m³. It had a double shell envelope, allowing the outer shell to be recovered for later use.

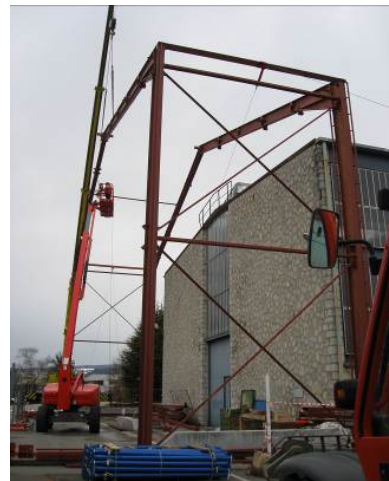
Fig. 5. Erection of the airlock

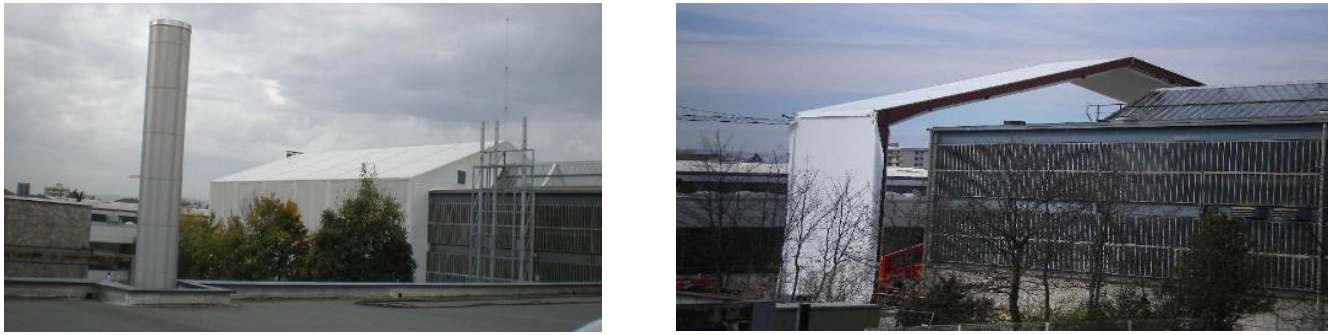
Fig. 6. Airlock in place over one third of the building

- Static containment by completely covering one third of the length of the building;
- Dynamic containment with ventilation designed to provide an hourly air exchange rate of 2.5 with very high efficiency filtration system.

Once the first third of the building had been deconstructed, the airlock was slid to the second and final thirds of the building on beams poured along the length of the edifice on both sides before work began.

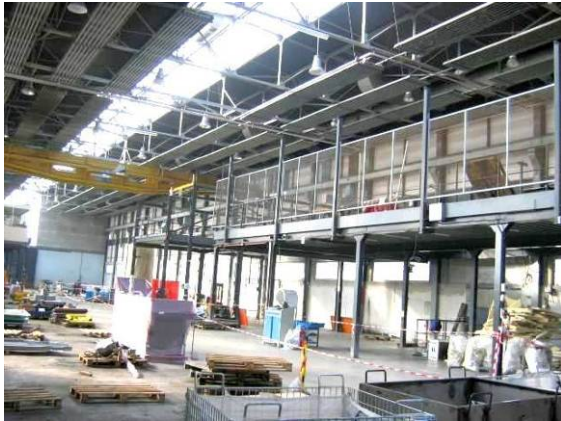
Fig. 7. Inside the building before the project

Fig. 7 and 8 presents the foundry before and after the clean-up and demolition work.

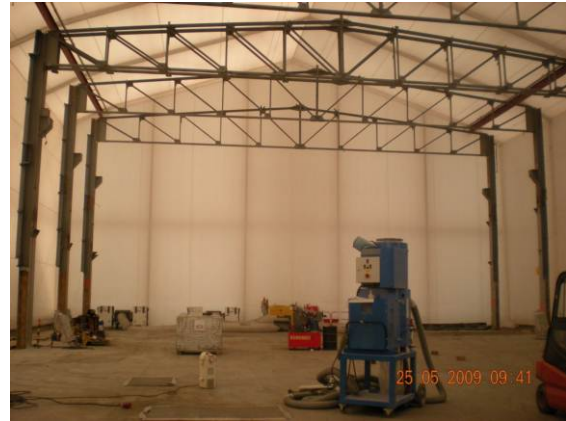
Fig. 8. Under the airlock after the demolition work

Nearly 7,000 m² of concrete surface was processed using the moveable airlock without any dust leaving the building. After cleanup, all interior surfaces were inspected by an independent organization to verify their acceptability in terms of the criteria set by the competent authority, i.e. no more than 0.4 Bq/cm² alpha of surface activity and no more than 1 Bq/g of specific activity in total uranium.
