**Dismantling of Highly Contaminated Process Installations of the German Reprocessing Facility (WAK) - Status of New Remote Handling Technology – 13287**

Joachim Dux, Daniel Friedrich, Werner Lutz, Martina Ripholz

WAK Rückbau- und Entsorgungs- GmbH, P.O. Box 12 63,  
76339 Eggenstein-Leopoldshafen, Germany

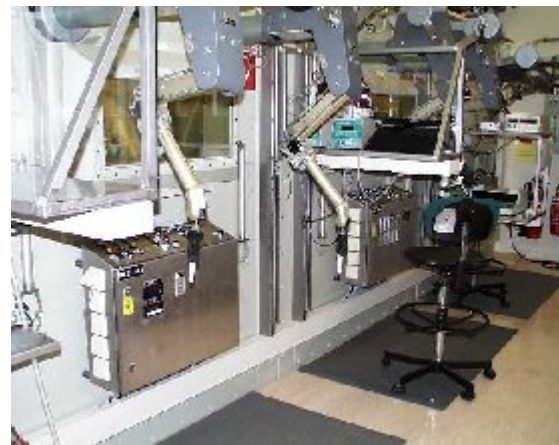
**Fig. 2. Front side of the shielded boxes with hand operated manipulators**

Remote dismantling of the LAVA hot cell equipment needs the manual removing of the HA laboratory equipment as a precondition. New installations in the crane hall such as crane systems, modification of ventilation system, lock systems for transfer of waste containers and drums are designed. A horizontal cut view of the shielded boxes of the high active laboratory (HA laboratory) is shown in Figure 1. The front side boxes of the high active laboratory (HA laboratory) is shown in Figure 2.

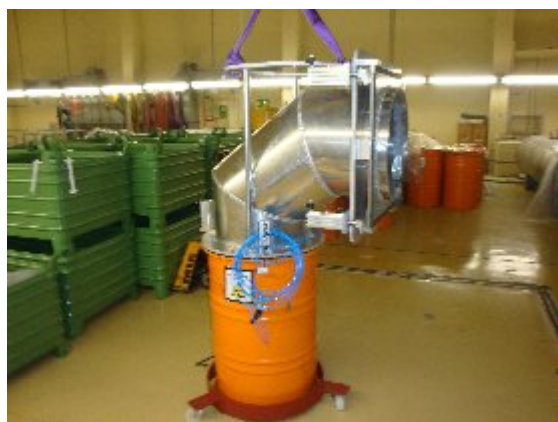
For the remote controlled loading in the maintenance area, the room was equipped with cameras and an electric driven crane trolley as well as the installation of a new locking adapter. The locking adapter used for the waste drums can be seen from Figure 3. This adapter was installed on top of the waste drum and fixed by three pneumatic sliders.

**Fig. 3. Locking adapter with waste drum**

The docking port was adjusted to the existing flange of the maintenance opening at the back side of the shielded boxes. Specific seals prevented any leakage of airborne contaminations resulting from particles or aerosols. After filling of the waste drum, the locking adapter was removed without personnel access and the drum lid was attached. This procedure can be seen from the photo taking during hot operation (see Figure 4)

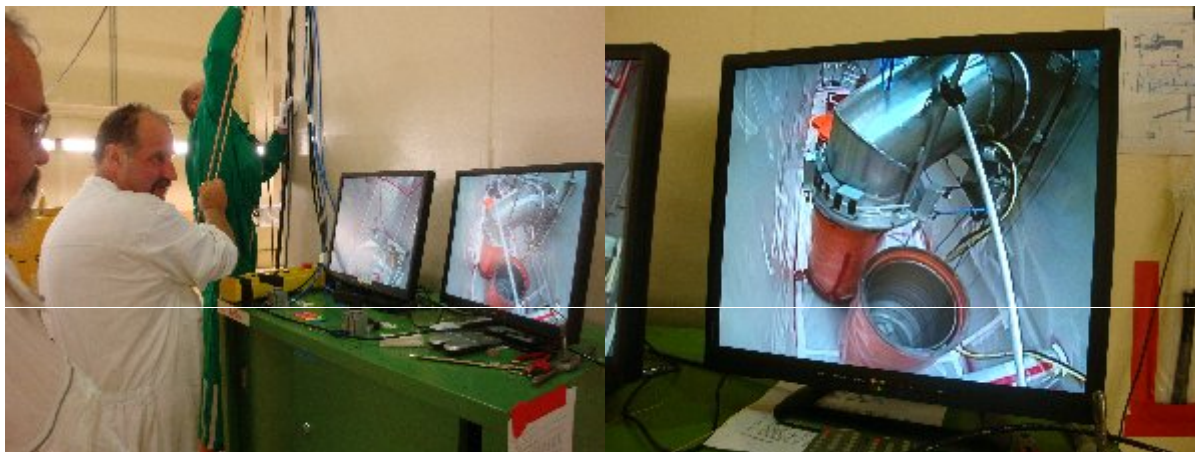
**Fig. 4. Remote controlled filling of waste drums via locking adapter**

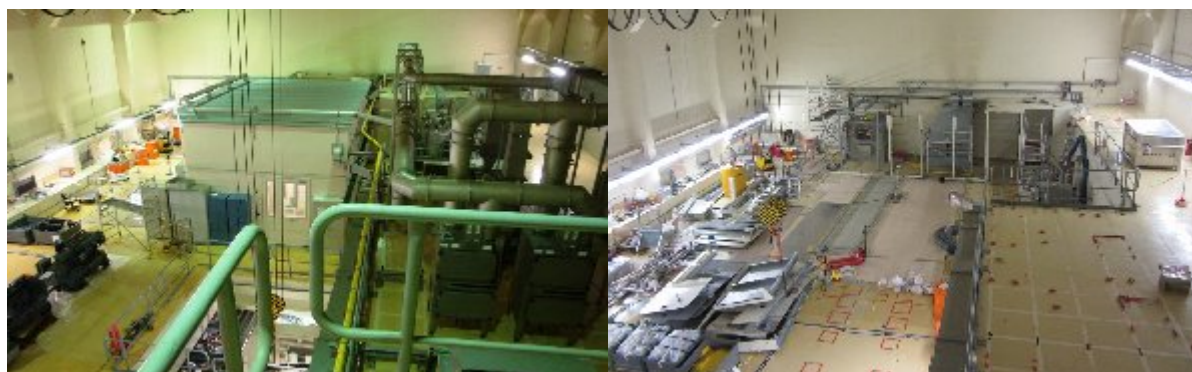
**Fig. 5. HLLW storage building crane hall before and after dismantling of the HA laboratory**

During the deconstruction in the year 2012, 58 t of steel, 19 t of lead, 2 t of stained glass windows and 5 t of equipment of the boxes were removed. The resulting group equivalent dose was 15.6 mSv. During the dismantling of the hot cell equipment and removal of the waste 4 operators were on duty. The dismantling of the containment was carried out by 8 operators. The planned duration of the dismantling was 32 weeks. The actual duration was 34 weeks from February the 6<sup>th</sup> till September the 28<sup>th</sup>. Figure 5 shows the crane hall before and after the deconstruction of the high active laboratory.

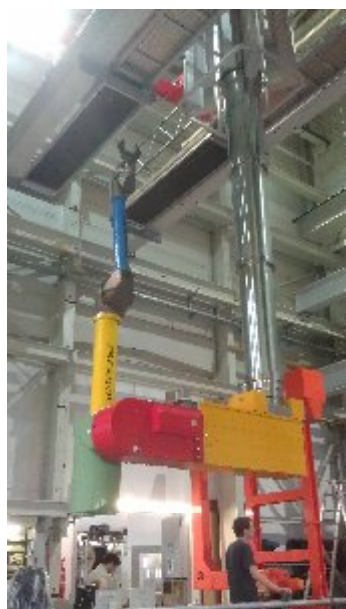
**Fig. 6. Telescope and power manipulator during functional testing**

The subsequent dismantling activities in the hot cells of the HLLW storage building will be carried out to large extent using new remote handling equipment (see Figure 6). The WAK chose the new state of the art electrically powered manipulator system TELBOT TB 1000 (manufactured by the Germany Company HWM). This manipulator has a max. horizontal range of 2.7 m by 100 kg payload. To approve the dismantling sequence and to train the operational staff a 1 : 1 mock-up of the hot cell with this process and remote handling equipment was installed.
