**Preparation for the Recovery of Spent Nuclear Fuel (SNF) at Andreeva Bay, North West
Russia – 13309**

D Field and N McAtamney Nuvia Limited

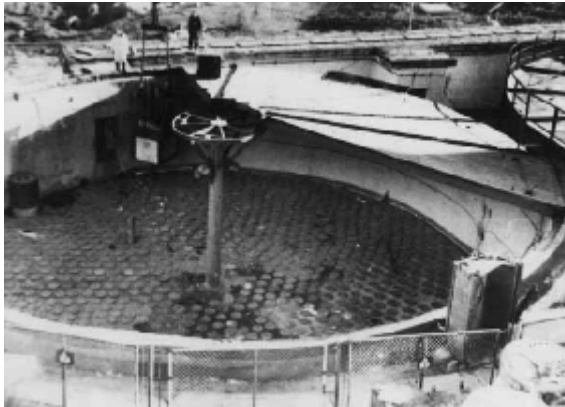
Figure 2 – SNF Store under construction in the mid 1980's

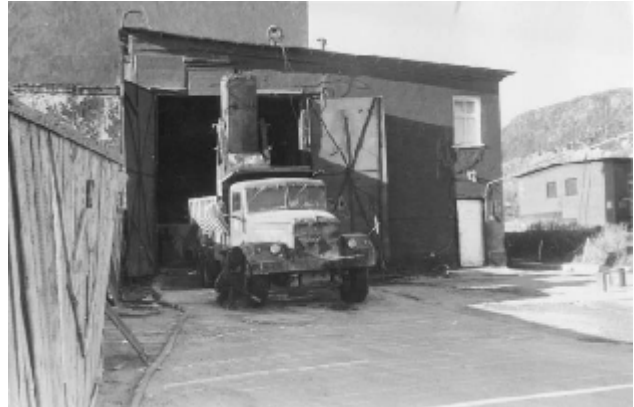
Figure 3 – Transferring SNF from the failed pond to the DSUs

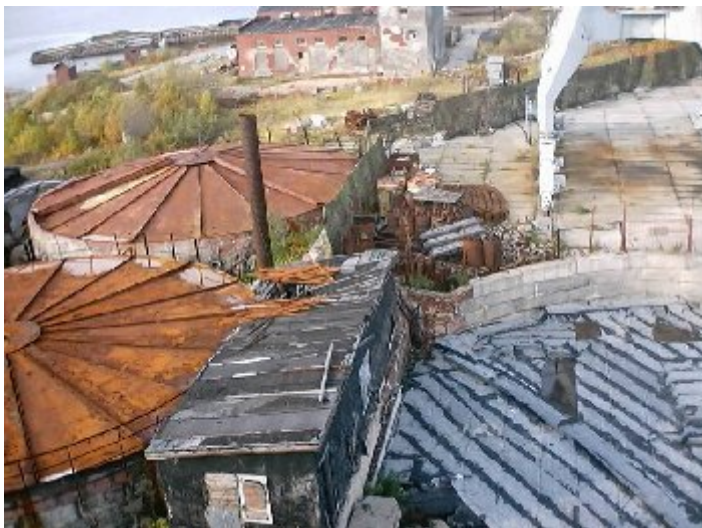
Figure 4 – Dry Storage Units in year c2000

The concrete tanks were originally intended as short term, temporary solution for storage of fuel until a proper facility could be built. Although the protection around the tanks had a design life of four years against corrosion, no proper storage was implemented due to lack of funds. As a consequence of lack of maintenance, the DSUs deteriorated and flooded from the ingress of snow melt water and precipitation.

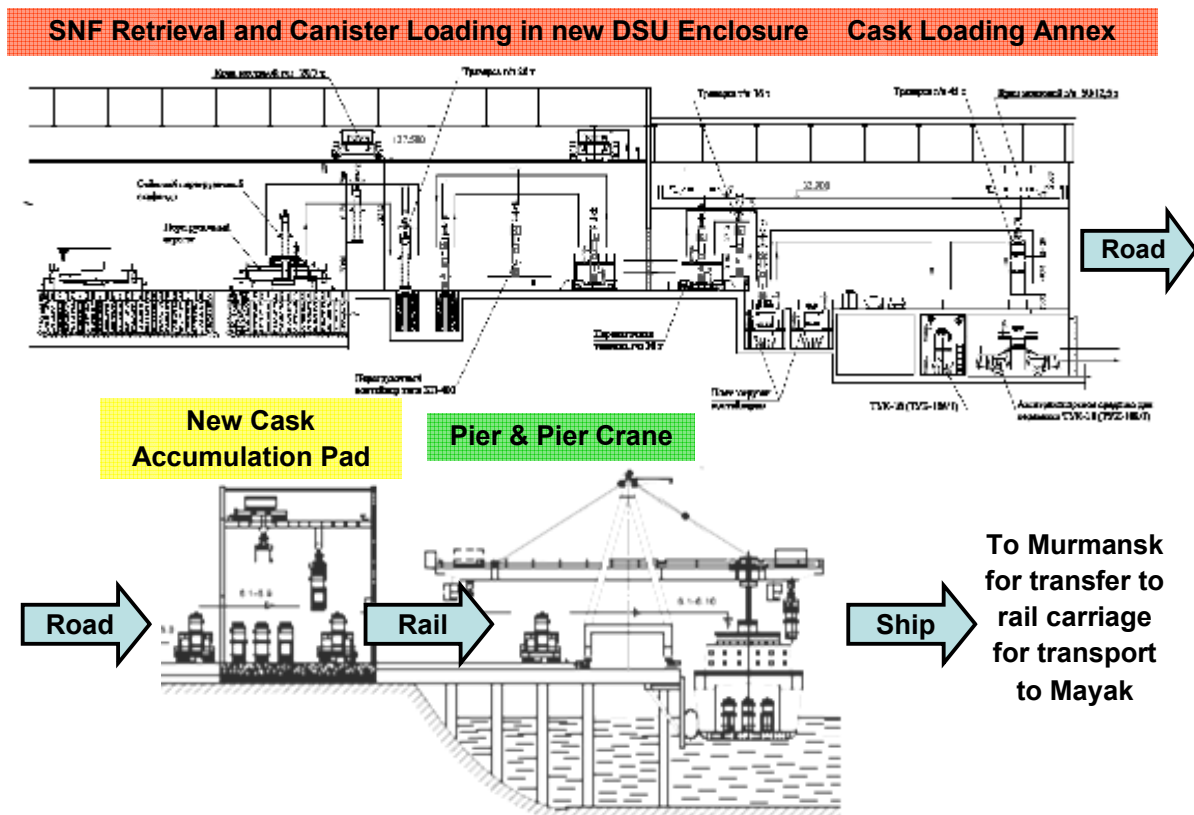
Figure 6 – Agreed SNF Retrieval and Handling Process

- Remove individual fuel assemblies from corroded canisters within the storage cells to avoid any risk of nuclear criticality, and place into new canisters;
- Where individual fuel assemblies cannot be removed, withdraw canisters after first draining the water and overpack them;
- Load the new canisters into certified casks for transport to Mayak RT-1 facility for reprocessing.

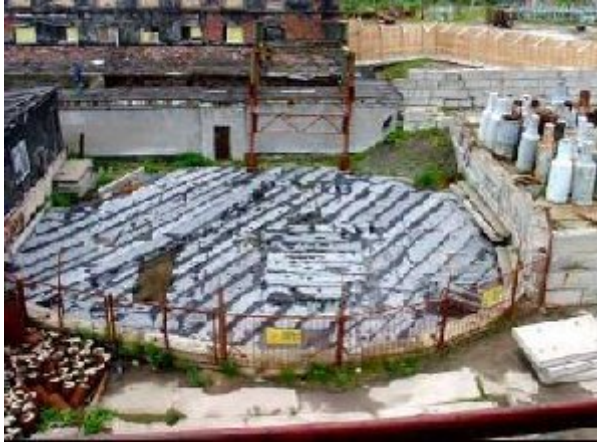
Figure 7 – Concrete beams and bitumen asphalt over DSU 3A covered provided poor weather protection

The original metal covers over tanks 2A and 2B provided basic weather protection; however the cover arrangement over DSU 3A was less effective as described earlier as there was evidence of water ingress.

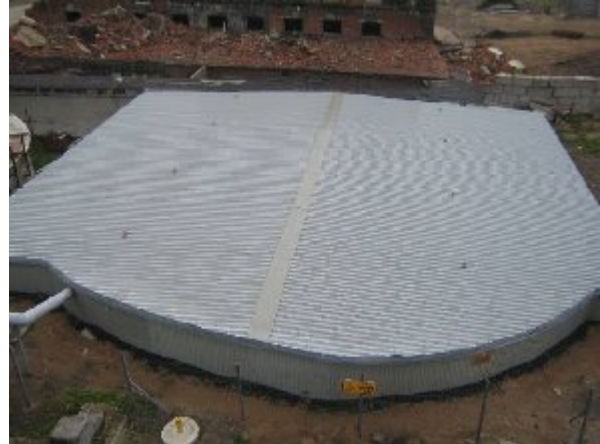
Figure 8 – Temporary weatherproof cover installed in 2004 had a stabilising effect on radiation levels

With funding from the UK, a new temporary cover was installed over DSU 3A in 2004. This included services such as an active ventilation system, water monitoring and an ASKRO radiation monitoring system.

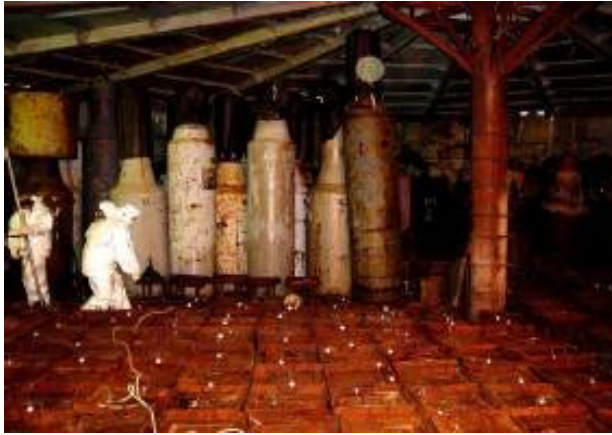
Figure 9 – Inside DSU 2A. Radiological conditions meant only brief access was allowed

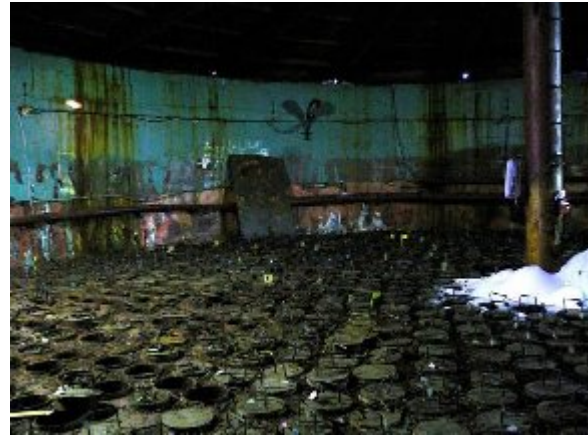
Figure 10 – Inside DSU 2B. Shield plugs were ill-fitting and snow could enter

The DSU tanks 3A, 2A, and 2B were put into operation immediately as they were completed in 1983, 1985, and 1986 respectively. Shield plugs were placed over the cells after the fuel canister had been transferred but most of these were ill-fitting. Transfer of the SNF from the failed ponds was completed in 1989.

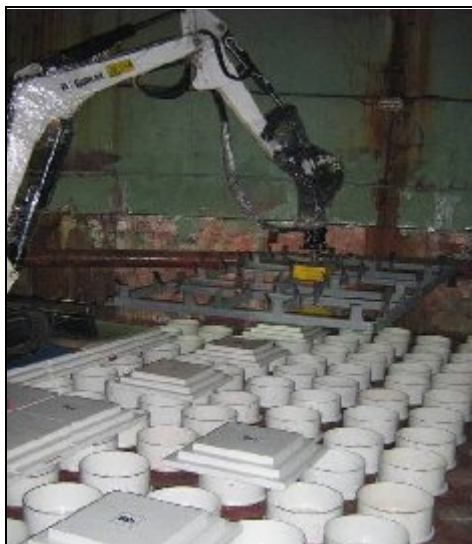
Figure 11 – Inside DSU 2B, Steel biological shielding was installed in 2010

The chosen design of biological shielding took the form of profiled steel plates of suitable thicknesses to attenuate the activity over each DSU to less than 12 $\mu\text{Sv/h}$. Installation of the shielding over DSU 2A and 2B was carried out semi-remotely using a Bobcat and was completed in 2009 with funding from the UK.

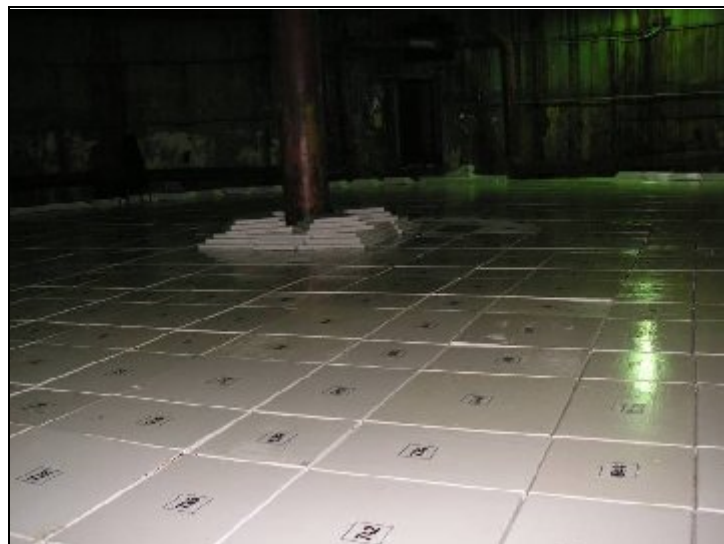
Figure 12 – Steel biological shielding greatly improved radiological conditions

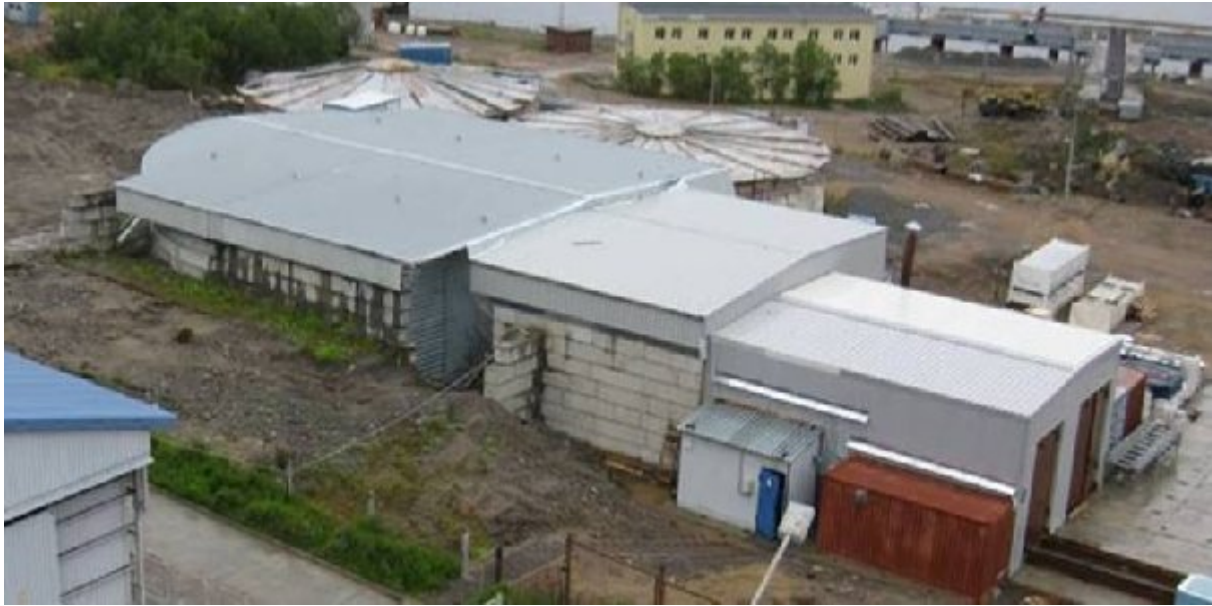
Figure 13 –DSU 3A with attached temporary process modules to carry out remote operations

The activity over DSU 3A however, was too high to adopt the same installation approach taken for the other two tanks. Instead operations needed to be carried out remotely from temporary process control modules. A Brokk 90 robotic manipulator and a rail mounted, remotely controlled HIAB crane were used to first remove the old concrete slabs, then clean up the

contaminated debris and finally install the shield plates. The £4.7 million contract for this work was funded jointly by the UK and Norway and successfully completed in April 2012. The project was extremely successful: radiation levels over DSU 3A have been dramatically reduced from peak readings of 42 mSv/h underneath the concrete beams, down to 7.44 μ Sv/h over the horizontal shielding.

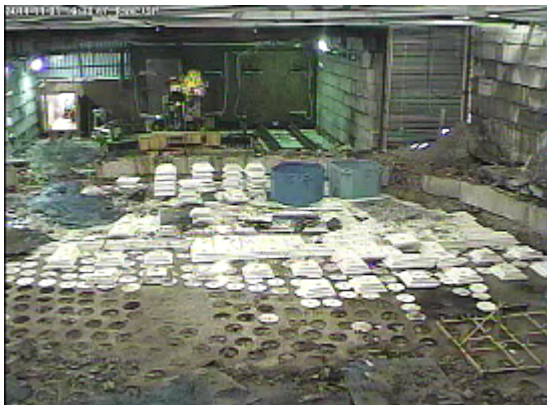
Figure 14 – Inside DSU 3B during installation of biological shielding

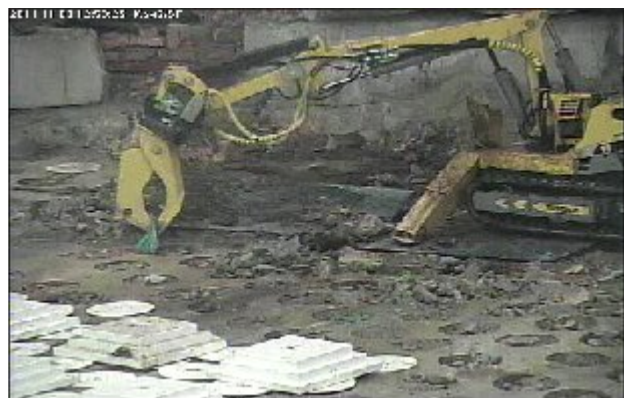
Figure 15 – Inside DSU 3B remote removal of debris using Brokk 90 robotic manipulator

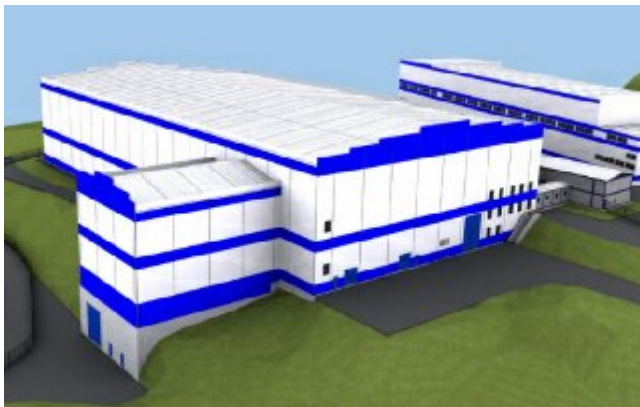
Figure 16 – Model of the new DSU Enclosure planned for construction starting 2013

The new DSU Enclosure is designed as two connected structures comprising the main hall and an annex for cask handling. The main hall over the DSU tanks is formed by two spans of 54m overall width, 108m in length and 22.5m height to ridge. This structure houses ancillary services and operational facilities within a three storey and single storey arrangement at the North and South gables. The cask handling annex is 19.8m span by 24.1m and 27.4m high, connected at the North East corner. Here, certified transport casks are prepared and loaded with SNF canisters before transferring to the cask storage pad where they will stay until offloaded onto a ship. The structure and safety systems of the DSU Enclosure are of a nuclear category and the design is seismically qualified.

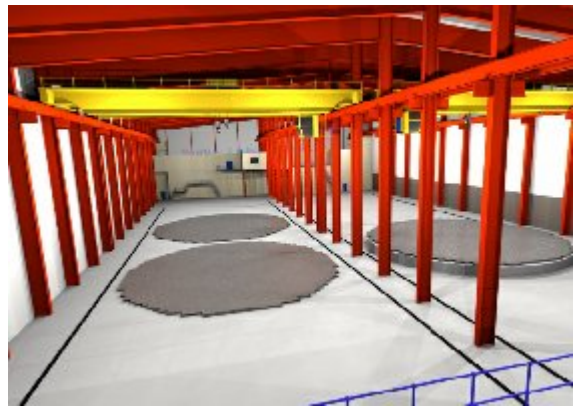
Figure 17 – Main hall of the DSU Enclosure with space to perform SNF retrieval and repacking into new canisters

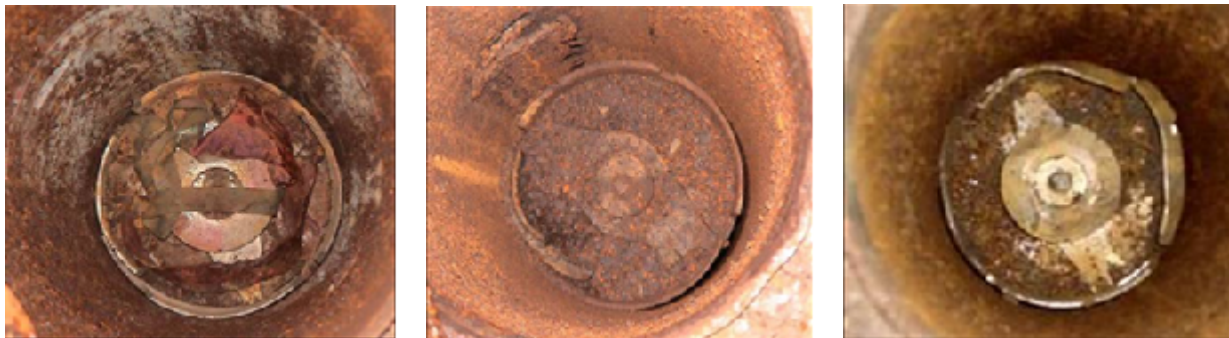
Figure 18 – View looking down into cells (shielding lid / plug removed) showing examples of various SNF canister heads which must be removed to gain access to the Spent Fuel Assemblies.

(i) Latch obscured by debris, (ii) Latch heavily corroded, (iii) Canister rim deformed.
