Dealing with Historical Discrepancies: The Recovery of National Research Experiment (NRX) Reactor Fuel Rods at Chalk River Laboratories (CRL) – 13324

Meggan Vickerd
Atomic Energy of Canada Limited,
Chalk River Laboratories, Chalk River, ON, K0J 1J0
vickerdm@aecl.ca

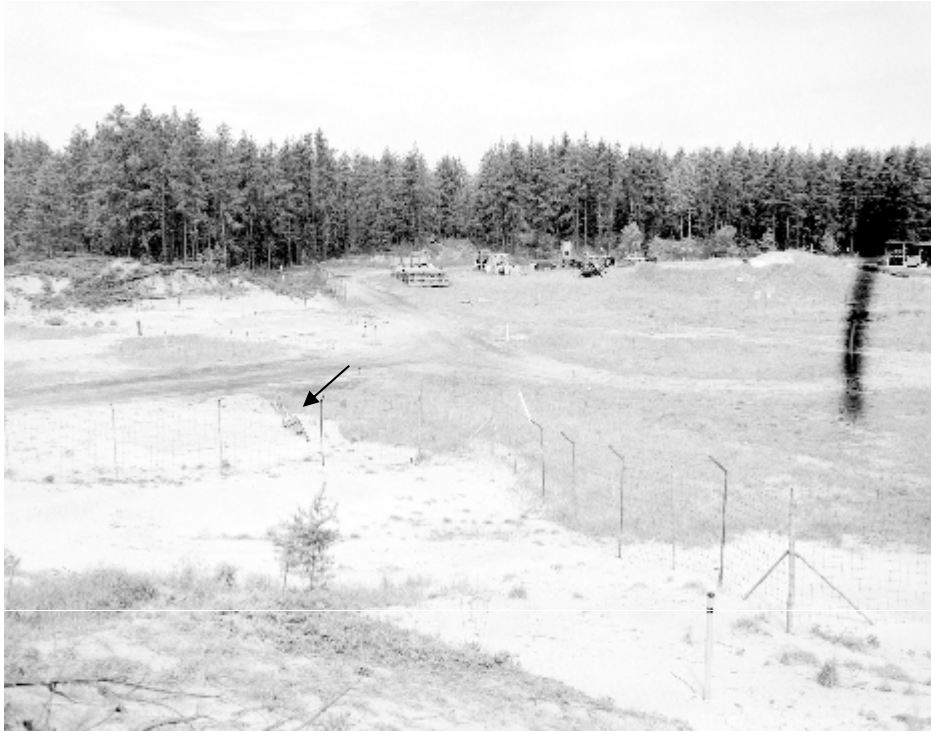
Fig.1 The “disposal grounds” in 1957, showing the “Wood Box” protruding above grade.

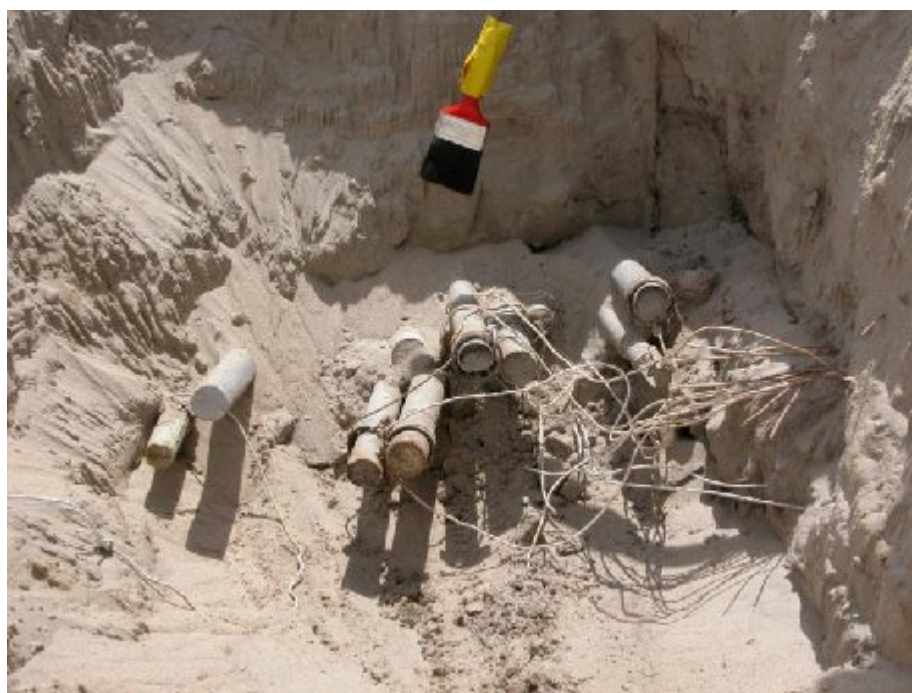
grade, confirming the fuel rods and cans were buried on an angle. Several photographs were taken as records including Fig. 3. As indicated in Fig. 3, fuel rods, some in aluminium cans, were buried in the sand with no other apparent containment. From the safe inspection distance, no identifying marks could be seen on the ends of the fuel rods and cans or their steel collars. Most of the fuel rods appeared to be contained in aluminium cans or flow tubes, with either crimped or welded ends. One fuel rod was not canned and had been stripped of its flow tube, exposing the fuel sheath which had obviously been cut during post accident examinations. Fig. 4 shows the visually evident uranium corrosion. The sheath cooling fin design identified this fuel rod as an NRX X-rod. Also visually evident was confirmation that some fuel rods had been broken off inside a calandria tube as shown in Fig. 5. This is consistent with operational records (i.e. 1954 Rehabilitation Report) and the description of Rod #5708 handling.

Fig. 3 Characterization activities in 2005 reveal the fuel rods. While several of the fuel rods or can had collars with identification tags, some fuel rods or cans were unmarked.

Rotted wood indicated the presence of what had been the original wood box containing the rods. Identification tags provided confirmation of several fuel rods listed in the suspect inventory. In total eight tags were observed to confirm the suspect inventory (as in Fig. 2) including: 430 Cut Ends, 651 Cut Ends, 476 Cut Ends, 7 Slugs from U.K. Rod #2052, Lavigne's Flat Bar Rod #3394, Canned Flat D373, U.K. Stability Rod #5, U.S. Stability Rod. During this characterization activity, discrepancies from the suspect inventory were already obvious as the inventory presented in Fig. 2 did not include an entry for "476 Cut Ends".

The 1954 Rehabilitation Report discusses the disposal of the six damaged X-rod fuels, seen in Fig. 3, for which a request for disposal was made on October 8, 1953. Approval for the transfer of the six damaged X-rod fuel rods was indicated and records of the completed transfer can be found in the weekly reports of October 16 to 22, 1953 and October 23 to 29, 1953. During the 2005 site characterization, a number of visual observations led to conclusion that NRX X-rod fuels were present at the "Wood Box" location. Specifically the physical state of one fuel rod was consistent with the description of handling for X-rod #9770. As such the six damaged X-rod fuels were included in the suspect inventory within the historical assessment and identified for retrieval. The assumption during work planning was that identification would be verified by the recovery of identification tags or identifying marks on collars or cans. None of the identification tags recovered indicated that the six damaged X-rod fuels were among the fuel rods recovered. Additionally no identifying marks on collars or fuel cans were observed during the recovery. As such X-rods 7989-F, 9770, 5712, 5708, 5619, and 5538 are not listed in the inventory transferred to the modern storage facility in 2007. Assigning the unidentified fuel rods identities of the six X-rod fuels would result in discrepancies in the total inventory tally. Item 9 on Fig. 2 indicated that they were in a separate box, thus the location of the damaged X-rod fuels remains uncertain. Verification of their recovery in this retrieval would require detailed analysis of the recovered inventory. Confirmation may also arise as a result of additional site characterization of the entire "disposal grounds" (now referred to as waste management area) and the retrieval of other NRX accident associated burials at this location. Another possibility exists that these damaged fuel rods were later recovered from the disposal area for further research. These fuel rods were of

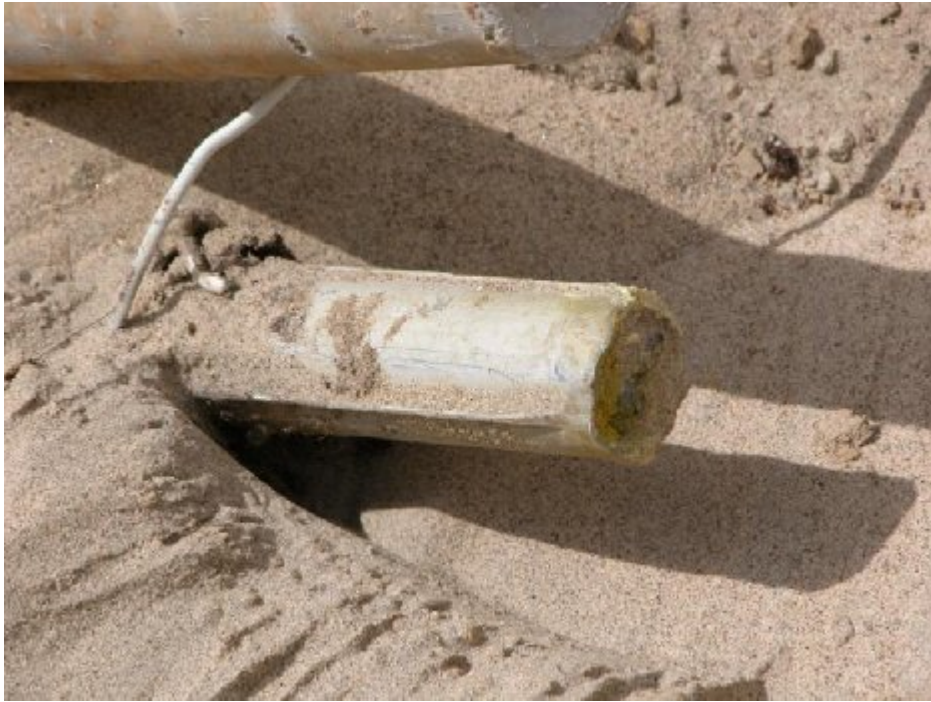
Fig. 4 An uncanned NRX X-rod which had been stripped of its flow tube, exposing the fuel sheath. Uranium corrosion is visually evident with the yellow product present.

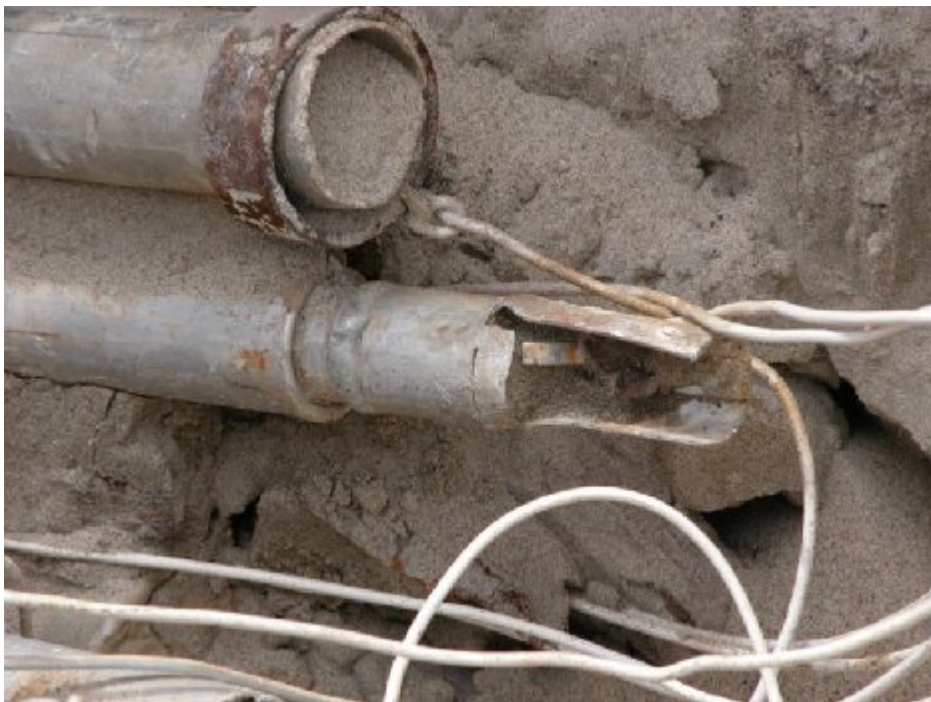
Fig. 5 A canned fuel rod that had been broken off inside a calandria tube.

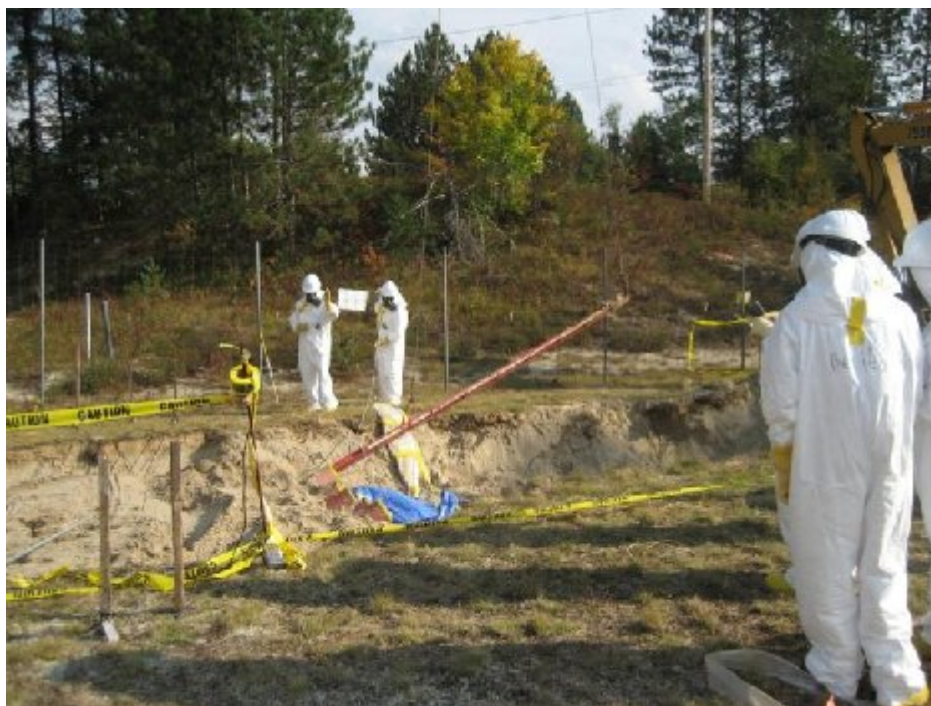
The retrieval of the inventory within the "Wood Box" and "Split Rod" burial and transfer to a modern fuel storage facility was executed in the Fall of 2007. Due to the primitive conditions of the "Wood Box" and "Split Rod" burial, the design of the retrieval was relatively simplistic. The process involved burying new fuel cans on an opposite angle to the legacy burial. The buried fuel rods and cans were then systematically and carefully exposed and rolled onto an angle iron using remote tooling. As shown in Fig. 6, the angle iron was then hoisted to the mouth of the new fuel cans and angled such that the fuel rod or can would slide into the new packaging.

Fig. 6 Retrieval of the fuel rods and loading into new modern fuel cans with remote tooling and the angle iron.
