Unique Construction and Social Experiences in Residential Remediation Sites – 13423

ABSTRACT

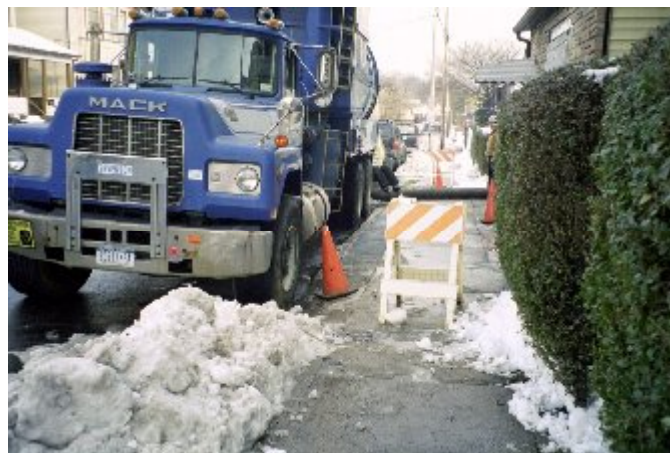
Fig. 1 – Vacuum Truck

Severson utilized a vacuum truck to remove contaminated material from interior excavations. A vacuum truck would be parked in front of the house on the street. Steel reinforced rubber suction hose was used to transfer the contaminated material to the vacuum truck. Figure 1 shows a vacuum truck parked in front of house with basement remediation.

The vacuum truck provided enough suction to remove at least one cubic meter of soil an hour and can easily hold up to six cubic meters of soil. There are several occupational safety and industrial hygiene concerns that need to be address when utilizing this technology. The blower for the vacuum truck is powered by the truck's engine. The truck's engine and blower can produce as much as 105 decibels A scale dependent on the amount of vacuum required for soil removal. With noise levels that high it was imperative to perform noise monitoring for workers and members of the public. On some occasions impacted neighbors that worked at night and slept during the day were relocated to a rental house or hotel until the vacuum truck work was finished.

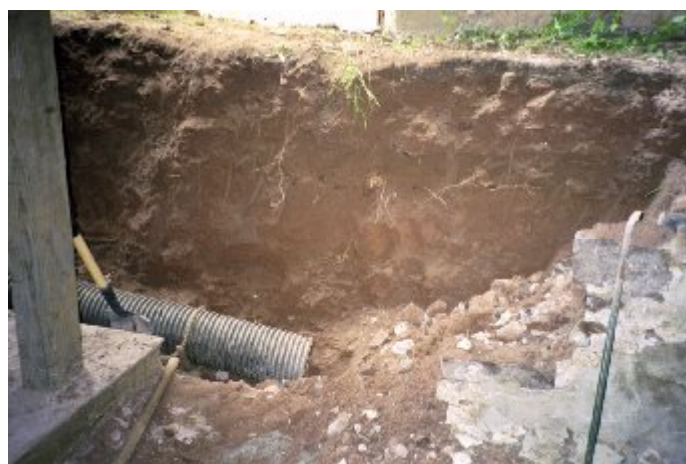
Fig. 2 – Rubber Hose for Vacuum Truck

Figure 2 shows two temporary support holes that were made by removing the contaminated soil with the vacuum truck and rubber suction hose. Laborers use shovels, pick axes, and pneumatic jack hammers with various bits for breaking the concrete slab and loosening soil.

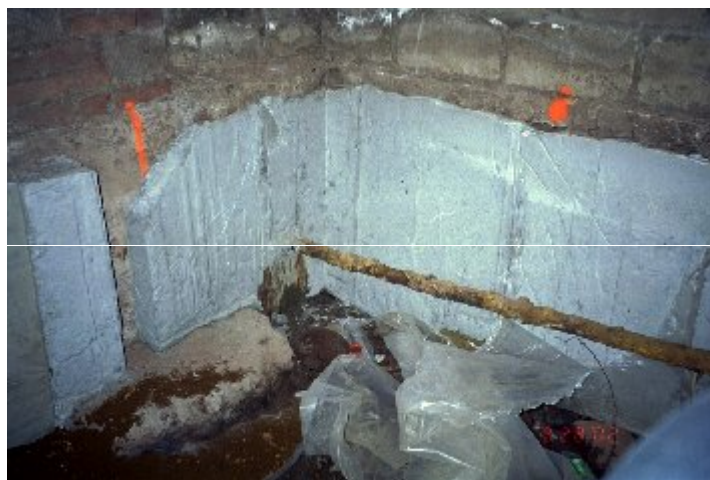
Fig. 3 – Foundation Underpinning

The preferred method was to underpin the existing footer with concrete. Figure 3 shows a foundation that has been underpinned to support remediation.

Concrete underpinning was usually completed in four foot sections on each wall that required underpinning. Laborers would excavate a trench approximately 1.2 meters from the wall to the required remediation depth but no greater than 1.2 meters. As the trench was being excavated the soil located against the foundation would be sloped at a 45 degree angle towards the inside wall of the trench. This provided sufficient support for the foundation until underpinning could be completed. Laborers would remove a 1.2 meter wide section of the soil exposing the entire bottom of the footer. Where the excavation was greater than 1.2 meters in depth, the laborers would remove the material directly under the footer to the required excavation limit. Once the material was removed a health physics technician would survey the bottom of the underpin excavation and the bottom of the footer with a sodium iodide (NaI) detector and an alpha/beta scintillation detectors. When remediation goals were achieved, the laborers would place poly sheeting around the inside of the space to keep contaminated soil from impacting the new concrete. This process

would continue until the foundation was completely supported. Once the foundation was properly supported the laborers would remove the remaining contaminated soil.

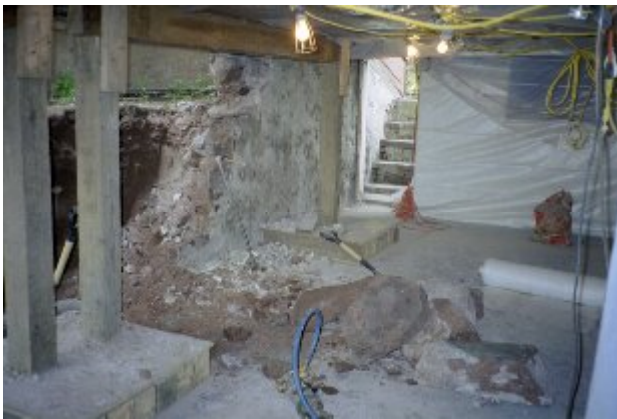
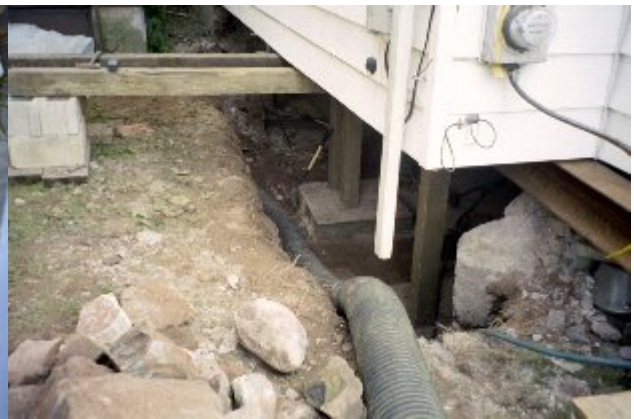
Steel beams were typically only used when the entire foundation wall had to be removed. Foundation wall removal was typically required when the mortar used was made with contaminated sand or the foundation wall was not structurally sound for underpinning. Figures 4 and 5 show a field stone wall that had to be removed to support remediation activities. This particular wall was being removed because the mortar used to build the wall contained TENORM contaminated sand.

Fig. 4 – Field Stone Wall Removal

Fig. 5 – Field Stone Wall Removal

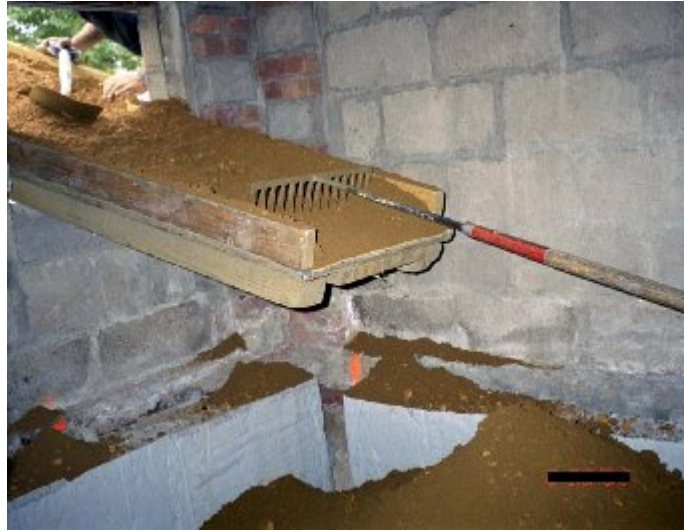
Fig. 6 Backfill Shoot

Placing backfill into the basements was labor intensive. Operations manufactured various size shoots that could be placed inside basement windows. This would allow an operator to use a small excavator or skid steer unit to place backfill material onto the shoot and have a laborer push it through the window with a shovel or rake. Several laborers would use wheel barrows to move the dirt around the basement with additional laborers grading and compacting. Figure 6 shows a typical shoot being used in a basement window.

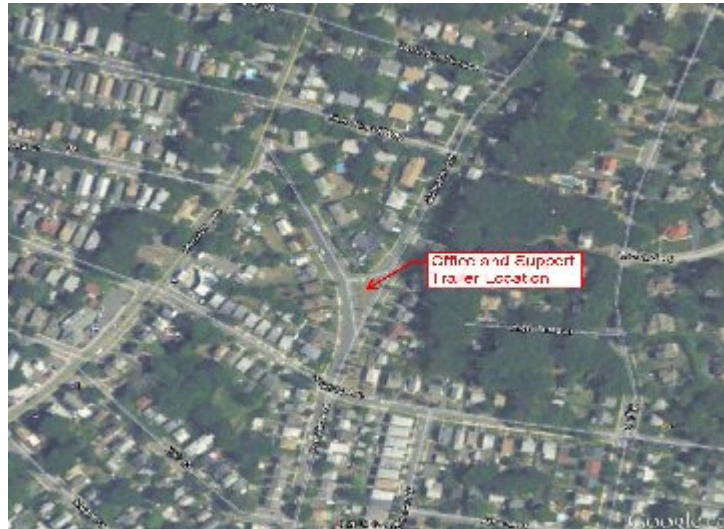
Fig. 7 – Office and Support Trailer Location

Remediation in urban areas sometimes means you are not performing work on a light industrial or commercial facility that has a designated protected site perimeter. Project sites were set up right in the middle of residential neighborhoods on available lots or dead end streets. Figure 7 shows an overview of one of the neighborhoods office and support trailers were located. Most of the houses in Figure 7 had some type of TENORM remediation performed on the property. Two particular projects were in extremely poor, rundown neighborhoods where the residents were not the property owners. This type of environment presented never before experienced situations for most of the workforce.

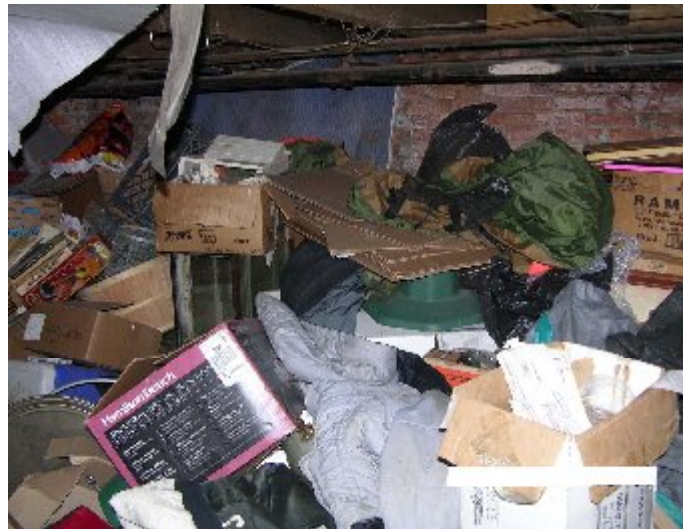
Fig. 8 Basement of Hoarder

It was not uncommon to find the condition of the properties in horrendous states of mess or clutter. Figure 8 shows an example of some of the cases. Figure 8 was taken in the basement of a hoarder. It was also not uncommon to remove as much as a 30 cubic meter dumpster full of garbage and debris from a home or property. In some cases the resident wanted all of their belongings put into storage and returned upon the completion of work.

The hoarding seen in Figure 8 also presented a biological hazard concern. Site personnel have

discovered medical sharps, animal dropping, animal carcasses, mold, insects, and wild animals. As well as illegal drugs and drug paraphernalia, and in rare cases; unexploded ordnance.
