**Facility Utilization and Risk Analysis for Remediation of Legacy Transuranic Waste at the Savannah River Site – 13572**

**Michael L. Gilles and John C. Gilmour  
Savannah River Nuclear Solutions, LLC**

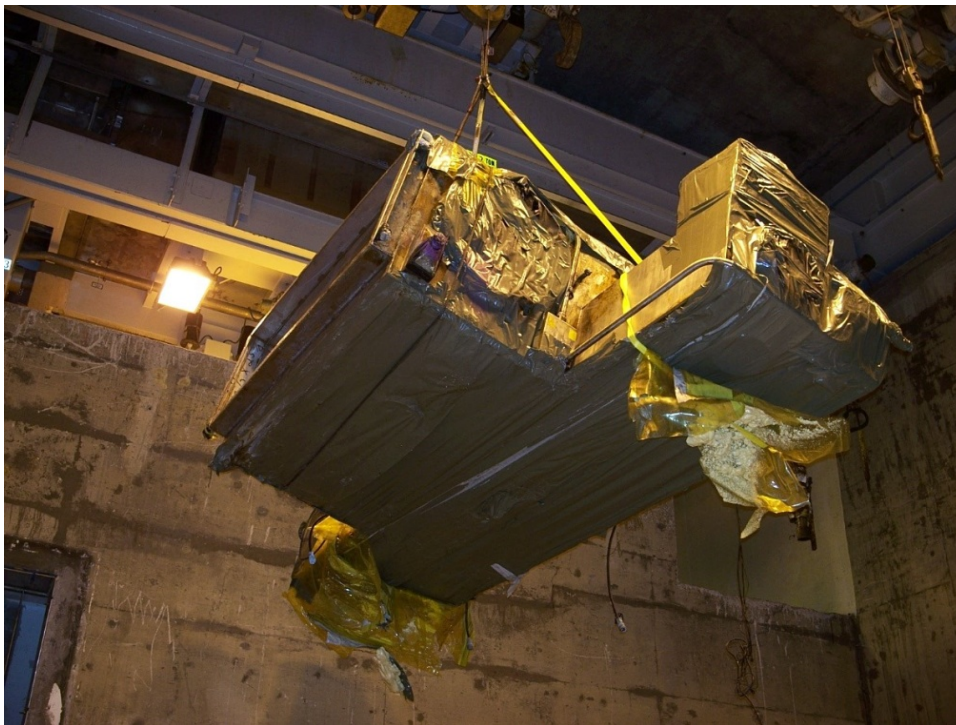
**Figure 1 – Legacy Glovebox Being Lifted in H Canyon Truckwell**

The H Canyon Truckwell (receiving bay for trucks/shipments, internal to the hardened structure) and the Warm Maintenance Shop and adjacent cell cover areas could be available to support box remediation for the ATP; however, they were not fully configured to support remediation activities. Facility modifications were required to address Life Safety Code issues due to increased, routine occupancy of these areas. These included evacuation ladders, hand rails, emergency lighting and a fire water mister in the Warm Maintenance Shop. Additional startup construction activities addressed increased power demand, pier supports, and tools and equipment needed for processing the waste. The project required higher than normal use rates on some of the Canyon equipment which necessitated a variety of equipment upgrades and repairs. For example, upgrades were needed for cell covers, the monorail cables, and motors and clutches associated with the overhead crane; numerous repairs were needed on the truckwell roll-up door due to wear and tear; and repairs were needed for a 5 ton self-expanding self-adjusting (sesa) brake on the overhead crane. A photo of a glovebox being lifted in the H Canyon Truckwell is provided in Figure 1.

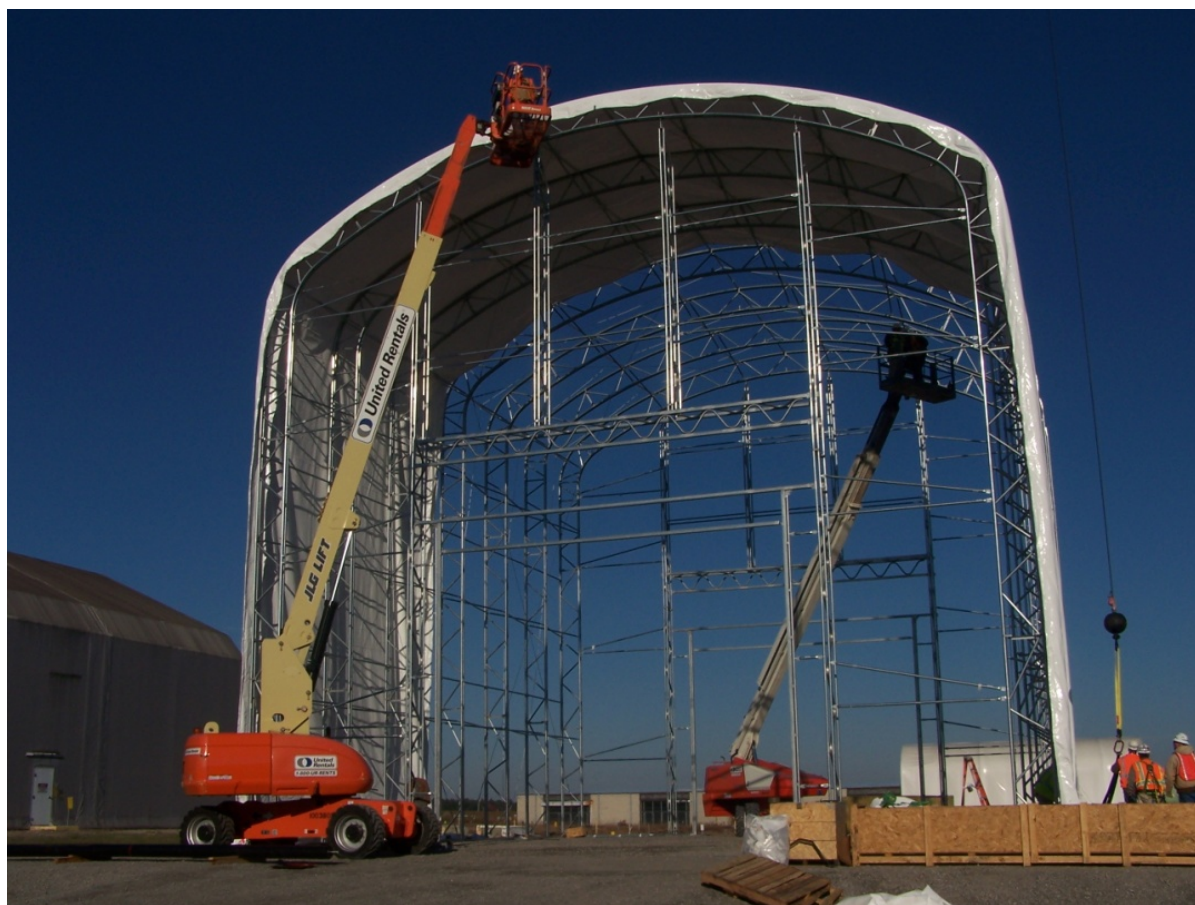
**Figure 3 – Construction of 9E Culvert Unloading Facility**

Previously, SRS had processed 8,600 m<sup>3</sup> of waste which contained 114,000 PEC, though much of the high risk containers had not been addressed. Prior to completion of the ATP, the total PEC in the remaining legacy TRU waste was 330,000 PEC. Included in the high risk legacy TRU waste were 83 concrete culverts and six concrete boxes received from offsite in the 70's stored on TRU Pad 1. These culverts contained over 6,500 inner containers and 11,000 grams of Pu-238 (190,000 curies). During initial activities for remediation of the culverts, it was discovered that water had intruded the containers and the containers were leaking, increasing the risk of radiological contamination and release to the environment. To mitigate the hazards with these leaking containers, a 1,400 ton crusher run surface was installed and a canvas-based containment with HEPA filtered exhaust was constructed. This new structure, designated 9E, commonly referred to as Big Top, is the highest structure installed in the SWMF (Figure 3). The time to construct and test the system, and complete the readiness assessment was less than 3 months.

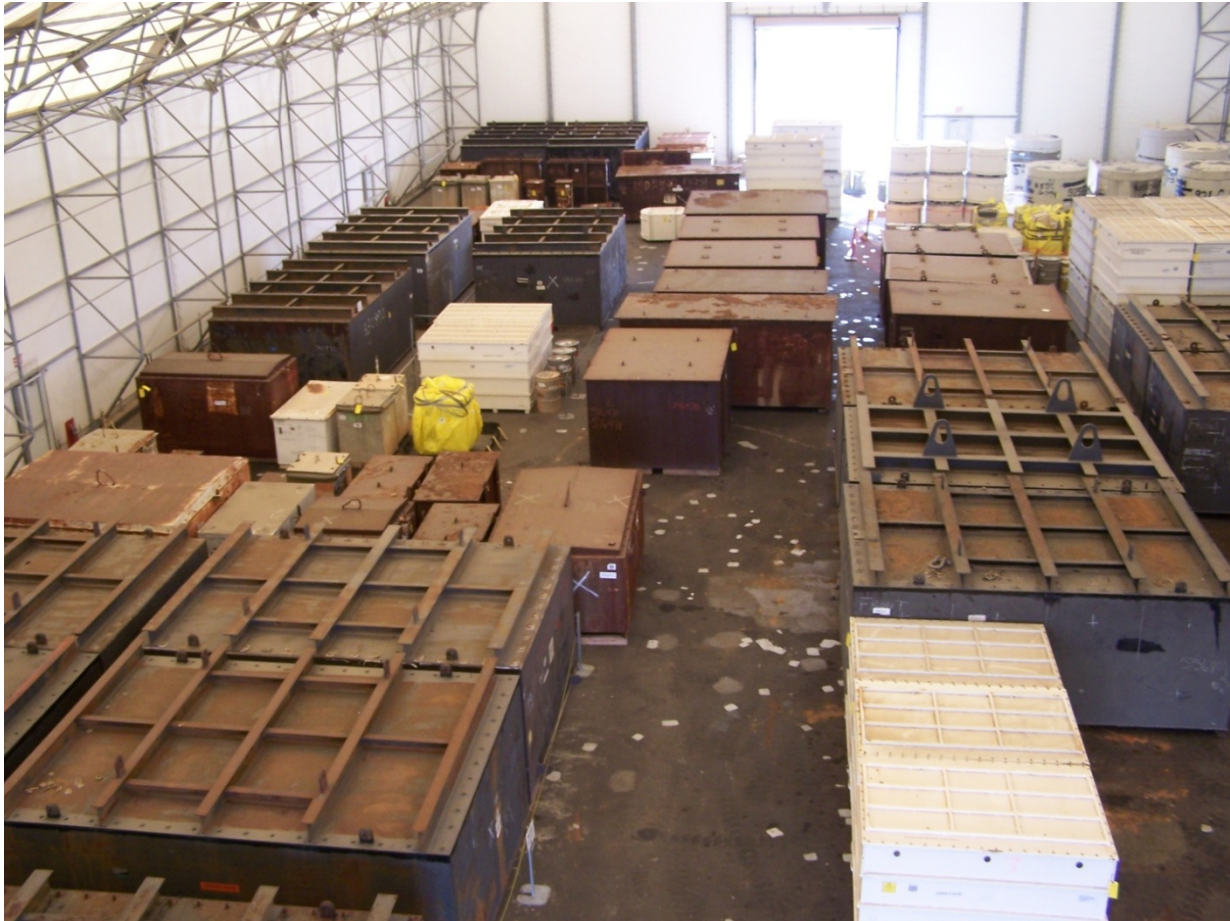
**Figure 4 – Miscellaneous steel and concrete boxes containing legacy TRU waste**

In addition to the legacy TRU waste in culverts located on Pad 1, legacy TRU waste was contained in other culverts throughout the Burial Ground and in miscellaneous steel boxes, drums, stainless steel welded "coffins", concrete casks, and polyboxes of various shapes and sizes (Figure 4). Though most of the containers had adequate integrity for movement, container integrity issues were encountered throughout the project. The 9E facility proved valuable for unpacking and repacking higher risk containers, venting special case containers, and dewatering containers with rain water intrusion.

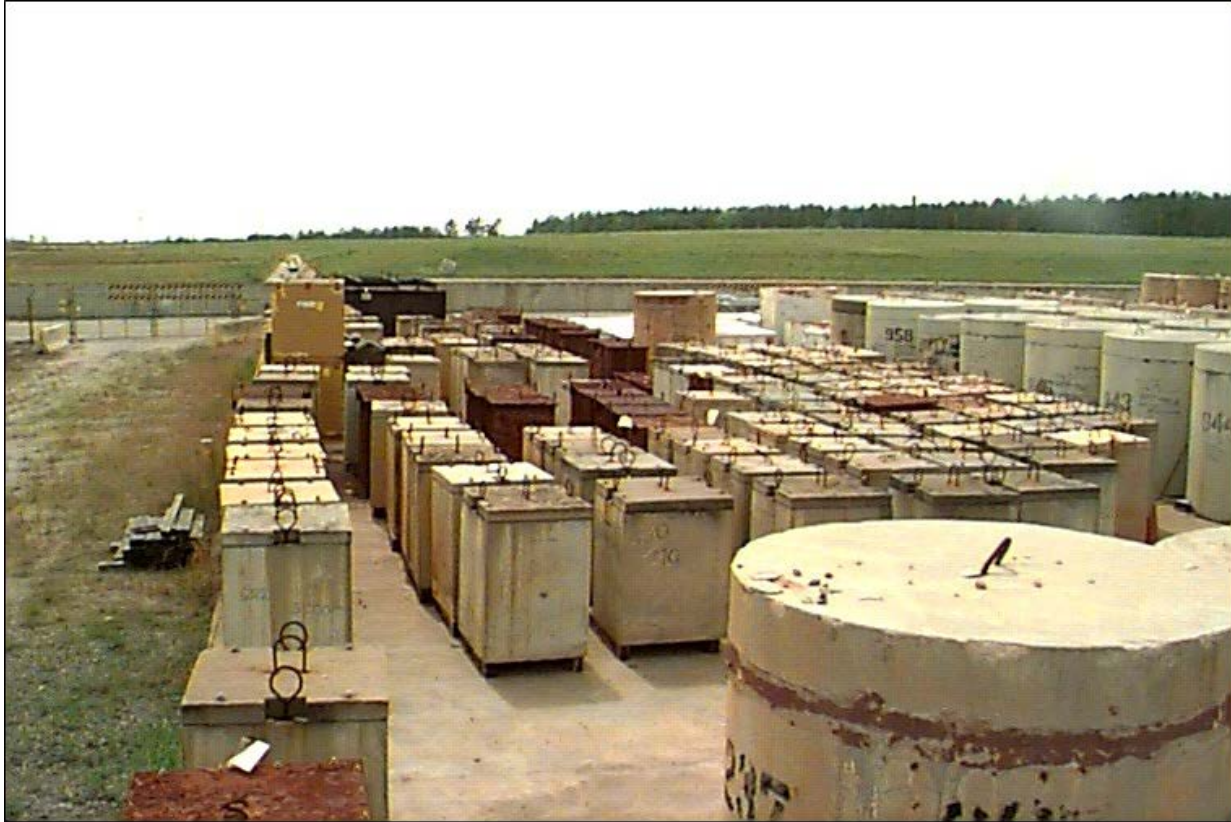
**Figure 5 – SRNL Concrete Casks on Storage Pad**

Between 1974 and 1996, SRNL generated 35 concrete casks of waste from the Hot Cells (Figure 5). The waste had been loaded remotely and was thus assumed to be Remote Handled (RH). Remediation of RH waste would require the waste to be removed from the casks and placed in 55 gallon drums. The original estimates to remediate the waste were based on deployment of either existing or portable hot cells which were cost and schedule prohibitive. As the VDT project team reviewed the details surrounding the casks, alternative ideas emerged. Radiological analysis, field x-rays, burial slips and interviews with the generating facility enabled the team to assemble the risk matrix for this waste. The concrete casks had been previously buried in the ground and had experienced flood conditions in the burial trench. As a result, rain water intruded the casks which added complexity to the handling of this waste. Considering industrial and radiological risks and the PEC/FGE associated with each container, the team determined that Cell 11 could be utilized to remediate over half of the containers and the more robust F and H Canyon box lines could be used to remediate the remaining containers with little to no impact on the safety bases. Project cost and schedule constraints were then determined to assess alternatives for waste handling and packaging. Ultimately, all three facilities were deployed for remediation of this waste stream. Preparation for the remediation heavily involved the work crews and the use of cold, to warm, to hot mockups.

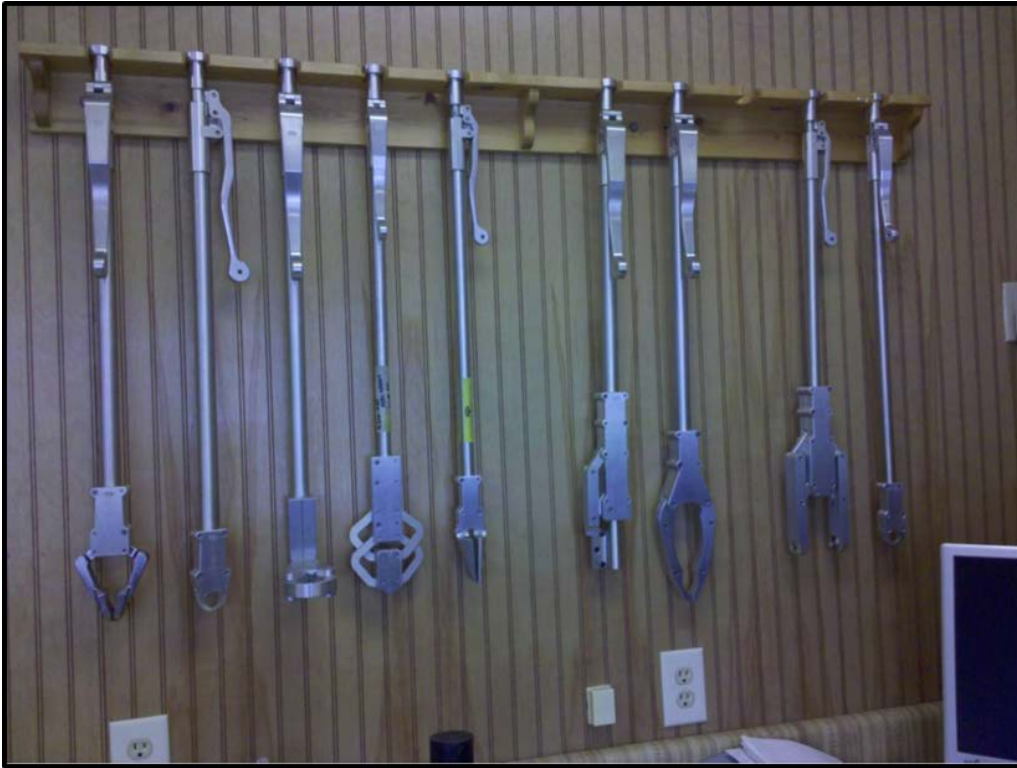
**Figure 6 – Extended Reach Tools**

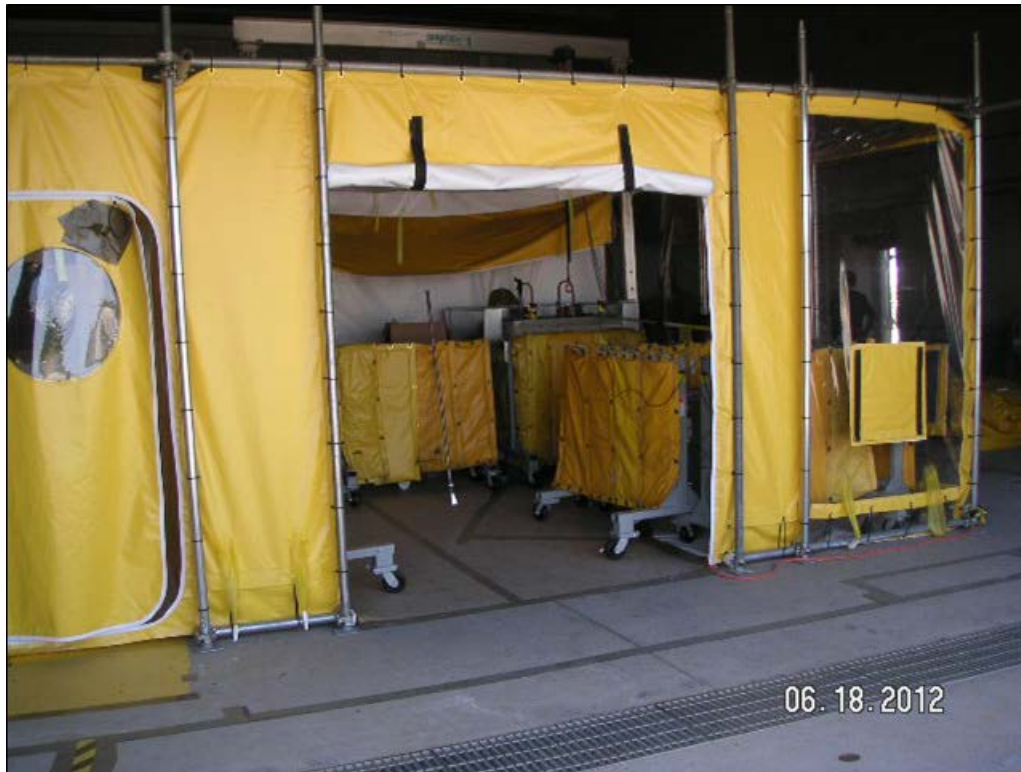
**Figure 7 – Final Cold Mockup for Cell 11 SRNL Cask Campaign**

Cold and then warm mock-ups were conducted to establish the protocol for remediating the waste. Due to less than optimal contamination controls in Cell 11, the work was conducted in a small containment structure (Figures 7 and 8). Six casks were remediated in Cell 11. During remediation activities, adequacy of the ventilation system was confirmed when a waste bag failed. The ventilation system successfully prevented air born activity and the spread of contamination. However, cost and budget considerations led to cessation of remediation activities in Cell 11. Several months later, remediation of casks began in F Area. The same tools and local ventilation were deployed in F Area, and cold mock-ups were conducted to confirm feasibility. Three low risk (low dose) casks were remediated in a hot mock-up setting, with the third cask as part of the readiness assessment. The F Canyon Box Line was shut down in

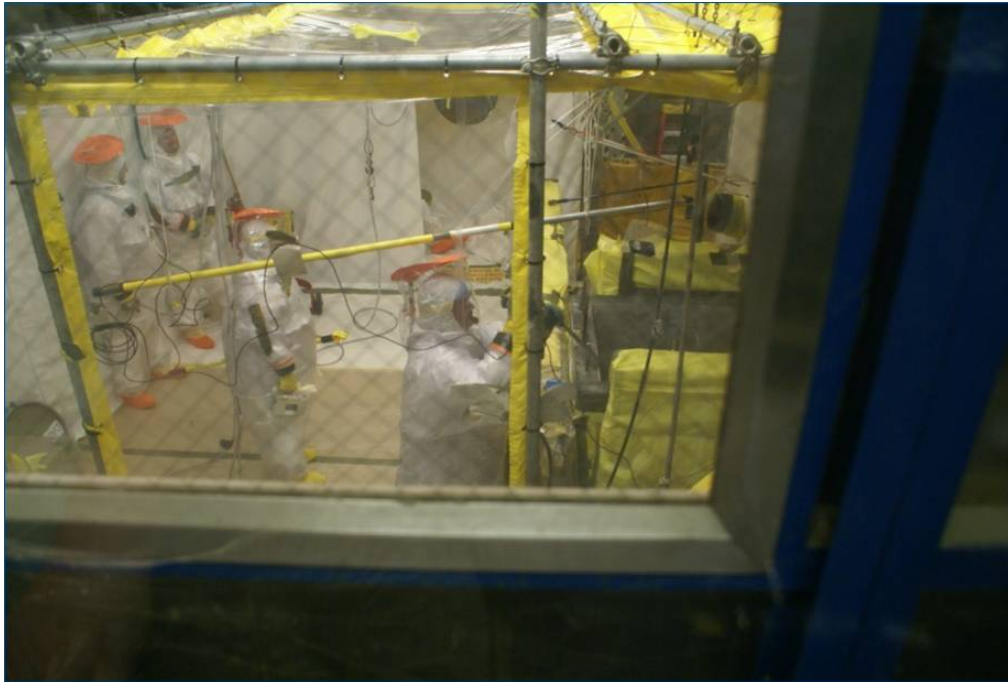
**Figure 8 – Warm Mockup in Cell 11 for SRNL Cask Campaign**
