## **Innovative Gamma Ray Spectrometer Detection Systems for Conducting Scanning Surveys on Challenging Terrain – 13583**

WM2013 Conference, February 24 – 28, 2013, Phoenix, Arizona USA

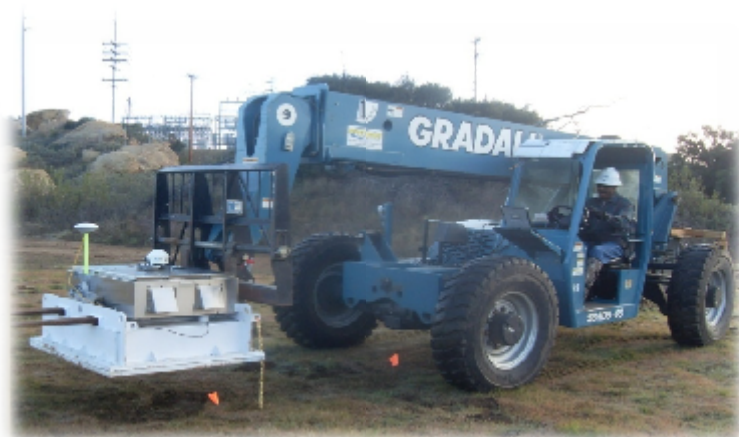
Figure 1: An ERGS II operator testing for proper scanning velocity before conducting surveys.

The shield was designed with forklift inserts allowing it to mount onto an industrial off-road

telehandler equipped with all terrain wheels (Figure 1). A telehandler is similar to a forklift, but with an extension boom with forks, wider chassis, off-road wheels, hydrostatic transmission, and other features to increase maneuverability on variable terrain and soil conditions.

preexisting Enhanced Radiation Ground Scanner I (ERGS I) detection system. The purpose of the ERGS I was to conduct ground surveys at select radioactive waste sites and during emergency responses. The ERGS II was very similar to the ERGS I and consisted of eight NaI(Tl) scintillation detectors enclosed in a lead and stainless steel shield.

Due to the offset center of gravity, weight, and large turning radius of the telehandler, the ERGS II was operated primarily in open, flat or moderately sloping terrain. It was the preferred detection system because of its wide field of view (FOV), mobility, and high detection sensitivity.

The ERGS II consisted of two RSI RSX-4 detector units. Each RSX-4 contained a set of four 4-liter NaI(Tl) detectors housed in a carbon fiber casing. The two carbon fiber cases were enclosed in a lead and stainless steel shield designed by USEPA and constructed by Radiation Shielding,

Inc. The electronic components were housed separately, on top of the shield. Both RSX-4 units were connected to an RSI RS-501 data storage console, which was also connected to GPS. Spectral and GPS data was transmitted via wireless router to a laptop mounted in the operator's cab of the telehandler, providing display of real-time data.

The detector was positioned so it was parallel to the ground at a height of 15 inches by adjusting the forks and boom of the telehandler. Plastic guide chains were affixed to the ERGS II shield and provided a visual aid to the operator to ensure the proper height was maintained during scanning surveys. The operator viewed the ends of the chains touching the ground and received assistance by radio or hand gestures from an assistant prompting adjustments as necessary. To ensure that 100% of the accessible ground surface was scanned, a transect width of 72 inches was selected, which was approximately 85% of the calculated 86 inch FOV. Thus, an overlap of the FOV was obtained when scanning adjacent transects ensuring complete surface coverage. The operator maintained a maximum scanning velocity of 2 feet per second by monitoring the velocity through ArcPad®, which was modified to display velocity. Additional velocity control mechanisms were used depending on the specific telehandler in use; e.g., an adjustable rheostat for the throttle.

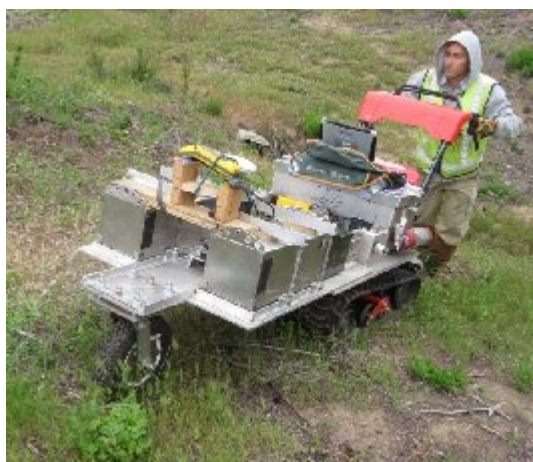
Figure 2: TMGS operator conducting a gamma scanning survey on a steep gradient.

scintillation detectors in an individual carbon fiber casing partially enclosed (rear of detector case that contained only electronics was not shielded to reduce weight) in separate lead and stainless steel, copper-lined shields (Figure 2). The copper attenuated the 59 KeV gamma ray created from the interaction of higher energy gamma rays with the stainless steel and lead. The detectors were mounted on a modified CanyCom Model BP419, off-road, dual rubber-track carrier. The TMGS replaced the Wheel-Mounted Gamma Scanner (WMGS), not presented in this article, that caused excessive operator fatigue and did not perform efficiently on rough surfaces. The TMGS was capable of safely scanning significantly steeper slopes than the other

The TMGS was powered by a gasoline engine and featured hand controls for starting, stopping, steering, and changing gears. The detectors were mounted to the CanyCom body on an aluminum frame custom designed by the USEPA. The detectors on the TMGS were mounted parallel at a distance of 18.5 inches apart, as measured from the centerline of the detectors. A mounting bracket

acted like a hinge to allow the detectors to move vertically for increased maneuverability on uneven terrain. A swivel wheel was installed on the front end of the carrier for maneuverability. Two modifications were made to enhance the durability of the TMGS in rough terrain; first, the solid rubber tracks were upgraded to the rubber integrated with forged steel to prevent the tracks from ripping, tearing, and stretching, and second, the stock yokes were upgraded to forged steel.

The TMGS electronics were contained in a metal case affixed to the vehicle. The case protected the contents from sudden inclement weather, damage if the vehicle rolled over, and airborne dust. Both detectors were connected to an RSI RS-701 data storage console, which was also connected to GPS. Spectral and GPS data was transmitted via wireless router to a laptop mounted on the CanyCom, providing display of real-time data.

The detectors were positioned parallel to the ground at a fixed height of 15 inches, requiring no adjustments by the operator as the hinged detector platform maintained the detectors at proper height. To ensure that 100% of the accessible ground surface was scanned, a transect width of 56 inches was used which was approximately 85% of the calculated 48 inch FOV. Thus, an overlap of the FOV was obtained when scanning adjacent transects ensuring complete surface coverage. A velocity test determined that the vehicle should not exceed full throttle in fourth gear to maintain a maximum scanning velocity of two feet per second. Reverse low was used while backing up. In conformance with project health and safety standards, the TMGS was operated on slopes up to 25 degrees. However, the vehicle was capable of accessing steeper gradients.

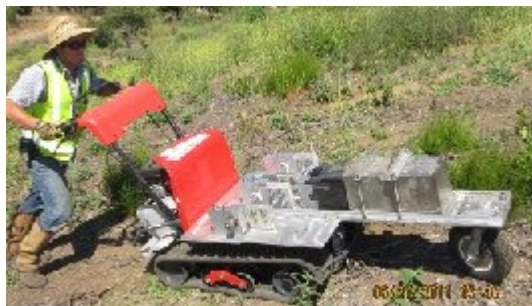
Figure 3: STGS operator conducting a gamma scanning survey on a steep gradient.

was designed for a single RSI RSX-1 detector (Figure 3). The STGS was more maneuverable than the TMGS but with a lower detection capability. Like the TMGS, the detector was positioned parallel to the ground at a fixed height of 15 inches. To ensure that 100% of the accessible ground surface was scanned, a transect width of 36 inches was used, which was approximately 85% of the calculated 30 inch FOV. Thus, an overlap of the FOV was obtained when scanning adjacent transects ensuring complete surface coverage. The STGS had a maximum two

foot per second velocity and 25 degree slope gradient requirement like the TMGS.

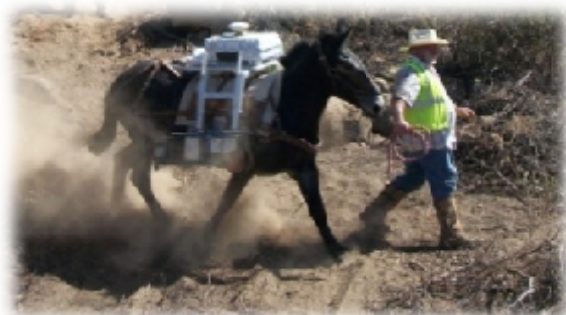
Figure 4: A mule handler leads the MMGS while conducting a gamma scanning survey on rough terrain.

scintillation detectors in an individual carbon fiber housing partially enclosed (rear of detector case that contained only electronics was not shielded to reduce weight) in separate lead and stainless steel, copper-lined shields and the mule provided additional shielding on the inner sides of the detector. The detectors were attached to a metal frame with outriggers on each side of a

modified mule saddle and harness, called the mule rig (Figure 4). The mule rig was mounted onto a mule (*Equus mulus*) guided by an experienced mule handler while a field

technician provided additional guidance and technical support. The MMGS was developed and employed for its maneuverability and ability to scan steep, rough, and vegetated terrain. It was also selected to scan in archeologically and biologically protected sites for its low impact and minimal ground disturbance where mechanized vehicles were not allowed to operate.

Several mules were trained and deployed. Thus, the mule rig and outriggers were adjustable to maintain a constant detector-to-ground height and to allow for modest adjustments when different animals were deployed (the size and leg length of each mule varied). The mule rig was upgraded from steel to a primarily aluminum to reduce the weight and mule fatigue. All electronics were

contained in a weatherproof, electronics housing affixed to a platform attached to the top of the mule rig.

Both detectors were connected to an RSI RS-701 data storage console, which was also connected to GPS. Spectral and GPS data was transmitted via wireless router to a laptop carried by a field technician, providing display of real-time data.

The detector height was set at 35 inches. The height of the detectors oscillated slightly as a natural consequence of the mule's gait. Periodically the mule rig needed adjusting and repositioning to maintain the correct height and to secure the rig to the mule. To ensure that 100% of the accessible ground surface was scanned, a transect width of 90 inches was used, which was approximately 85% of the calculated 104 inch FOV. Thus, an overlap of the FOV was obtained when scanning adjacent transects ensuring complete surface coverage. In addition, the field technician viewed the scanned surface coverage and followed behind or ahead of the MMGS and marked the ground with environmentally safe spray paint as a guide to the mule handler.

The mules were extensively trained to respond to commands given by the handler. They were taught to walk slowly, a challenging objective, in an attempt to maintain a maximum velocity of 3 feet per second. Occasional excursions beyond the maximum velocity were deemed acceptable as controlling a mule at all times was not possible or feasible. However, mainly due to the operating height, the MMGS was not as sensitive to variances in scanning velocity as the other detection systems.
