The Role of Gamma-ray Imaging in Performing Radiological Characterisation at the Magnox Storage Ponds at the Bradwell Decommissioning Site – 13628

Karl Hughes and Tracey Shaw
Babcock International, B14.1, Sellafield, Cumbria, CA20 1PG, UK

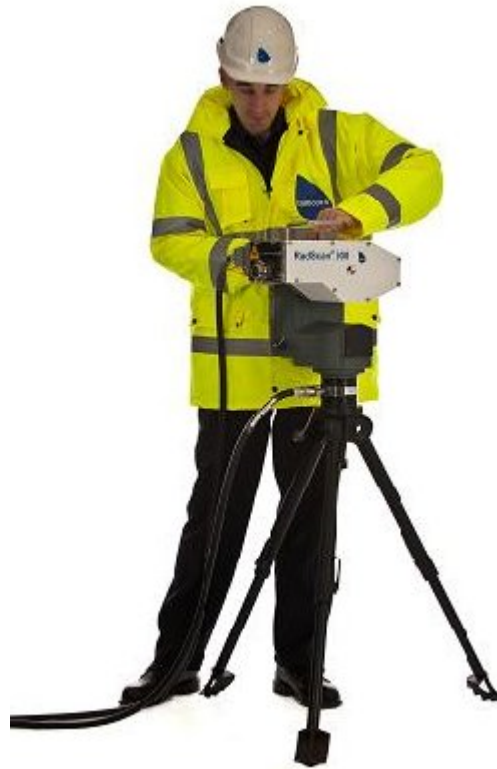
A photograph of the RadScan gamma-ray imaging unit is shown in Figure 3, showing the inspection head which was deployed into the ponds area. The system is controlled from a workstation, connected to the measurement head by an 80 metre umbilical cable, which was located in an adjacent area of lower dose and contamination. RadScan was first deployed into the Main North Pond, and then subsequently into the Main South Pond. To optimise the view to the walls and floors of the pond, RadScan was deployed on both sides of the pond, and at various positions along the length of the pond.

Fig. 3. A photograph of the RadScan gamma-ray imaging system.

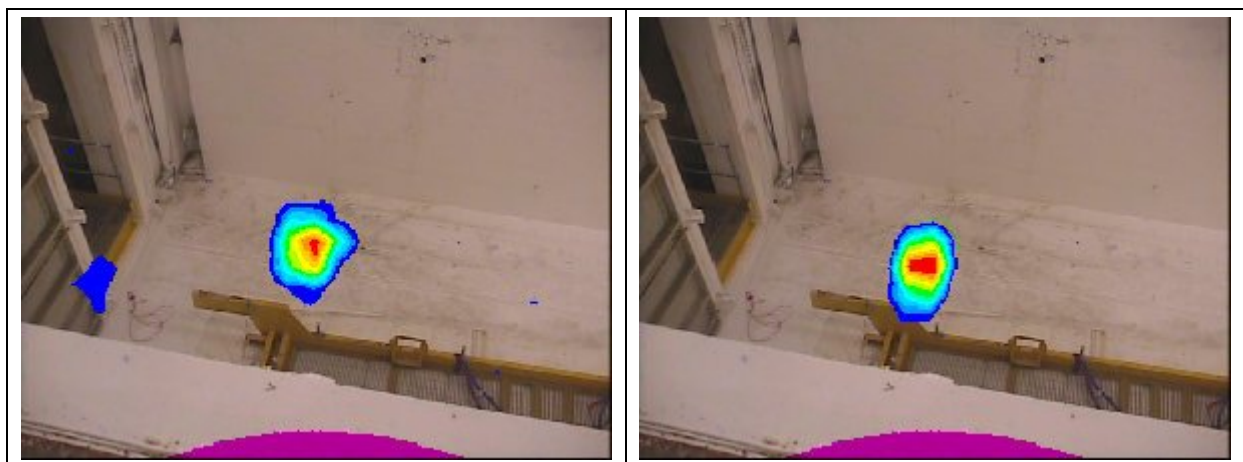
Fig. 8. Detail of the most intense hotspot in the South Main Pond shown for Co-60 (left image) and Cs-137 (right image).

The scans of the two ponds identified a number of similarities and differences between the distributions of contamination between the two ponds. In both cases the majority of the activity was dominated by Cs-137 with occasional, discrete Co-60 hotspots being present. Only on one of the ponds was there any contamination associated with the wind-water line. The surveys also highlighted that contamination was associated with specific construction joints that run across the width of the pond. There was no evidence, in either of the ponds, for the presence of contamination being associated with rails that run the entire length of each pond (these were the rails upon which the spent fuel flasks were positioned when the ponds were operational).
