Campoverde Decommissioning of Former Controlsonic Deposit – 14036

Giovanni Zorzoli, Campoverde SRL

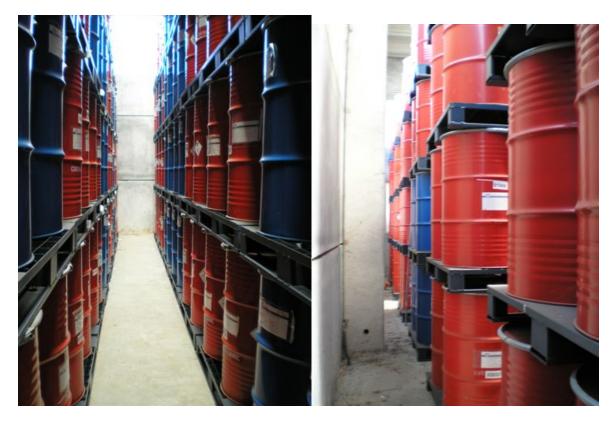
Figure 1 and 2 – Controlsonic deposit, with no space for the movement of the drums.

The work had a first part of preparation, in order to study in which order analyze the drums, mainly because the space available was very limited, as shown in the figure 1 and 2.

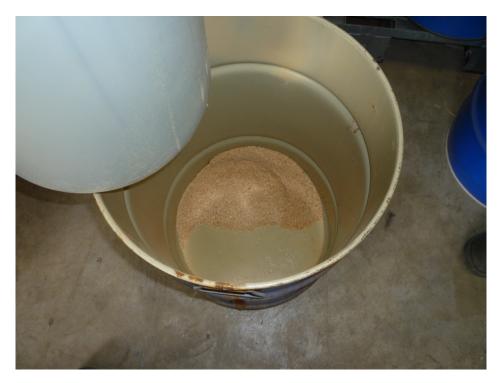
Figure 3 – The bottom of the drum is checked: in this case, the drum isn't replace for the transportation.

The area for the intervention consists of a steel tank on which was placed, one by one, the drum that had to be checked. The first thing done was the test of the bottom and the internal side of the drum (as shown in Figure 3); if these would have been ruined or unsuitable for the transportation, the drum would have been replaced with one validated for the transportation (type A drum). On the substituted drums, smear test were taken, in order to determine the future of the empty drum: reuse (if the drum wasn't contaminated) or disposal as a radioactive waste (if contaminated). On the small tank inside the drum both Campoverde and ARPA were doing measurements. Once confirmed that the waste was no more radioactive, the drum was directed to the final disposal.

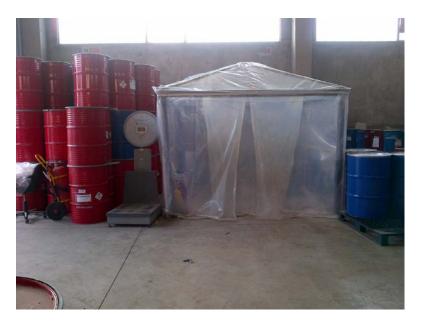
Figure 4 – The "little house" for the treatment of the solid waste.

Inside the deposit, an area for the treatment of the solid waste has been created: a steel tank was put above some plastic cloths. Then, a small house has been built, with wooden beams, plastic covering and an aspiration system (Figure 4).

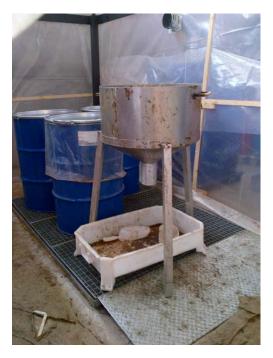
Figure 5 – The grill on which the drums were opened.

Each drum containing solid waste was taken inside the house and, once opened, the vials were divided from the dry solid and the liquids thanks to a grill: the bag containing the vials was opened on the grill (Figure 5) in order to make the liquid drain on a underlying tank, while dry solid and vials were put in two different drums. In this way there has been a clear distinction between the three kind of waste (liquid, dry solid and vials).

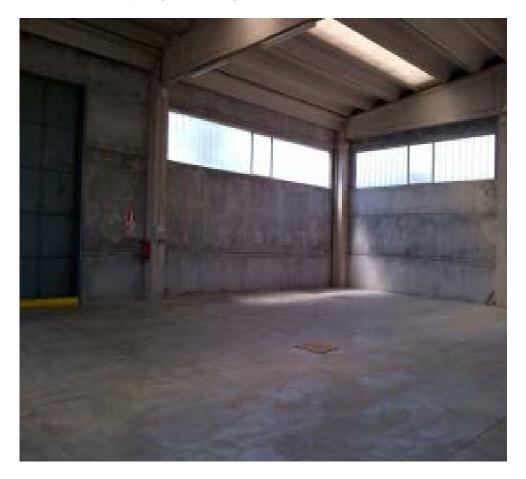
Figure 6 – Controlsonic deposit after the decommissioning.

After two months of real hard work, Campoverde completed the decommissioning of Controlsonic deposit. All the repackaged wastes had been transferred to Campoverde deposit, and the warehouse was left with anything inside (Figure 6).

In the weeks after the end of the operations, ARPA Piemonte did some measurements inside the warehouse (smear test to check the surface contamination, controls with a portable

spectrometer), in order to exclude the presence of contaminated areas. All the measurements pointed out that there was not any surface contamination. So, for the local authority, the warehouse had to be considered free from any radiological constrain, and therefore available to host any kind of conventional activity.
