Overview of Hanford Single Shell Tank (SST) Structural Integrity - 14203

Rick Rast, P.E.
Washington River Protection Solutions, WRPS
P.O. Box 850 MSIN
Richland, WA 99352-58
Richard_S_Rast@rl.gov
(509)-376-6056

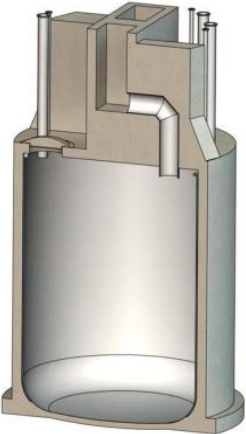
<p>Type I Single-Shell Tank:</p> <ul style="list-style-type: none"> • Diameter = 20-ft • Height = 25-ft 7-in • Wall Thickness = 12-in • Footing Thickness = 18-in • Concrete design strength = 3000-psi • Rebar yield strength = 40,000-psi • Capacity = 55-kgal

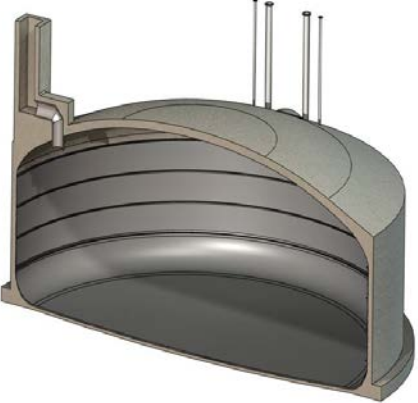
<p>Type II Single-Shell Tank:</p> <ul style="list-style-type: none"> • Diameter = 75-ft • Wall Height = 21-ft • Wall Thickness = 12-in • Dome Height = 8-ft 8-in • Dome Thickness = 15-in • Footing Thickness = 24-in • Concrete design strength = 3000-psi • Rebar yield strength = 40,000-psi • Capacity = 530-kgal

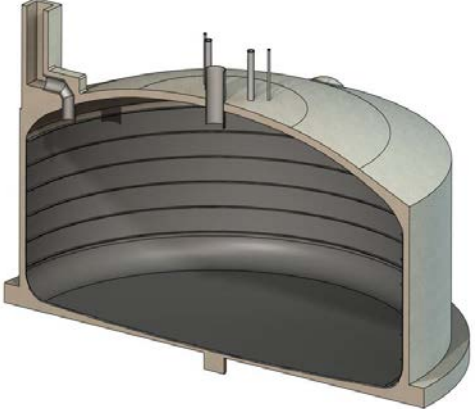
<p>Type III Single-Shell Tank:</p> <ul style="list-style-type: none"> • Diameter = 75-ft • Wall Height = 27-ft • Wall Thickness = 15-in • Dome Height = 8-ft 8-in • Dome Thickness = 15-in • Footing Thickness = 24-in • Concrete design strength = 3000-psi • Rebar yield strength = 40,000-psi • Capacity = 758-kgal

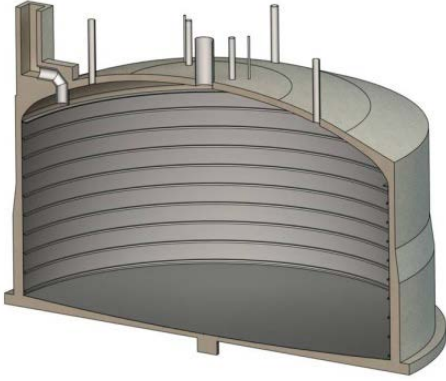
<p>Type IVa Single-Shell Tank:</p> <ul style="list-style-type: none"> • Diameter = 75-ft • Wall Height = 35-ft 8-in • Upper Wall Thickness = 15-in • Lower Wall Thickness = 24-in • Dome Height = 8-ft 9-in • Dome Thickness = 15-in • Footing Thickness = 23-in • Concrete design strength = 3000-psi • Rebar yield strength = 40,000-psi • Capacity = 1000-kgal

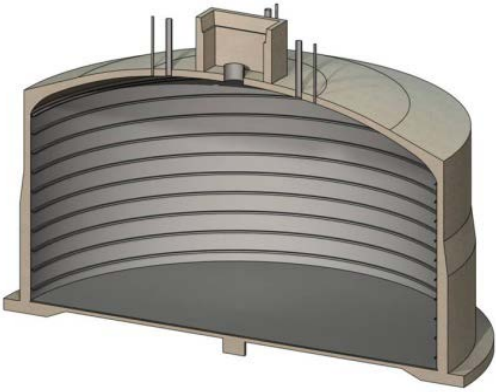
<p>Type IVb Single-Shell Tank:</p> <ul style="list-style-type: none"> • Diameter = 75-ft • Wall Height = 37-ft • Upper Wall Thickness = 15-in • Lower Wall Thickness = 24-in • Dome Height = 8-ft 9-in • Dome Thickness = 15-in • Footing Thickness = 24-in • Concrete design strength = 3000-psi • Rebar yield strength = 40,000-psi • Capacity = 1000-kgal

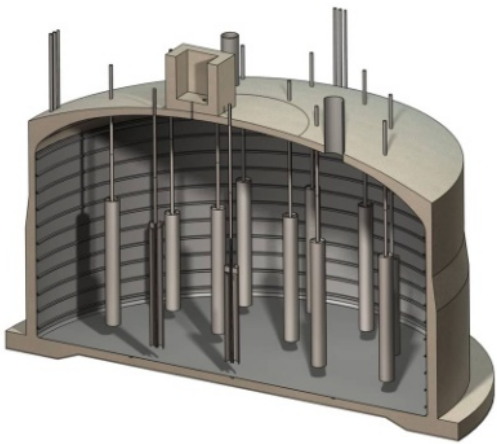
<p>Type IVc Single-Shell Tank:</p> <ul style="list-style-type: none"> • Diameter = 75-ft • Wall Height = 38-ft • Upper Wall Thickness = 15-in • Lower Wall Thickness = 24-in • Dome Height = 6-ft 9-in • Dome Thickness = 15-in • Footing Thickness = 36-in • Concrete design strength = 4000-psi • Rebar yield strength = 40,000-psi • Capacity = 1000-kgal

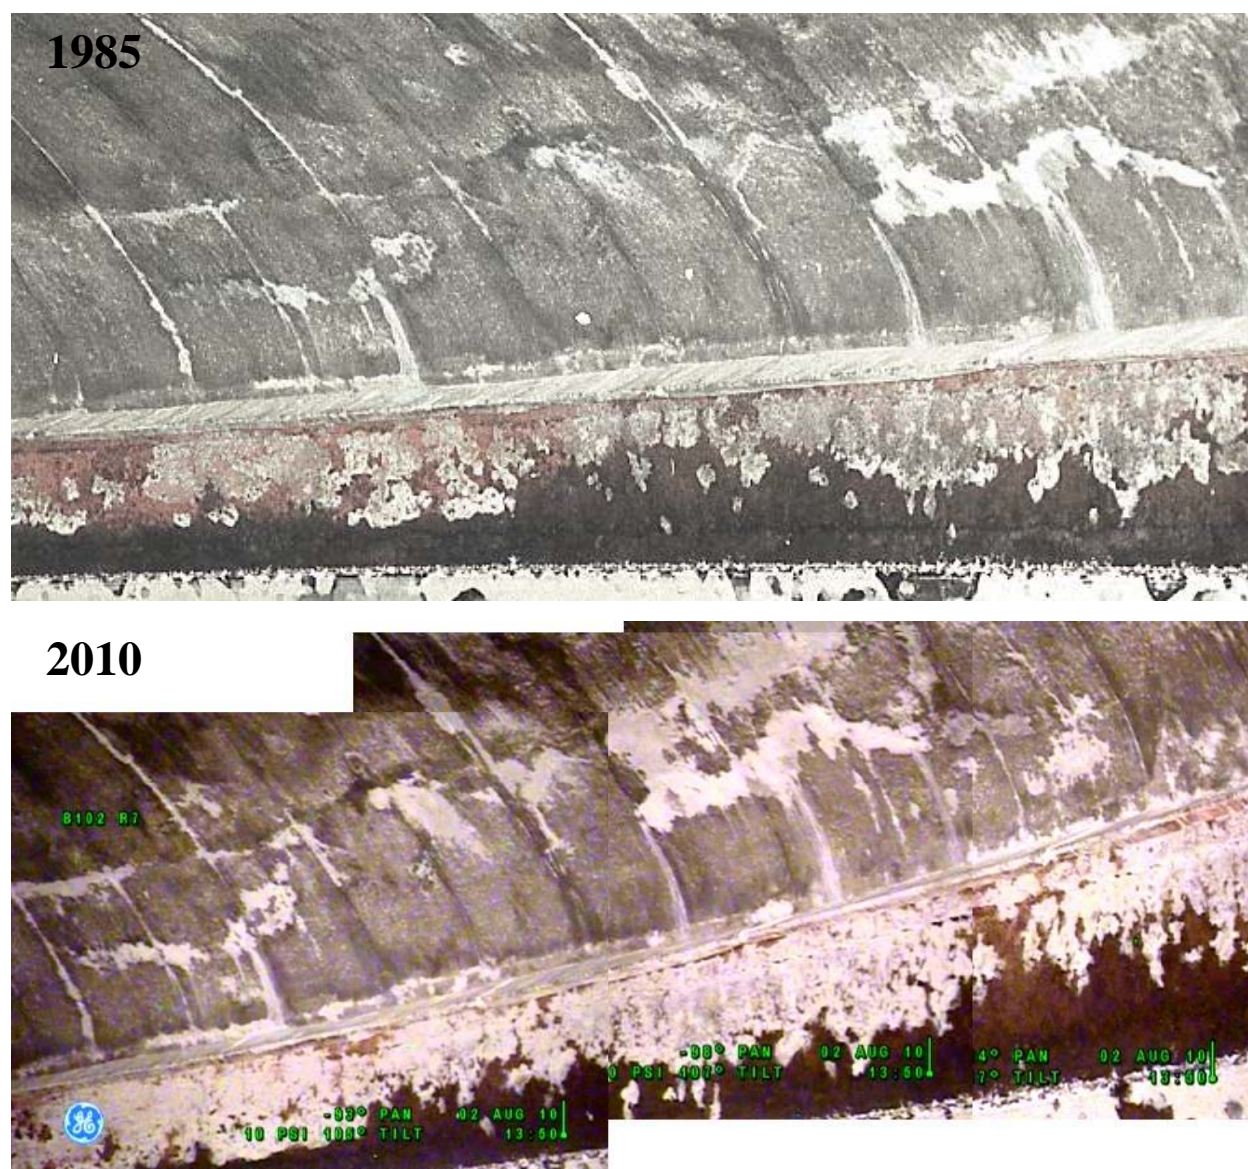
Where possible, images from current in-tank inspections were compared to historical images of the same region. A photo comparison of 241-B-102 is provided in Figure 7. Visual inspection of Tank 241-B-102 and all other tanks inspected in FY 2010 and FY2011 did not reveal any degradation of the concrete dome and haunch.

Figure 7. Comparative Photographs of Tank 241-B-102 Haunch Region

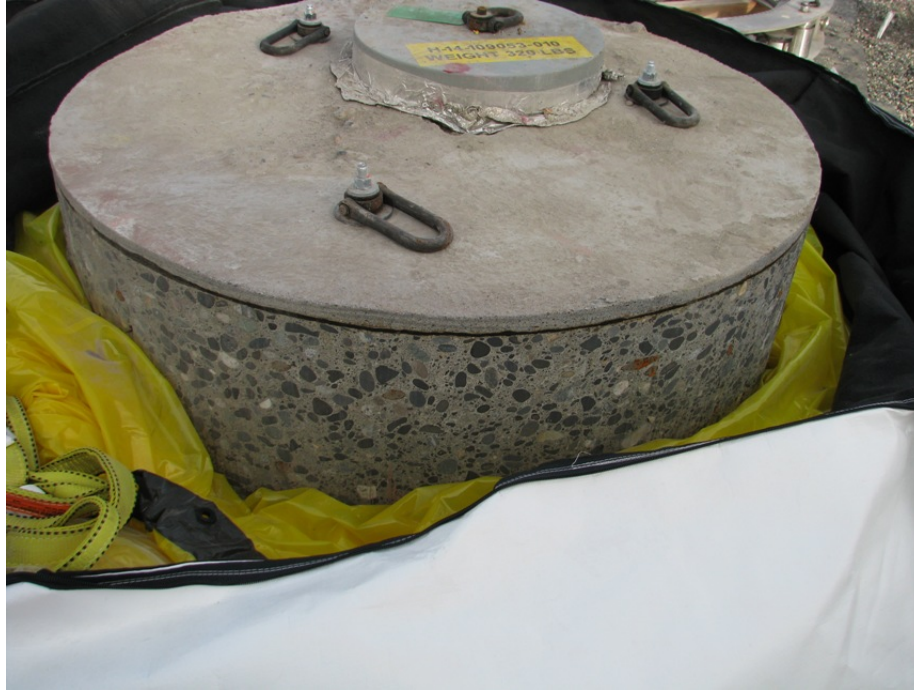
A 55-inch diameter section of reinforced concrete (RC) was removed from the dome of C-107 in December 2010 [7]. The RC section was removed completely intact, double wrapped in plastic, and placed in an isolated area in 241-C farm. Figure 8 displays the unwrapped, intact 55-inch section of RC removed from 241-C-107.

Figure 8. SST 241-C-107 Dome Plug

The field inspection revealed that the concrete was in good condition, with no noticeable cracks or voids. The placement of the rebar generally matched the design drawings, with the benefit of slightly more concrete cover than designed.

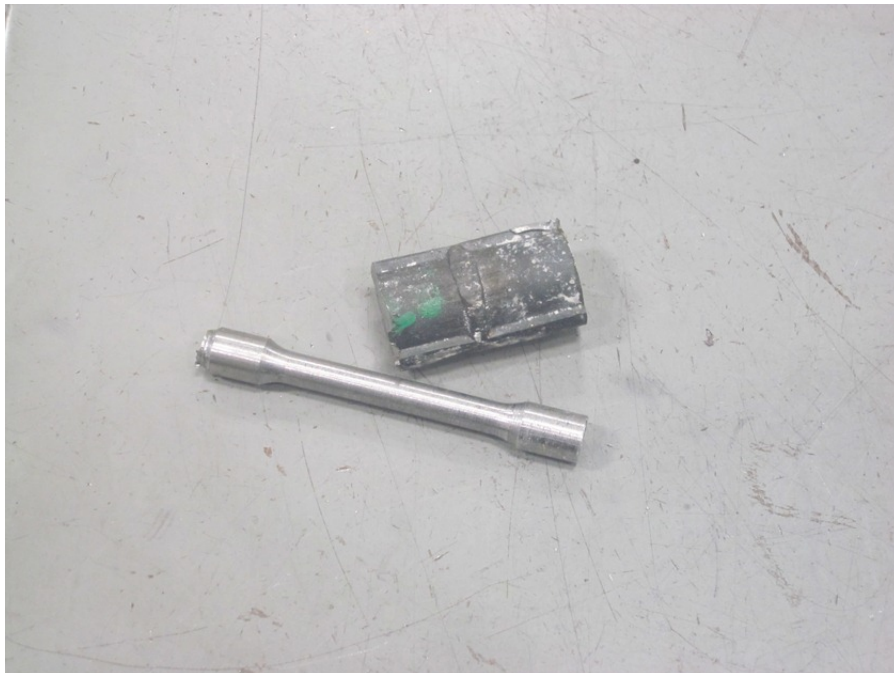
Forty-eight specimens were loaded in the calibrated test frame in accordance with test procedures described in ASTM A370. The test data provided included yield and tensile strengths, modulus of elasticity, and percent elongation. The yield strength was determined using the 0.2% Offset Method, in accordance with ASTM A370. An example of an ASTM A370 test specimen is shown in Figure 8. Results of A370 tension testing are presented in Table III.

Figure 9. C-107 ASTM A370 Specimen

The C-107 rebar were segregated based on length. The five specimens 28 inches or longer were subjected to ASTM A615 [15] testing and not modified prior to testing. With the exception of Sample 44, specimens less than 28 inches long were cut, machined, and reduced to the size required for ASTM A370 [16] testing.

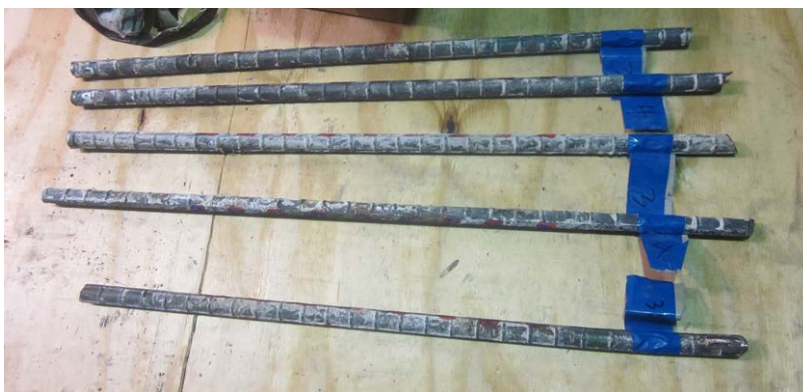
Five rebar pieces were 28 inches or longer, as received. These rebar samples were tension tested as full rebar sections, in accordance with ASTM A615. An 8 inch gauge length with 2 inch gauge marks was provided between the load frame grips. An example of the rebar test specimen prepared for testing is provided in Figure 10. The results of the tension tests on the full section rebar are provided in Table IV

Figure 10. C-107 ASTM A615 Tension Test Specimens

Including A370 and A615 test results, the average yield strength of all the C-107 rebar is 47.24-ksi. This value is greater than the 40-ksi yield strength for the Grade 40 rebar specified in the original tank construction and therefore greater than the value used in the Analysis of Record. This is expected as the 40-ksi yield strength is a minimum value with nominal values typically higher
