**Development and Deployment of the Extended Reach Sluicing System (ERSS) for Retrieval of Hanford Single Shell Tank Waste – 14206**

Roger Bauer \*, Reed Figley \*, Alex Innes \*\*

\* Washington River Protection Solutions

\*\* AGI Engineering, Inc.

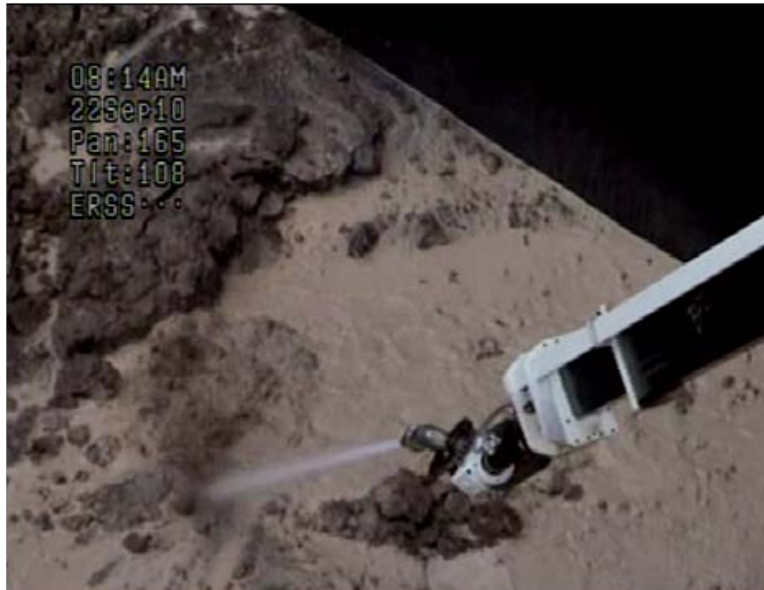
The prototype ERSS was designed, manufactured, and tested over approximately a three and a half month period during the summer of 2010. The prototype was tested by AGI at the factory and shipped to Hanford for further tests. After testing the ERSS at the Hanford Cold Test Facility (Figure 9), the unit was shipped back to the manufacturer for further testing and upgrades.

**Figure 8 - Prototype ERSS Testing at the Hanford Cold Test Facility**

Based on the Cold Test Facility experience, minor updates were made to the unit in order to ensure proper hose reel operation, improve hose management, and reduce boom deflection and rebound during mast transverse movements. Additionally, any damage resulting from testing, shipping or handling was corrected.
