Discovery of the First Leaking Double-Shell Tank- Hanford Tank 241-AY-102 – 14222

* Washington River Protection Solutions LLC, Richland, WA 99352

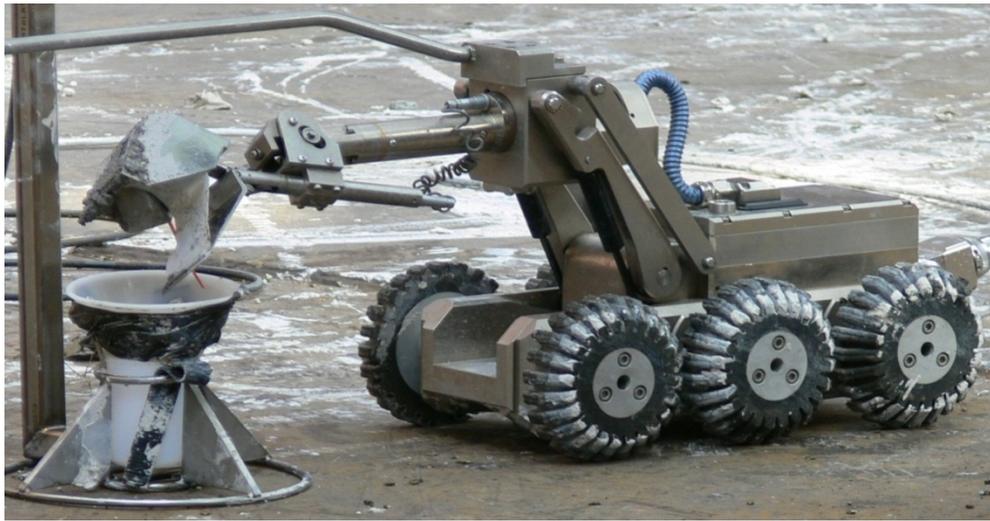
As this was a first-of-its-kind task, a method for obtaining samples of the material in the annulus was needed. The Off-Riser Sampling System, shown in Fig. 2, was the only available remote sampler at the Hanford tank farms that was fit for this task. This sampler was equipped with a scoop that could obtain material off the floor, but it would not be able to obtain material from the air-slot or mound locations near Riser 90 as designed. The consistency of these materials was unknown, and the location of a majority of the material near Riser 90 was not conducive to using the Off-Riser Sampling System (Fig. 2). Therefore, a second remote sampler was required.

Fig. 2. The Hanford tank farms Off-Riser Sampling System.

Once deployed through Riser 91, the Off-Riser Sampling System (Fig. 2) was maneuvered over the three thermocouple conduit pipes and a sample was collected. The thermocouple conduit pipes were very difficult to maneuver over and resulted in many tumbles of the sampler and, ultimately, terminal damage to the sample scoop. One scoop of sample material was collected from this location and taken to the laboratory for analysis. Additionally, it was observed that the material at this location was wet under the dry solid surface. The sampler left wet tracks on the annulus floor after it drove through the material in an attempt to collect samples.

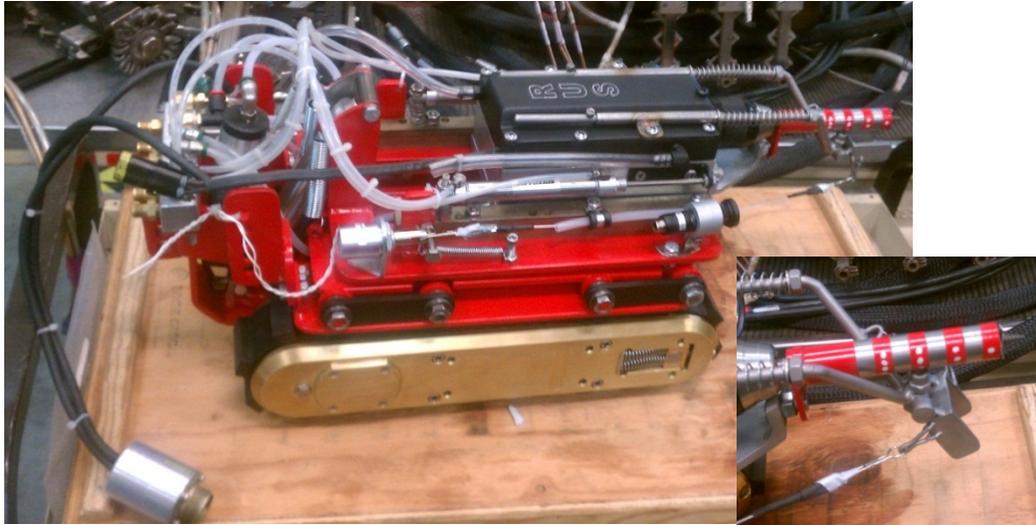
Within 10 weeks, the Remote Underground Sampler (Fig. 3) was designed, fabricated, tested, certified, and deployed into the 241-AY-102 annulus through Riser 90 to collect samples. This tool was designed by modifying off-the-shelf robotics and parts to collect potentially hard

material, as the annulus materials' consistency and texture was unknown. The sampler's primary collection mechanism was an auger bit within a sleeve. A scoop was positioned underneath the end of the auger to collect any material that was not collected in the sleeve. This scoop was designed to dump material into a sample container as well as compress back toward the sampler through compression springs as the auger bit and sleeve were pushed further into the sample media. This was incorporated into the design so the bit could take a full depth sample and the scoop would not hinder its progress. Additional capabilities included an air actuated tilt and rise function for the sampler platform and a camera and light attached in order to aid the operator during its remote maneuverability.

Fig. 3. The Remote Underground Sampler designed to collect material from the annulus sample locations near Riser 90.

Prior to the Remote Underground Sampler's deployment into the annulus (Fig. 3), a mock-up test was performed to ensure it was capable of performing all of the required functions. The mock-up test, performed at AREVA Federal Services LLC, included deploying the sampler through a glove bag and 0.30 m riser, maneuvering the sampler in a 0.76 m wide space using the attached and remote cameras deployed in the mocked-up riser, maneuverability in a space typical of where the "mound" was located, collecting a sample of material from a salt block at a mocked-up version of the "air-slot" location, and then depositing the material into the sample bottle for collection through the glove bag. The results of this limited mock-up testing indicated that the sampler would be capable of maneuvering within the tight annulus space and function as required.

The sampling event using the Remote Underground Sampler (Fig. 3) started off with more difficulties than expected [8]. When initially deploying the new sampling device through Riser 90 into the annulus, the sampler got stuck. The internal diameter of the riser used for deployment of the sampler was slightly smaller than expected. Although the sampler was ultimately maneuvered and fit through the annulus riser, the light and camera sustained terminal damage in the process. During the sampling of the two locations (e.g. the filled air-slot and the mound shown as locations (1) and (2) in Fig. 1) on October 15 and 17, 2012, additional functionalities were lost on the sampler leading to its terminal failure. These included the following:

- Loss of functionality of sample scoop
 - Pre-cleaning potentially removed essential lubrication for its functionality.
- Loss of raise and tilt functionality
 - The actuators that allowed these functions were only rated to 140 °F, but the environment in the annulus was potentially near or above this temperature leading to its failure.
- Loss of auger functionality
 - After taking the last sample on October 17, 2012, the auger had seized and was unable to rotate. This may have been due to a particle being lodged between the sample sleeve and the auger bit in the sleeve.

Following the conclusion of the sampling and analysis activities, a formal Lessons Learned was created based upon designing equipment for unique purposes under time constraints [8]. This document was published in OPEXShare on May 20, 2013. It highlighted some of the issues that arose with the new sampler (Fig. 3) development and provided recommendations to

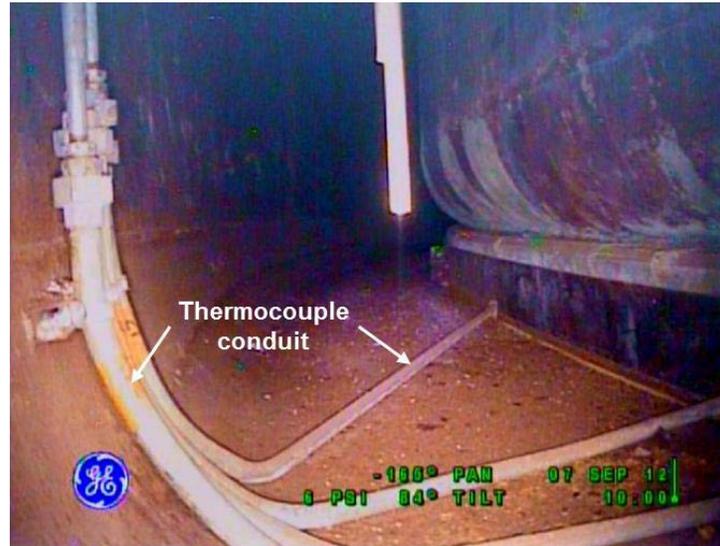
A total of three locations were identified in the 241-AY-102 annulus for material collection in order to determine its origin [4]. The main concern was whether the primary tank was leaking waste into the annulus. The first sampling location was the material on the floor of the annulus near Riser 83. The Off-Riser Sampling System (Fig. 2) was deployed through Riser 91 since it was the closest riser that was large enough to deploy the sampler and access that sample location. In order for the sampler to get to the sample location, it would have to maneuver over three 0.10 m diameter thermocouple conduit pipes (see Fig. 4). The second sampling location

Fig. 4. Thermocouple conduit pipe located on the annulus floor between Riser 91 and Riser 83.

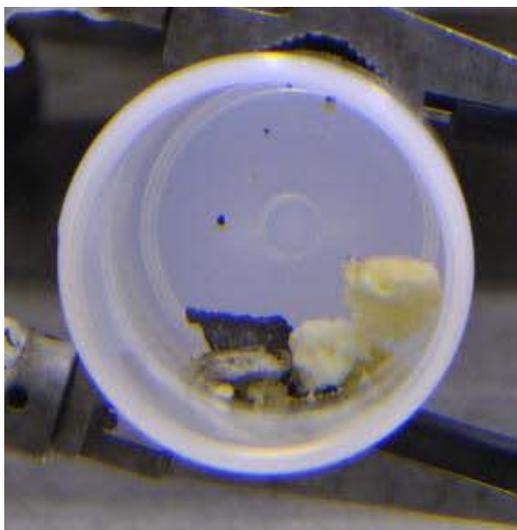
The 12.8-gram sample (see Fig. 5) was weighed when it was received at the laboratory [6]. Of the total mass, 6.2-grams was the yellowish-white material and the remainder was the darker material. The dark material was magnetic and was separated from the yellowish-white material to analyze separately. For the lighter colored material, analyses for anions, cations, radioisotopes, carbon analysis, pH, and solid phase characterization were performed. For the dark material, only a solid phase characterization was performed.

Fig. 5. Sample material collected from the annulus floor near Riser 83.

Results of the solid phase characterization, using Scanning Electron Microscopy (SEM), Polarized Light Microscopy (PLM), and X-ray Diffraction (XRD), indicated that the darker material was consistent with mill scale. The lighter material's solid phase characterization [7] identified sodium and potassium salts. The remaining analytical results [6] were compared to 241-AY-102 interstitial liquid and supernatants from both 2006 and 2012 to determine if the concentrations were similar to those of tank waste liquids (see Table I). Other information used to assist with the analysis of this material's origin included the visual observation of liquid at the annulus sample location that dried and re-wetted over time, the pH of the sample material (approximately pH 11 using litmus paper), and the radioactive dose rate of 45 mR/hr obtained in the field upon collection of the sample in the glove bag.

The floor sample taken under Riser 83 was found to have solid phases typical of tank waste, including the sodium and potassium salts [7]. Analytical data for this sample [6] was characteristic of 241-AY-102 interstitial liquid and supernatant (Table I). Visual inspection of this location during and after sampling indicated the area was moist, with the sampler creating

tracks during sampling activities that dried over time [5]. The quick pH test of this material using pH test paper with 1 mg solid sample and a couple drops of water estimated the pH at approximately 11, which was consistent with caustic tank waste. Finally, the sample had a measurable dose rate of 45 mR/hr window open upon collection of the material out of the tank riser in the field [6]. The assessment team was led to the conclusion that this material's origin was tank waste.
