## Managing Changed Conditions/Activities—D&D of the Paducah U.S. Department of Energy C-340 Metals Reduction Complex—14304

Craig Jones, \* Robert Seifert,\*\* Brad Montgomery\*

\* LATA Environmental Services of Kentucky, LLC

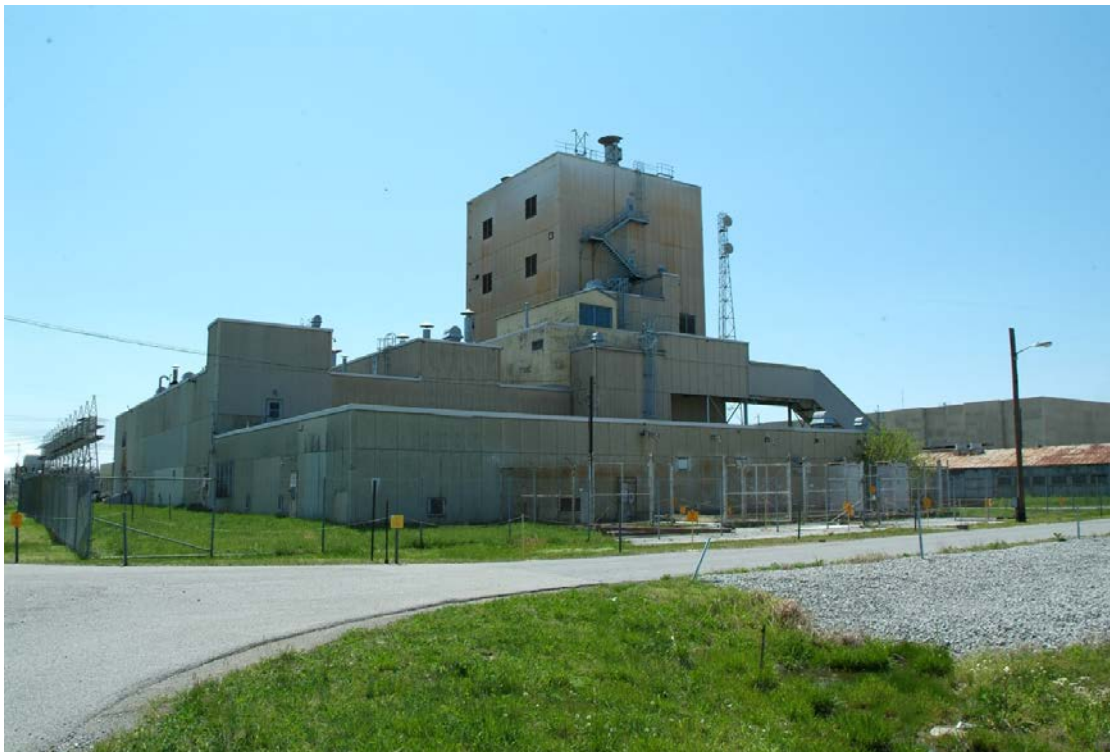
The Paducah C-340 Metals Reduction Plant Complex (Figure 1) had a combined footprint of approximately 5,700 m<sup>2</sup> (61,000 ft<sup>2</sup>). It was made up of the C-340-A Powder Building (2,350 m<sup>2</sup> and 36 m 120 ft tall); C-340-B Metals Building (2,950 m<sup>2</sup> or 31,000 ft<sup>2</sup>); and the C-340-C Slag Building (400 m<sup>2</sup> or 4,400 ft<sup>2</sup>). These buildings were physically adjoining structures located near the eastern perimeter of the Paducah Gaseous Diffusion Plant, which, during the demolition, was an operating uranium enrichment plant operated by USEC.

**Figure 1. C-340 Complex, View from Northeast**

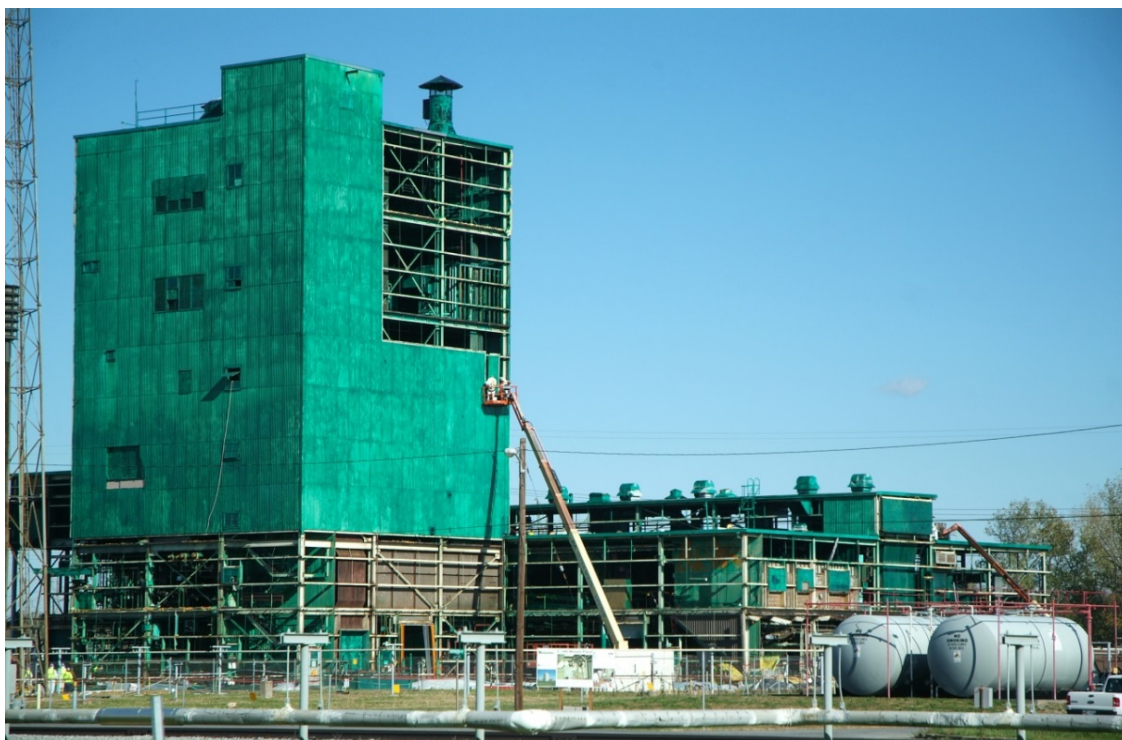
The exterior siding of the C-340 Complex consisted of transite, a corrugated siding made of a mixture of cement and asbestos. The transite panels are approximately 3 ½ feet (1.07 meters) wide and 10 ½ feet (3.2 meters) long, and weigh from 130 pounds (58.97 kilograms) to 170 pounds (77.11 kilograms) per panel. The panels are bolted with lead-containing fasteners to the building. An approach of manual removal of the approximately 2,000 transite panels was chosen. The higher levels were accessed via manlifts with “glazier attachments” mounted on the front edge of the lift basket. The glazier attachment provides a channel for the bottom edge of the transite panel to rest in. Workers lifted themselves up to the panel to be removed, cut the bolts, placed the bottom edge of the sheet in the glazier attachment, and then strapped the panel to the lift. The worker then lowered the basket to the ground where support crew removed the panel and stacks for containerizing and disposal. The lead-containing bolts were containerized separately for management as lead waste. Figure 2 illustrates workers accessing transite during removal activities.

**Figure 2. Transite Removal at the C-340 Metals Complex**

Key to performing the transite removal safely was implementation of fall protection harnesses for workers in the manlift baskets; keeping those not involved with the removal outside of the work area; ensuring that the ground support crew remained clear while the manlift was elevated; applying fixative to transite prior to removal and water misting during removal to control fibers; monitoring of both breathing zone and work area for fibers; and using personal protective equipment consisting of protective suits and respiratory protection.

It was critical to select manlifts that had adequate lift capacity and to operate them in the correct mode to handle the combined weight of a sheet of transite and the two-man removal crew without exceeding the manufacturer's safety limits. Additionally, the

manufacturer's recommendation established 3.0 m<sup>2</sup> (32 ft<sup>2</sup>) as maximum area for loads to be handled on the glazier racks due to wind loading on the manlift baskets. The C-340 Complex transite panels were larger, at about 3.7 m<sup>2</sup> (40 ft<sup>2</sup>). To ensure safety of the workforce, an engineering evaluation was performed based on the larger area of the C-340 transite panels. This evaluation resulted in establishing a lower wind speed (than allowed by the manufacturer's recommendation) for safe operation of the manlifts when handling the transite panels. This lower wind speed then was incorporated into work controls for the transite removal activity.

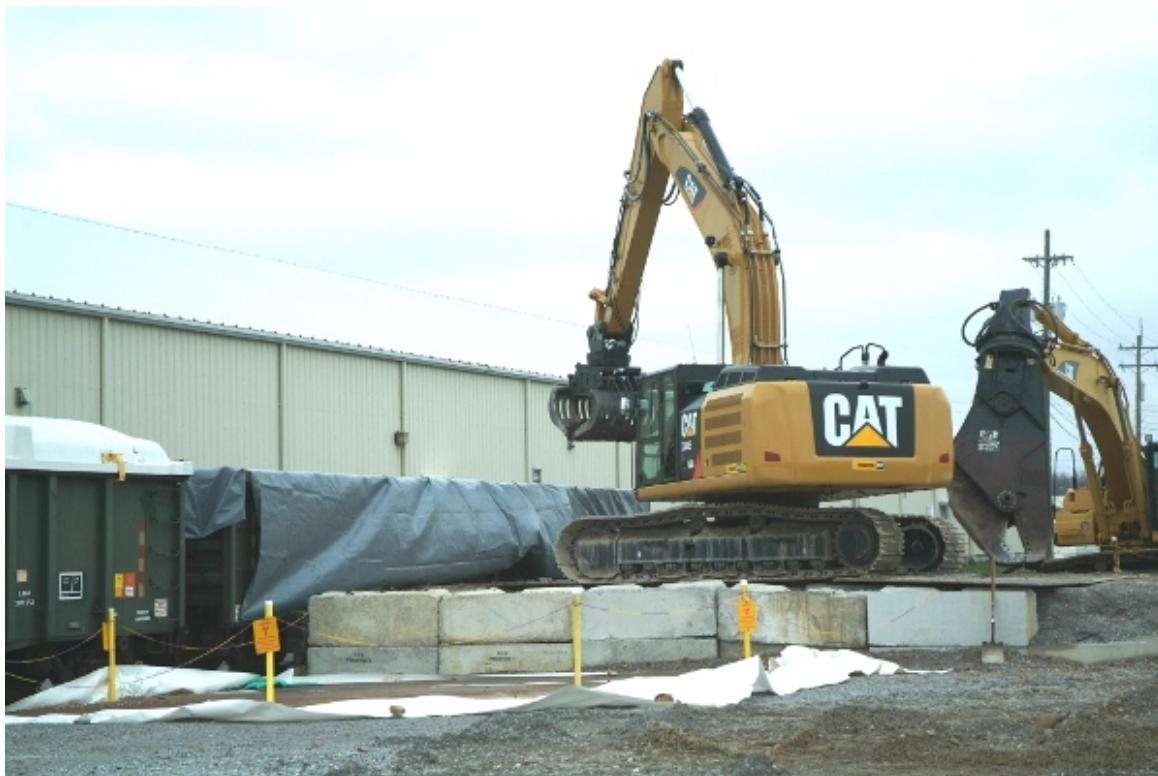
**Figure 3. Downsizing (background) and Loading C-340 Debris into Gondolas**

Based on actual weights, approximately 1,850 tons of debris was loaded into railcars for off-site shipment, or a variance of approximately 14% greater mass than expected. Via downsizing of debris and careful loading of the railcars, an average density of nearly 50 pounds per cubic foot was achieved. Prior demolition activities and a scrap yard clean up on-site using railcar shipment achieved significantly lower densities (average of 20 pounds per ft<sup>3</sup>), indicating the downsizing and railcar loading techniques were effective in reducing costs for the PCB remediation waste disposition. The downsizing was performed using shears mounted on excavators. Downsizing occurred at the C-340 Complex prior to movement across the plant site in roll-off bins to the rail head. Further downsizing to support packing in to the gondolas was performed at the railhead, as illustrated in Figure (Placeholder for C-340 video).

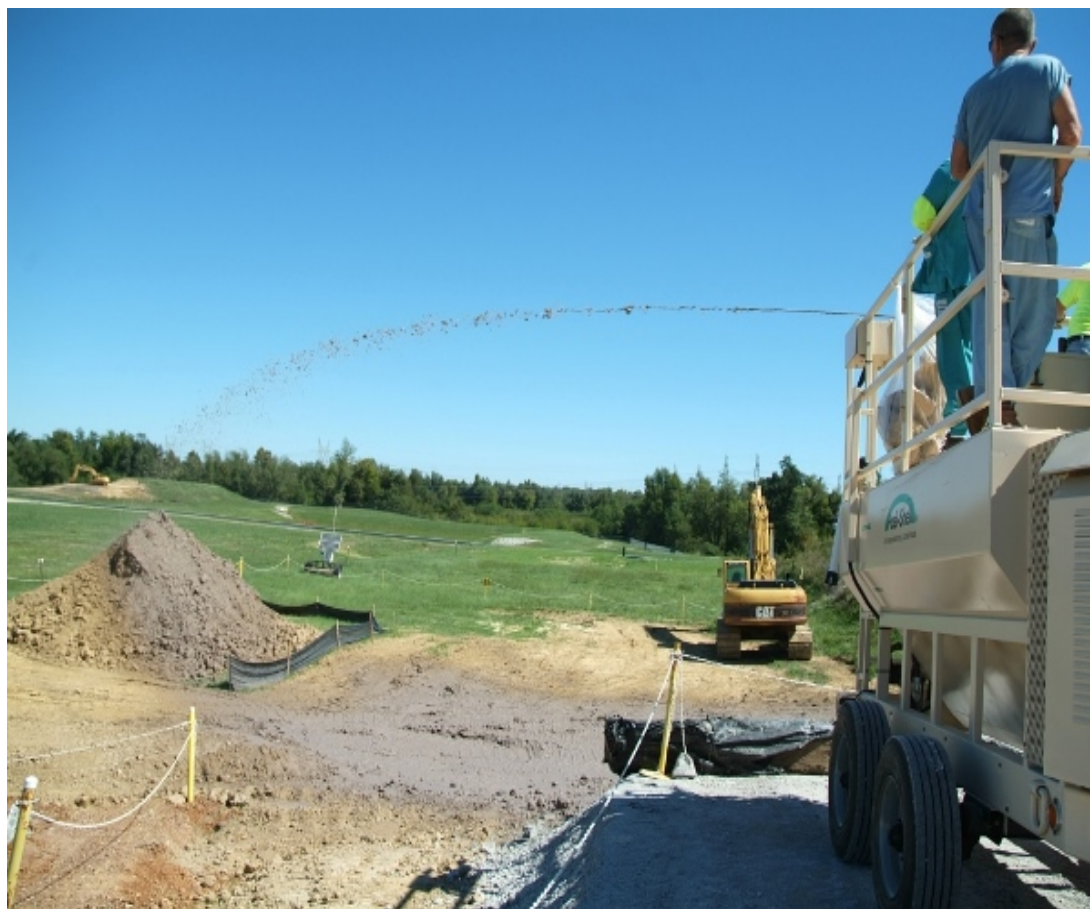
Spraying the material eliminates need to have workers on or immediately near the piles to place tarps, eliminates need to secure the tarps, and eliminates risk of tarps blowing away during wind. This was more effective than other conventional methods and reduced the risk of mobilizing contamination during precipitation events. Figure 4 shows an example of application of Posi-Shell during worker training.

**Figure 4. Workers Being Trained to Apply Posi-Shell Alternative Waste Cover Using a Hydroseeder**

During demolition of contaminated facilities, preventing rainfall from coming in direct contact with waste can be an important storm water control. It is not always possible to complete loading and transport of debris on the same pace that demolition occurs, resulting in stockpiled debris piles. Covering the piles with tarps can generate safety issues for workers placing the tarps, as well as issues securing during wind. Additionally, the tarps can become damaged due jagged edges of demolition debris. The C-340 project used an alternative cover known as “Posi-Shell,” to cover waste during precipitation events. The Posi-Shell is sprayed onto the debris using a hydro-seeder, and forms a coating over the top of waste to minimize precipitation contact with the debris.
