Remediation of the Active Liquid Waste Tanks at Chalk River Laboratories, AECL-14339

G.M. Polley
Perma-Fix Environmental Services

M. Vickerd, G. Peplinski
Atomic Energy of Canada Limited

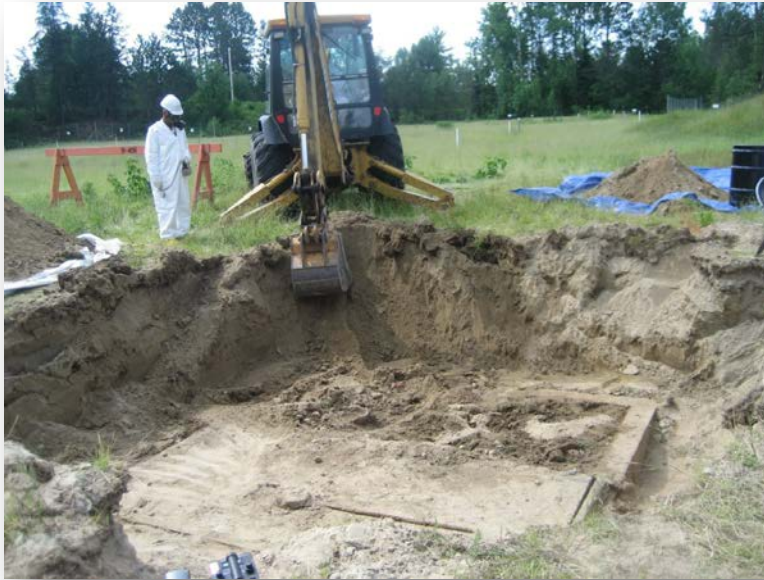
ALWT-1 is a concrete tank 3.5 m by 3.7 m and 3.0 m in height, buried 1.2 m below the ground surface. The tank has a central concrete dividing wall and originally had a partial concrete cap on the northern half only. Both halves of the tank were filled with sandy backfill and completely full of liquid. Based on the intrusive sampling of the tank it was estimated that ALWT-1 contained approximately 2,200 to 2,800-gallons (8,300 to 10,600 litres) of retrievable liquid waste depending on the surface retention of liquid on the sand. In Fig. 1 the top surface of ALWT is exposed revealing the partial concrete cap on the northern portion while the southern portion has at least three red clay funnel shaped pipes and has been backfilled with sand. A newly fabricated concrete lid was grouted in place on the southern half of the tank following the discovery of the tank being partially open.

Fig.1 The top surface of ALWT-1 exposed.

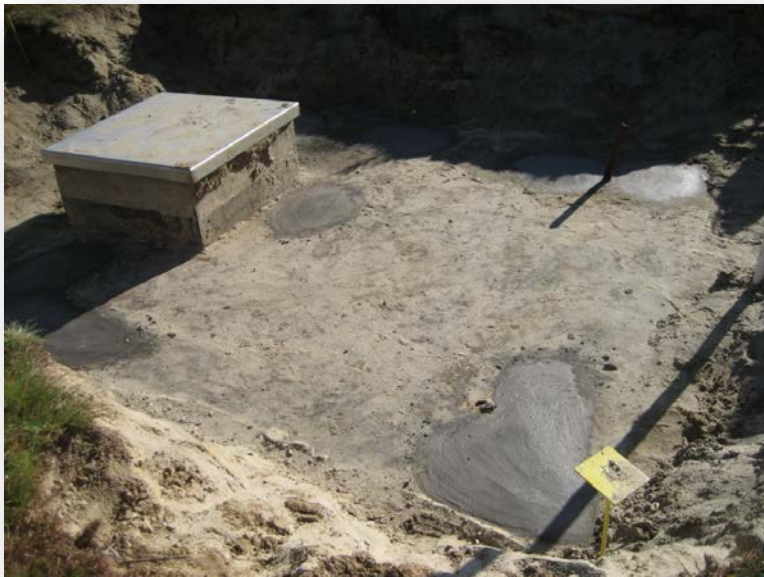
ALWT-2 is buried 1 m below the ground surface. The physical dimensions of the tank are 3.7 m by 3.7 m and 2.9 m in height. In Fig. 2 the top surface of ALWT-2 has been exposed revealing the hatch access off-centered in the lid towards the north side of the

tank and raised approximately 0.5 m from the top of the tank. A stainless steel hatch cover (about 180 lbs) was fabricated and installed to replace the original hatch cover. Intrusive sampling of the tank's contents verified the configuration of sand and liquid within the tank. Sand had also been backfilled into ALWT-2 creating a conical pile directly under the hatch with liquid above the sand in the southern portion. Based on the intrusive sampling of the tank it was determined ALWT-2 contains approximately 1,300 to 1,600- gallons (4,900 to 6,000 litres) of liquid waste, depending on the surface retention of liquid on the sand.

Fig.2 The top surface of ALWT-2 exposed.

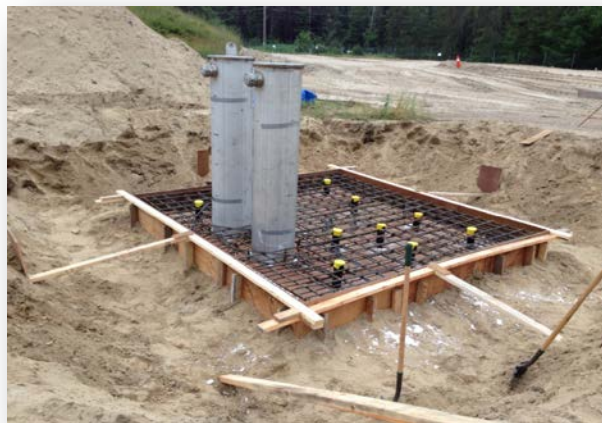
The data obtained from the historical records, and assessed against National Building Code of Canada requirements, indicated that the ALWT lids would not support the weight of the cover soil plus the design snow load for the area. Therefore, the lids would require reinforcement prior to beginning the liquid waste extraction. New lids were designed to meet the loading requirements and preparations were made to install the lids. Each tank was excavated to expose the original lid and a riser was installed on the existing lid to allow for access after the new lids were fabricated in-situ and the excavation was backfilled. The rebar was then installed and the concrete was poured using a fast set recipe to allow for obtaining adequate strength for backfilling within three days. Fig. 3 illustrates the installation of both the risers and rebar on ALWT-1 prior to the concrete pour.

Fig.3 The installed risers and rebar on ALWT-1 prior to the concrete pour to provide adequate reinforcing of the tank lid.

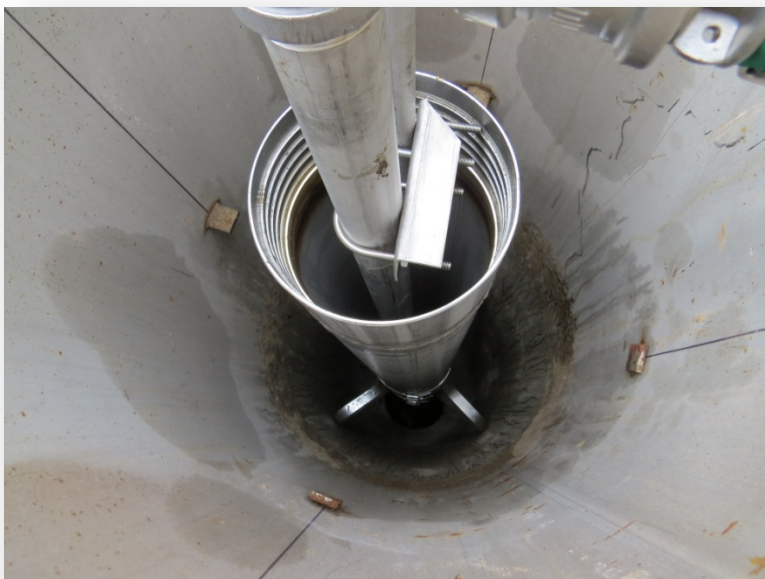
The next step was well installation. The drilling company used a carbide cutter bit to cut through the original lid and then an auger bit was used to drill to the bottom of the tank. With the drilling complete, a fifteen-foot long, six-inch diameter standpipe was pushed to the bottom of the tank. The standpipe was designed with a screened section at the bottom to allow liquid waste flow into the pipe and keep the sand out. As shown in Fig. 4, extraction pipes were placed inside the standpipe for transferring the liquid waste from the tank to the process enclosure.

Fig.4. A view down the riser of ALWT-2 showing the extraction pipes installed within the standpipe.

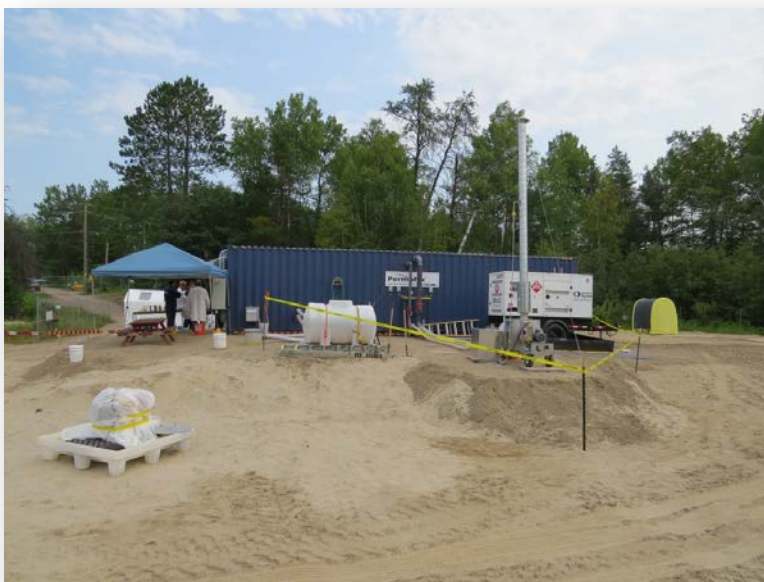
The process enclosure was deployed to the CRL site and placed adjacent to ALWT-1, as shown in Fig. 5. A formal start-up process was performed to ensure that the system worked as designed and that no damage occurred during transport from Tennessee. The processing activities included liquid waste extraction, pH adjustment, internal tank transfer, a second pH adjustment, sampling and finally transfer to the 375-gallon (1,420 litres) totes. The bulk extraction, processing and packaging was completed in approximately one week. At this point, the process enclosure was relocated to ALWT-2 and the liquid waste “sipping” began on ALWT-1. The sipping process was retrieval of

Fig.5 The process enclosure staged beside ALWT-1.

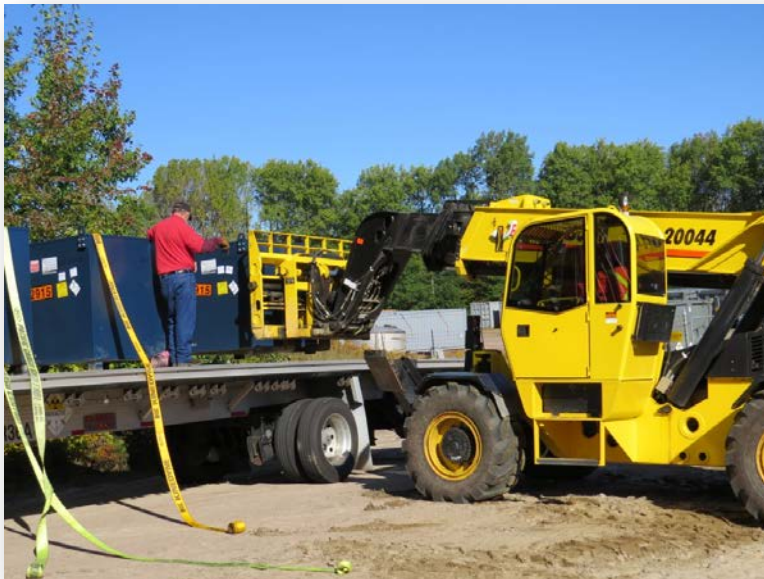
The liquid waste was shipped to the Perma-Fix DSSI facility for thermal treatment (as shown in Fig. 7). A total of 3,117-gallons (11,800 litres) of liquid waste was shipped for treatment. The waste was batched and mixed with diesel to create a combustible mixture. The residual ash resulting from the thermal treatment was packaged and returned to the CRL site for long term storage.

Fig.7 Loading of transport packages for off-site shipment.
