**Removal of Radioactive Waste Tank and Drain Lines from the Whiteshell Laboratories  
Research and Development Laboratory Complex - 14341**

Kevin Larsen, Bill Cunliffe, Leonard Rasmussen

*Atomic Energy of Canada Limited, Ara Morradian Way, Pinawa, Manitoba,  
Canada, [larsenk@aecl.ca](mailto:larsenk@aecl.ca), [www.aecl.ca](http://www.aecl.ca)*

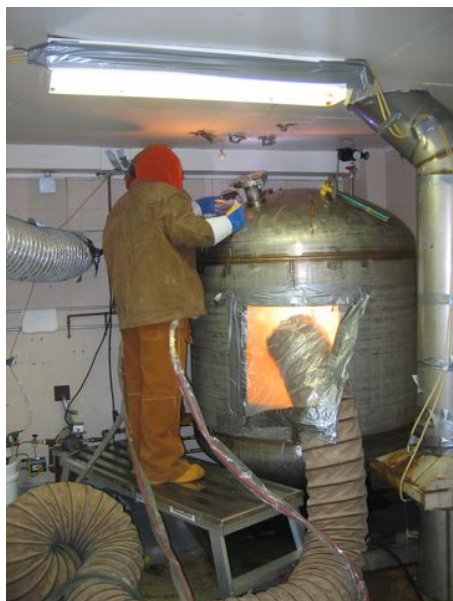
The UTS tank was sectioned in-situ (See Figure 1). A number of techniques were assessed for sectioning the tank, including a plasma cutting torch, a chipper saw, and mechanical nibbler. A plasma torch was selected as the primary technique for the present job to evaluate its effectiveness for potential use in future decommissioning activities, with a chipper saw available as backup. As sections were separated from the tank, they were directed into the tank (See Figure 2), safeguarding the workers from the hot surface and jagged edges. When the bottom of the tank was too full, cutting was stopped and cut sections removed. After cutting, cutting debris was vacuumed with a HEPA vacuum. Sectioned pieces of tank were then bagged and disposed of in a B25 waste container.

**Figure 1: Sectioning UTS tank in-situ tank at the bottom of the tank**

An additional barrier was implemented by covering the tank surface and openings to aid more in controlling the plasma sparks and heat away from the workers directing more of it back into the tank. The use of large fire blanket was implemented to create the additional separation barrier while the workers were working above the tank.

Smoke generated by the plasma cutting equipment was a concern due to the limited space within the UTS tank room. As part of the planning and preparation, WL Engineering developed a ventilation and monitoring control plan in conjunction with HVAC, specifically outlining a procedure and conditions required during the Plasma cutting work. Implementation of a portable "High-Efficiency Particulate Air" (HEPA) air-handling unit with a flexible trunk hose and conical air inlet to capture smoke and fumes generated during the tank cutting to help reduce or eliminate smoke generated during plasma cutting.

- Plasma cutting was found to work well, however the thickness of the tank wall was found to be underestimated for the top and bottom sections, which resulted in the purchase of a plasma cutter with insufficient output. A plasma unit with a larger cutting range may have provided additional latitude for those conditions.

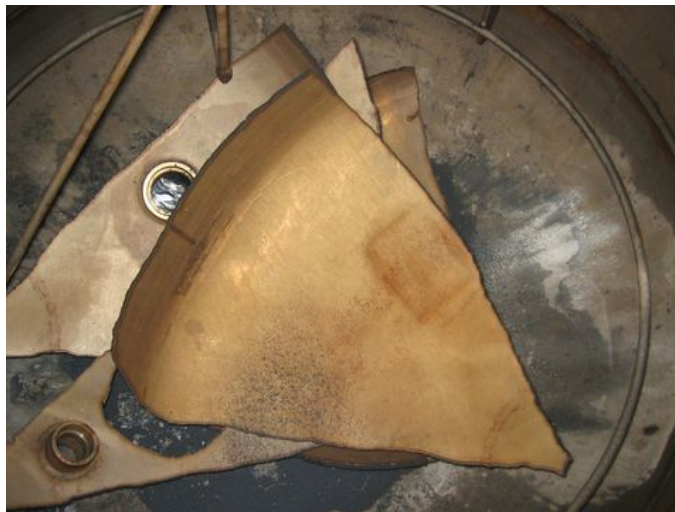
**Figure 2: Sectioned pieces of the UTS tank**

Removed tank piping and lines, and cut and section tank pieces were individually wrapped in plastic and sealed with tape and transferred for placement in a B-25 waste container for management as non-compactable solid low-level radioactive waste.

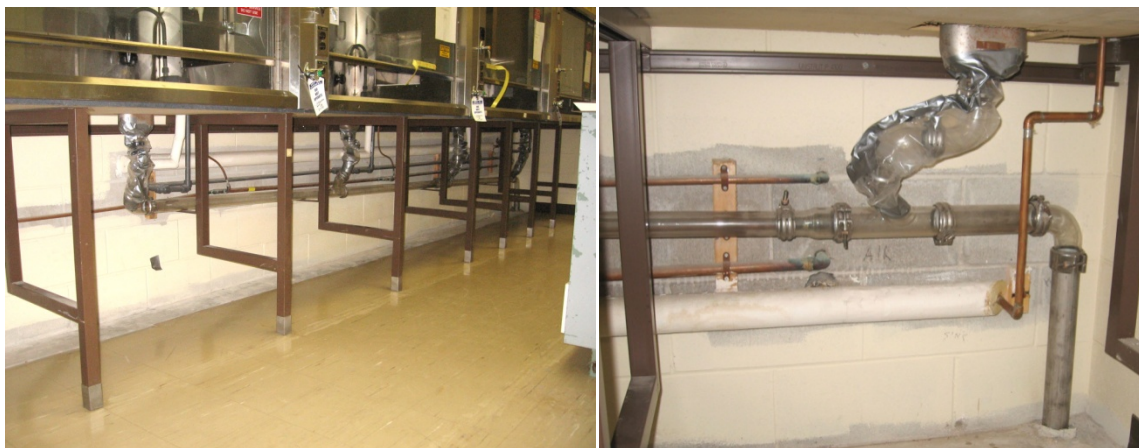
Modified glove bags were used on all actinide hazard glass drain lines, drain lines with visible presence of material/sediment inside and at the first bend in a new drain line section (i.e., the first bend coming from a drain source). A modified glove bag is a sleeve that fits over the section of drain line that is to be removed and partially over the adjacent section of drain line. It allows for de-coupling and removal of a section of drain line while containing the open ends of the drain

line. After the target drain line section is decoupled from the rest of the line, the section of pipe can then be easily separated by taping it off and then cutting it off at the isolation point so that the two resulting ends are still closed off from the outside. The section of pipe to be disconnected is now completely isolated from the outside of the plastic sleeve. See Figure 3.

**Figure 3 Drain lines under fume hoods and a close-up of a modified glove bag on a glass drain line**

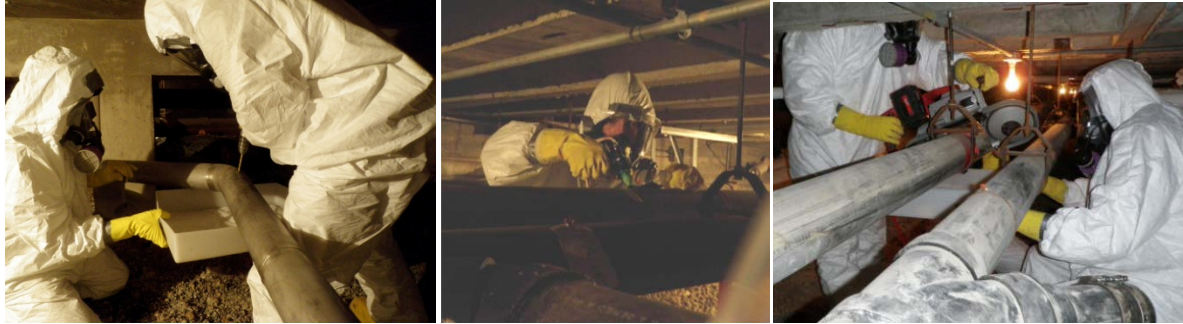
Since non-glass drain lines had to be cut, it was proved too tedious and time consuming to perform a modified glove bag with a band saw inside of the bag. A solution was developed that did not require a glove bag. First, a small hole was drilled into the top of the drain line and expanding foam<sup>1</sup> was then injected via the drilled hole at the top of the pipe to stabilize/fix contamination in the drain lines prior to cutting. The pipes were then cut using a band saw at the location where the foam was inserted. A tray lined with wet wipes was placed under the pipe and collected the cut filings. After the line was cut, the open ends were bagged and the section removed. For reciprocating saw cuts, in addition to foaming, shaving cream was applied around the outside diameter of the pipe, and then the cut made at the location of the shaving cream. This considerably reduced the dispersion of cutting debris/contamination. Shaving cream was not required for band saw cuts because of an additional risk of the band saw blades dislodging if they got wet. Moreover, debris from band saw cuts is minimal.

**Figure 4: Inserting expanding foam, drilling a hole, and cutting a drain line with a band saw**

Drain line sections needed to be approximately 5 feet long in order to fit in a B1000. However, drain lines were drilled and foamed every 10 feet in-situ and then cut at these locations. Each 10 foot section was then brought out into a more ergonomic favourable location where they were drilled and foamed in the middle and then cut.

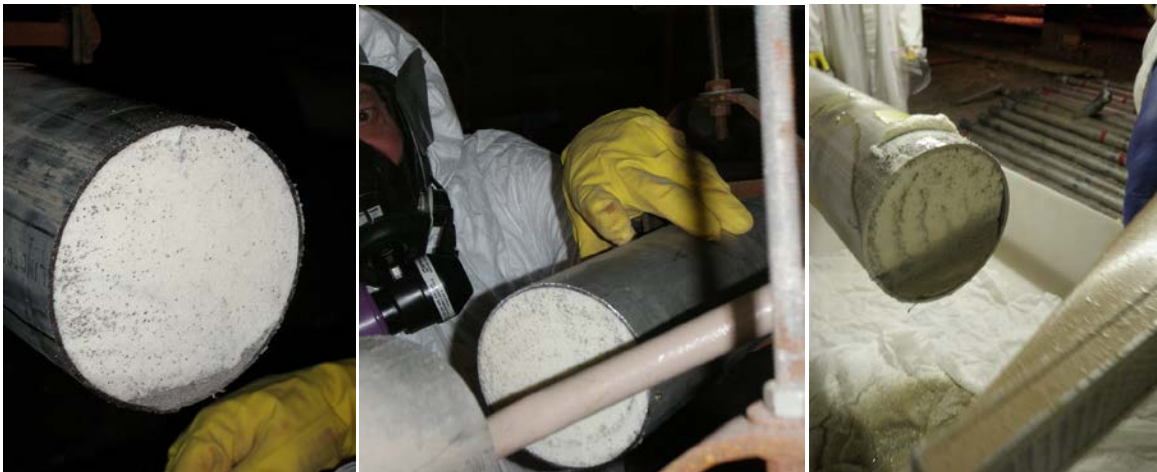
**Figure 5 Examples of cut drain lines with expanding foam inside**

Low cost, off-the-shelf items such as expanding foam and shaving foam proved effective in the safe and efficient removal of the drain lines and minimized the spread of contamination by containing it. This method was much faster than glove-bagging every 5 or 10 feet.

- As expected, the further downstream the drain line branch, the higher the level of contamination was found.
- The joining clamps of drain lines were the most prone to accumulating contamination (radioactive and non-radioactive)
- Foaming pipe thru a drilled hole, when both ends of the pipe are closed off, presented a potential risk of back-pressure spray and must be conducted in PPE (i.e., Respirator and Tyvek® Suit) to protect the worker from any possible contamination picked up on the foam spray. Alternatively, if possible, avoid foaming shorter, closed off sections of pipe.
- The expanding foam did a good job containing most contamination. If there were larger accumulations of contamination, then the expanding foam only contained some of it, and some of it did come out.
- A disadvantage of the foam is that it did not allow for access to make direct swipes on the line.
