Structured Planning and Preparation Leads to Safe Open-Air Demolition of Contaminated Facility – 14520

Cynthia Dayton **, Catherine Bohan *, Thomas Dogal **, Kirk Winterholler **

** CH2MHILL B&W West Valley, LLC

WM2014 Conference, March 2 – 6, 2014, Phoenix, Arizona, USA

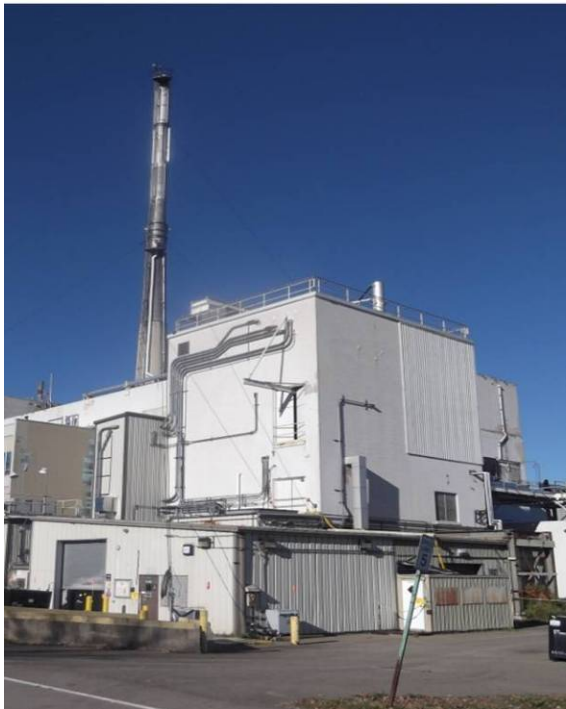
Photo 1 - The 01-14 Building, prior to the start of demolition

The 01-14 Building was a 18.3 meters (60 feet) tall steel, reinforced concrete, and concrete masonry block structure constructed at the WVDP in the 1970s as part of a modernization effort undertaken by nuclear fuel reprocessing operator Nuclear Fuels Services. It was constructed adjacent to the site's Main Plant Process Building and housed new acid recovery equipment for use in commercial fuel reprocessing. (See Photo 1) Nuclear Fuels Services was in shutdown mode for facility modifications at the time of 01-14 Building construction and since fuel reprocessing never resumed at the site, the building's acid recovery system was never activated.

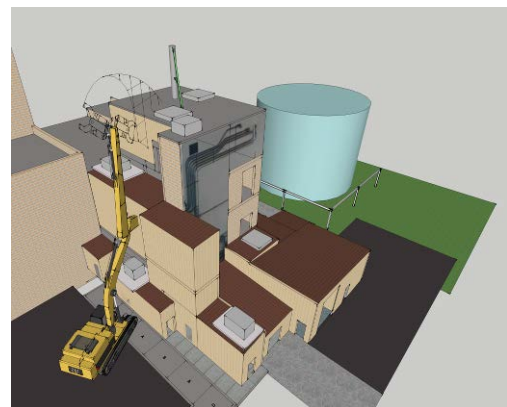
Figure 2 – The 01-14 Building's close proximity to adjacent structures is depicted in the drawing above.

The 01-14 Building was constructed adjacent to the Main Plant Process Building (MPPB) at the WVDP. Internal contamination in piping, vessels and equipment, close proximity to the highly contaminated MPPB, a dedicated ventilation stack that approached the reach capacity of demolition equipment, guy wires from the Main Plant Process Building ventilation stack that stretched over the top of the 01-14 Building, connections to the nearby Utility Room and co-location next to the site's water tower contributed to making physical demolition a complex effort.

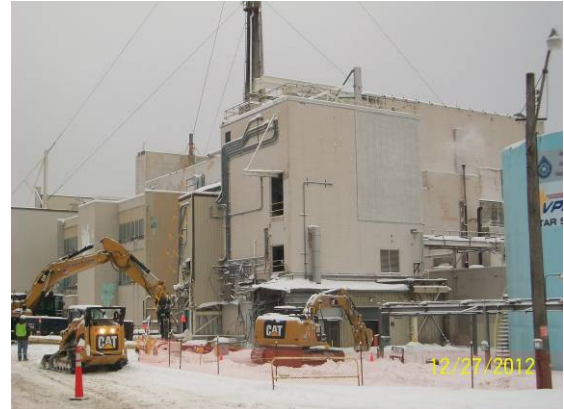
Photo 2 – Phase 1 demolition of the 01-14 Building.

Phase 1 – These sections of the 01-14 Building consisted of the lower story, metal-sided non-radiological areas of the building. They included the control room, truck bay, conference room, motor control center rooms, drum loading area, ammonia pipe gallery, and a utility pipe bridge.

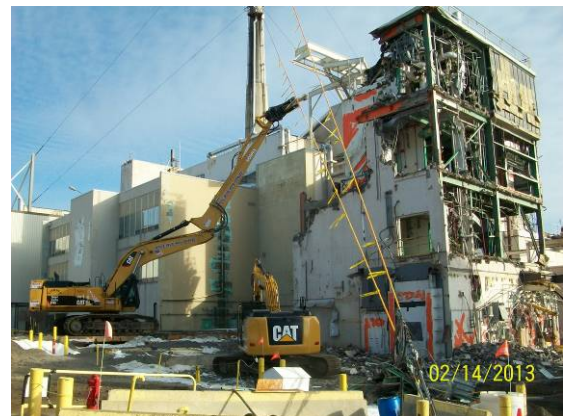
Photo 3 – Phase 2 demolition of the 01-14 Building.

Phase 2 – These portions of the 01-14 Building consisted of the roof, structural steel and the masonry block areas of the structure.

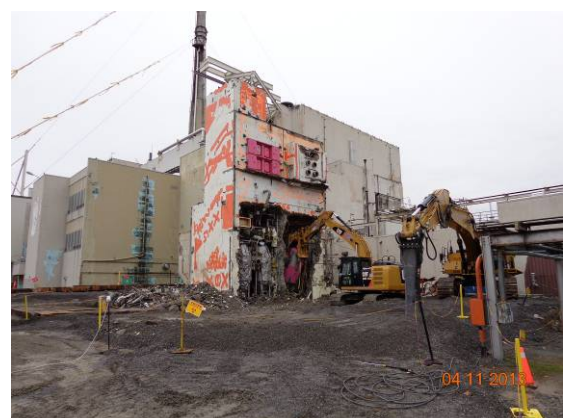
Photo 4 – Phase 3 demolition of the 01-14 Building.

Phase 3 – This final phase involved the reinforced concrete portions of the building, including equipment and contaminated areas. Structural steel was also removed during Phase 3.

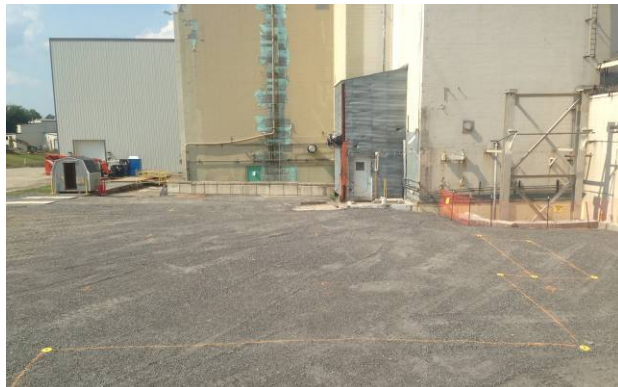
Photo 5 – The 01-14 Building slab covered with backfill.

End State – The floor slab of Building 01-14 Building had a very irregular footprint. The demolition end state required the slab to be covered with structural fill overburden which was then sloped to drain. High visibility survey markers were installed on the overburden surface at each change of direction in order to aid in follow-on actions to be conducted at specific locations on or below the slab.
