Frozen Soil Barrier Technology - Facts about the Oak Ridge National Laboratory Barrier – 14554

Elizabeth Phillips*, Edward Yarmak**

ABSTRACT

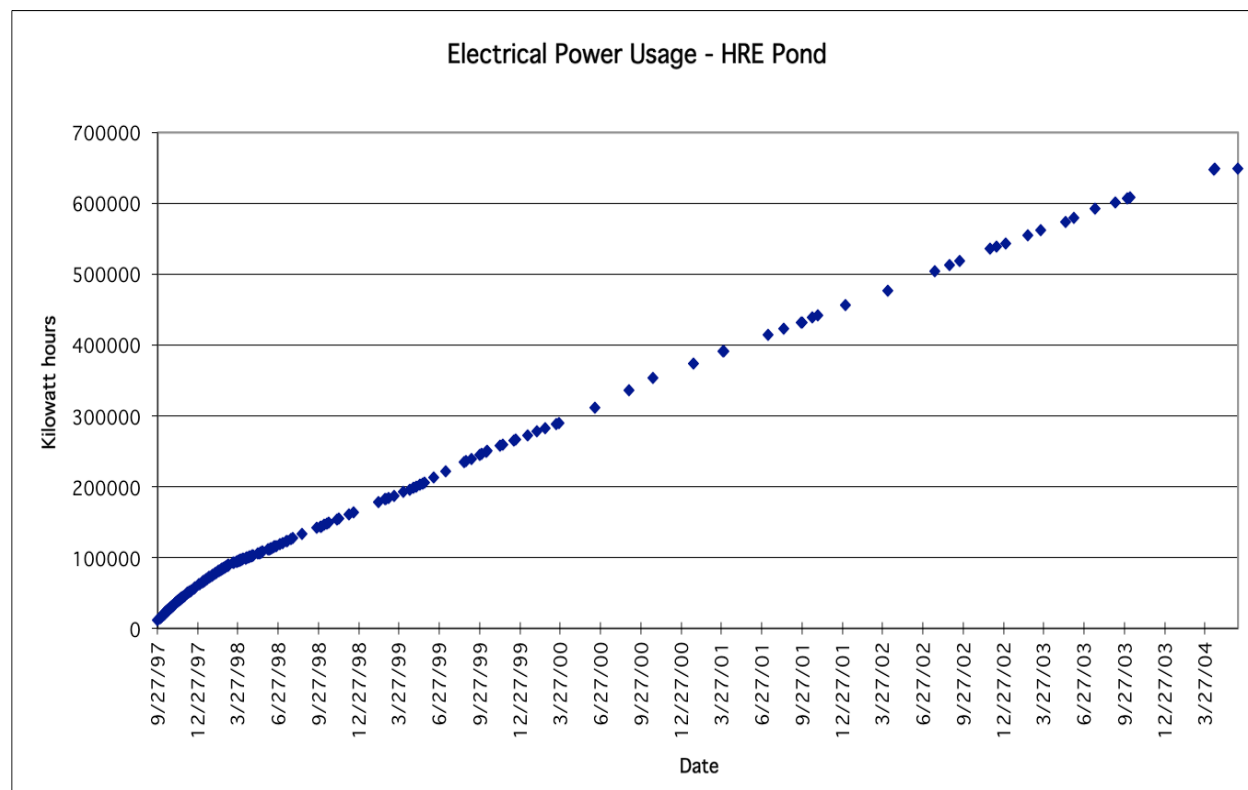
Fig. 4: Electrical Power Usage at HRE Pond

The system began operation in September 1997 and operated for 6 1/2 years. The refrigeration condensing units driving the thermoprobes were run at approximately -32°C (-25°F). The barrier was formed within seven weeks from startup, and electrical power usage to form the barrier was 33,000 kW-hours. The barrier walls reached the 3.66 m (12 ft.) design thickness within 18 weeks after start up, and cumulative electrical power usage was 72,000 kW hours. The total volume of frozen soil was 3,060 m³ (108,000 ft³), and the total volume of material contained within the frozen barrier was 4,780 m³ (168,750 ft³). An eight-day simulated power outage was conducted during operation when ambient air temperatures averaged between 32°C to 35°C (90°F and 95°F), and the barrier lost less than 2% of its thickness with the centerline of the barrier remaining frozen up to the base of the insulation during that test. On December 31, 1999, the average barrier thickness was 7.8 m (25.6 feet), over twice the design thickness.

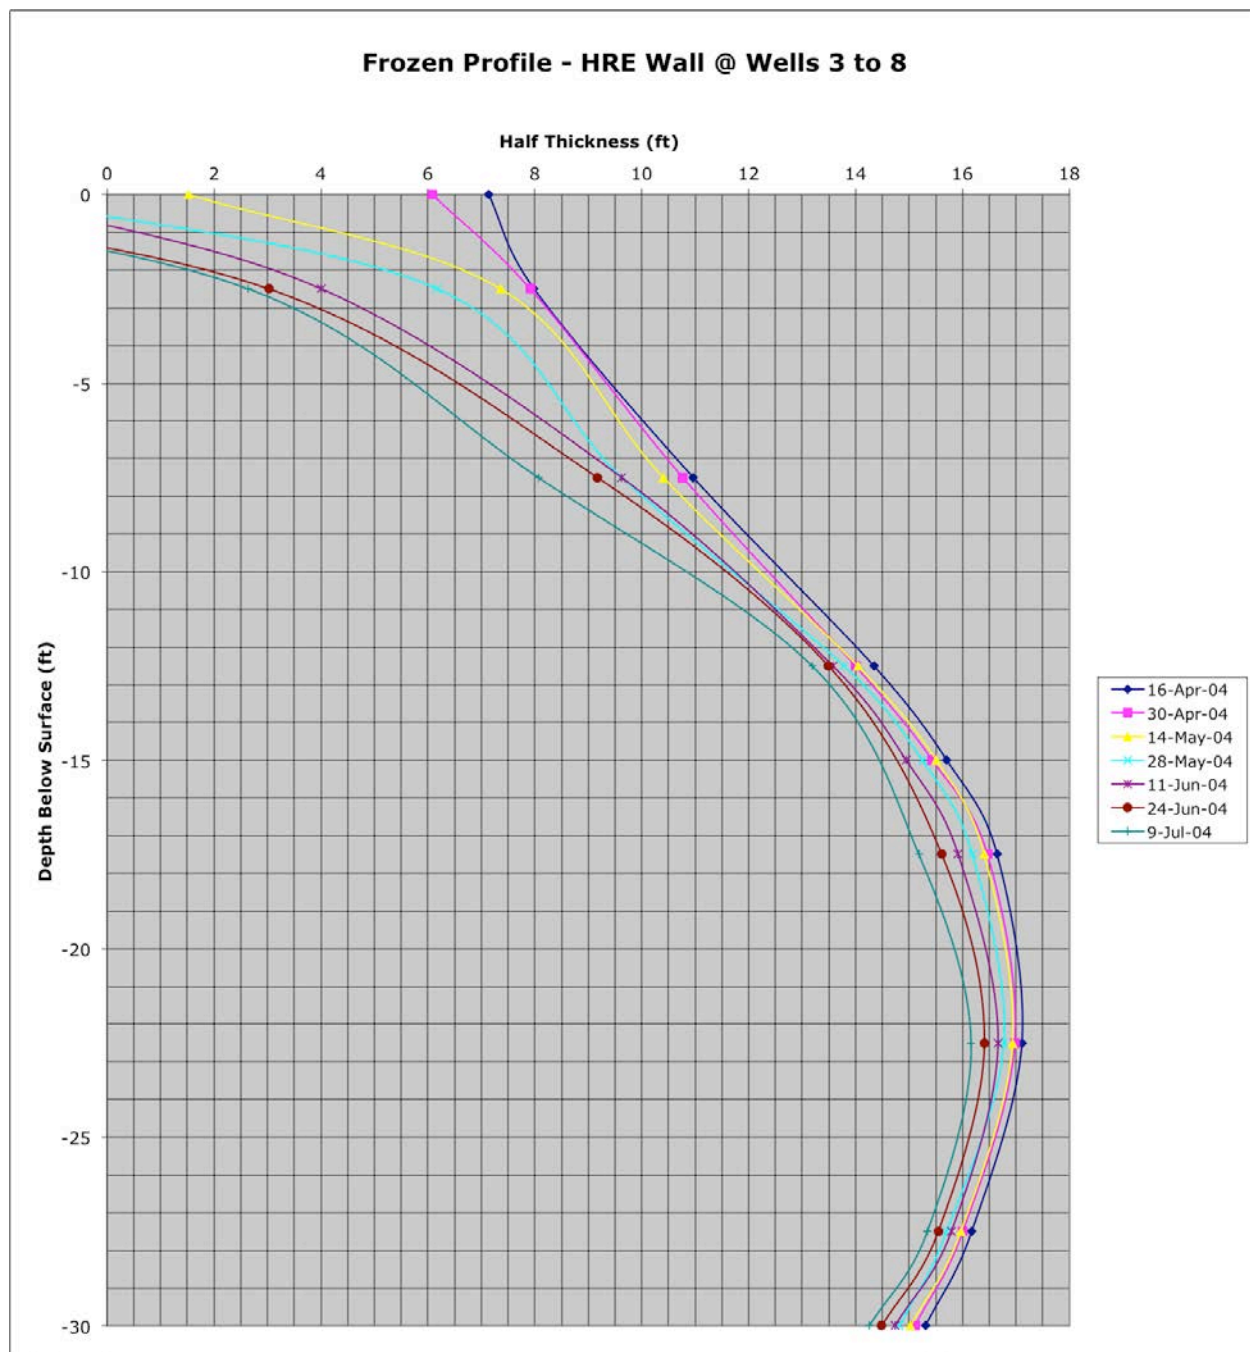
Fig. 5: Frozen Barrier Thaw from April 16 to July 9, 2004

The barrier was decommissioned on April 16, 2004, and had only diminished approximately 10% by the end of the summer of 2004. The monitoring system was not disabled when the barrier was turned off and Figure 5 is the record of the barrier thaw until the power was cut to the monitoring system. Note that the top of the barrier was still frozen to the base of the insulation for a month after the refrigeration power was turned off. The bulk of the barrier was still frozen when Bechtel Jacobs Company LLC excavated the soil in April 2005. The thermoprobes were in pristine condition and showed no signs of rusting or degradation. The system used an average of 97,900 kWh per year for the period it was in operation (648,189 kWh total when turned off on April 16, 2004). The total power consumption for the site was monitored and shown on Figure 4. Figures 6, 7, 8, and 9 show photos of the barrier system taken during the total site remediation project performed in 2004 and 2005.

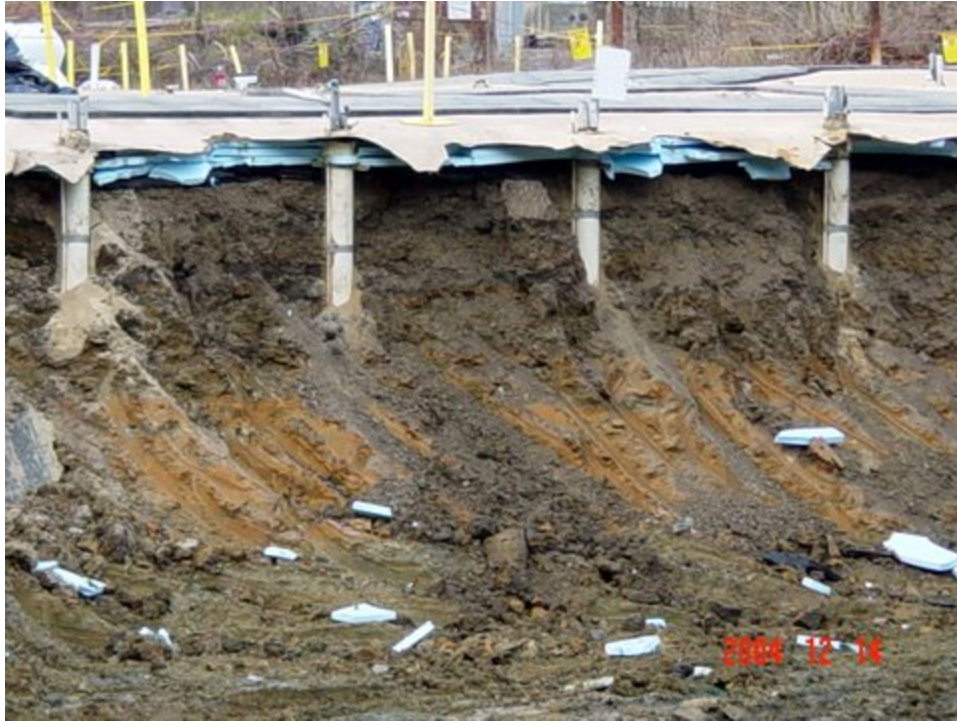
Fig. 6: Exposed Frozen Soil Thawing in December 2004

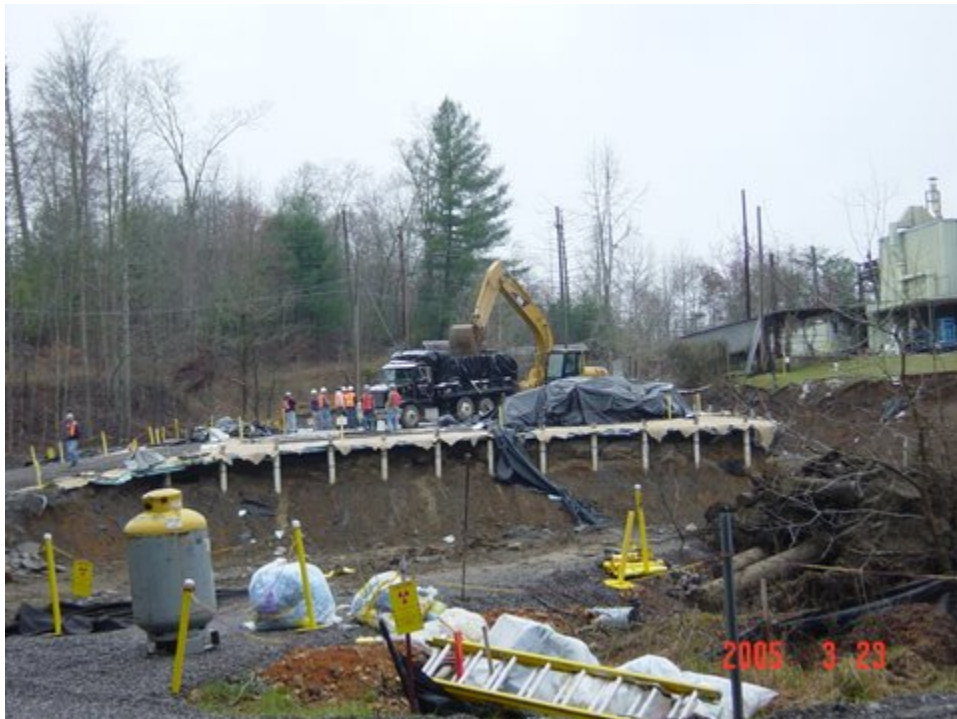
Fig. 7: March 2005 Site Remediation

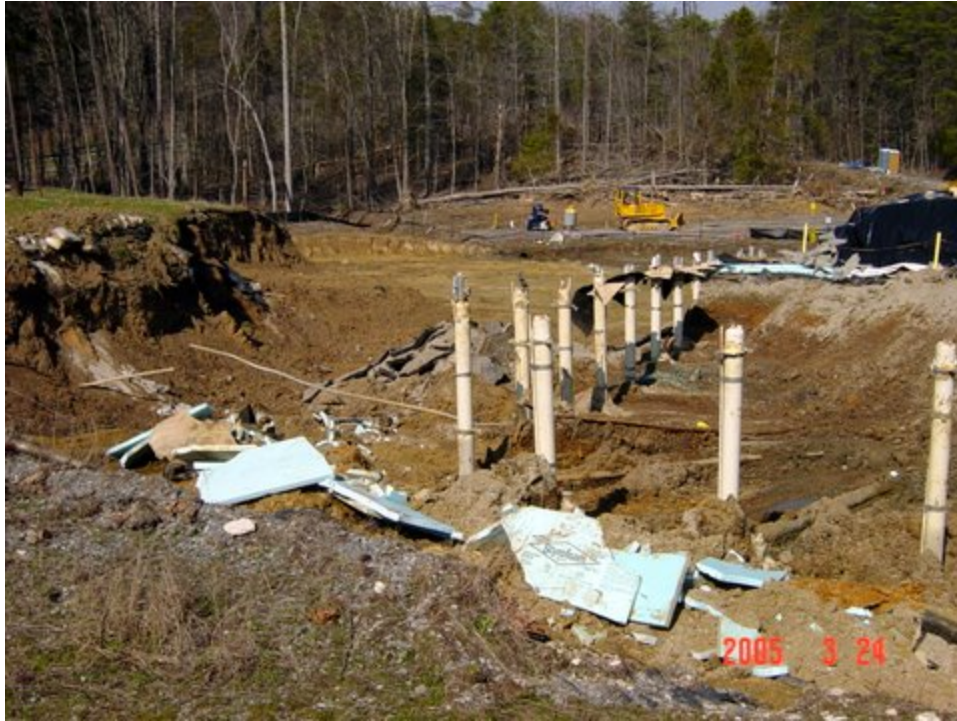
Fig. 8: March 2005, Thermoprobes are in Good Shape

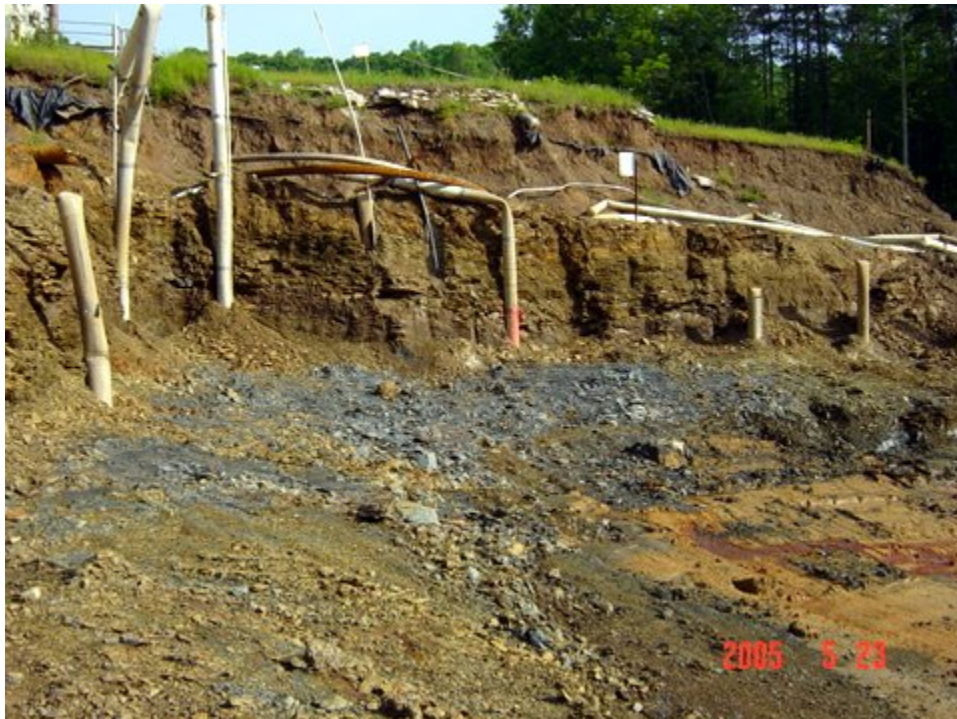
Fig. 9: May 2005, Excavation Nearly Complete
