Challenges and Successes during Implementation of Residential Soil Remediation Program – 14567

Libby Bowen, AMEC
AMEC Environment & Infrastructure, Inc.
1090 Elm Street Suite 201, Rocky Hill, Connecticut 06067

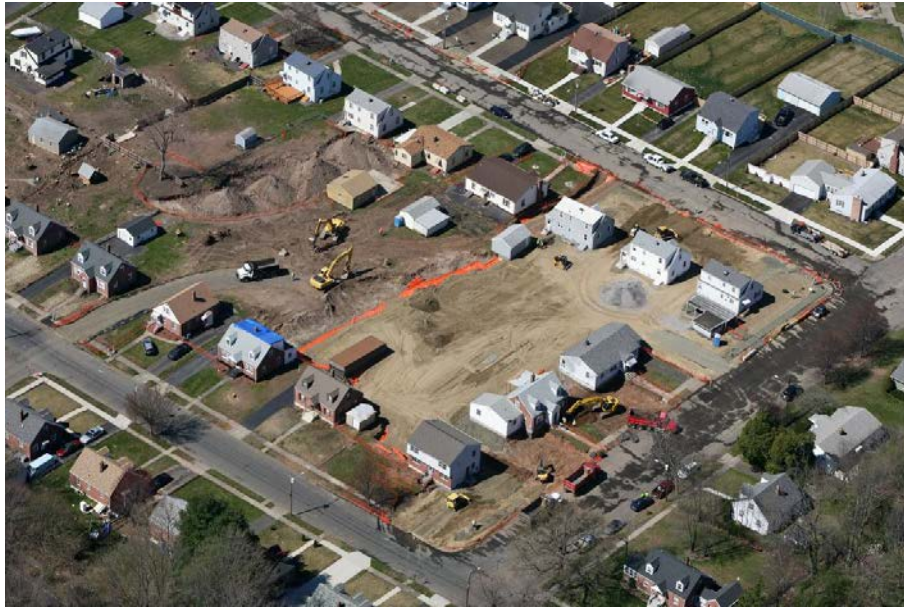
Figure 3: Aerial view of one block during excavation and backfill

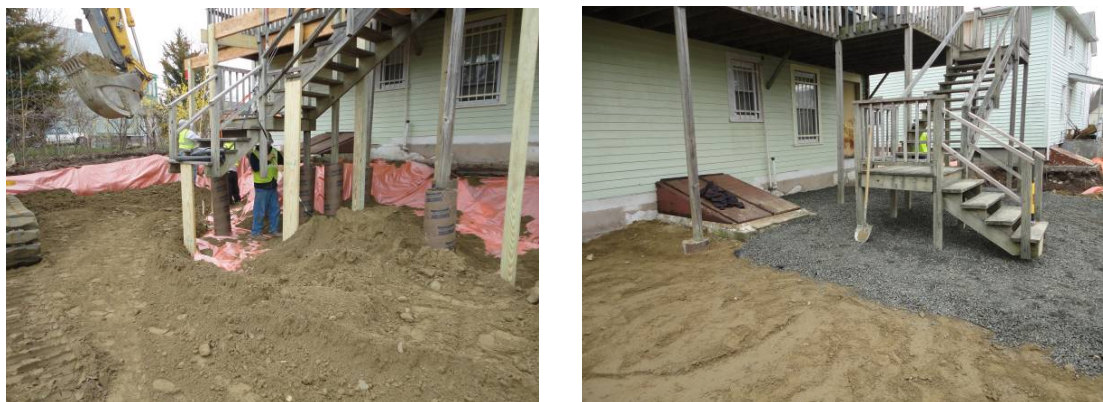
Figure 4 and 5: Excavation and backfill around a three story staircase. This work was completed in one day to allow safe access to apartment on the 2nd and 3rd floors.

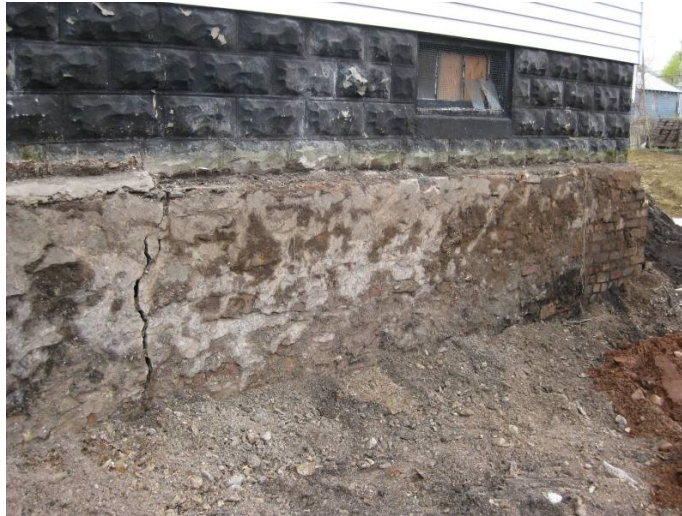
Figure 6: Photo showing crack in foundation constructed of stacked stone and brick.

Infiltration of water into basements became an issue during the 2011 construction season when Hamden, Connecticut received more than twice the average rainfall. During one particular rainfall of over 2.5", the project team received calls from approximately 15 homeowners who reported water in their basements. In some cases, the area around the foundations had not yet been backfilled, but in some cases, properties were fully restored with concrete aprons and or backfill, topsoil, and sod at grade. After the porous waste fill was replaced with the approved backfill material, rain water was accumulating at low spots adjacent to the houses and seeping through the foundation walls or through cracks that were due to settling.

The project team responded immediately and realized the importance of resolving these issues and maintaining the confidence of the property owners. Countless hours were spent looking at resident's basements, and visiting properties during and after significant rain events to see where water was coming in and to attempt to determine whether infiltration of water was a preexisting or new condition.

A proposal was made that in cases where a building's foundation would be exposed during excavation, stone backfill be used rather than the common borrow material used as backfill throughout the project. This would allow water to drain through the stone to the underlying native sand or porous fill material that was left in place at depths of greater than four feet. This proposal was approved by the CTDEEP and was implemented immediately. Response to this issue included returning to some properties where restoration was complete, re-excavating and replacing the common borrow material with stone. This solution worked well and water issues occurred in only very isolated circumstances after the contractor began using stone to backfill around building foundations.

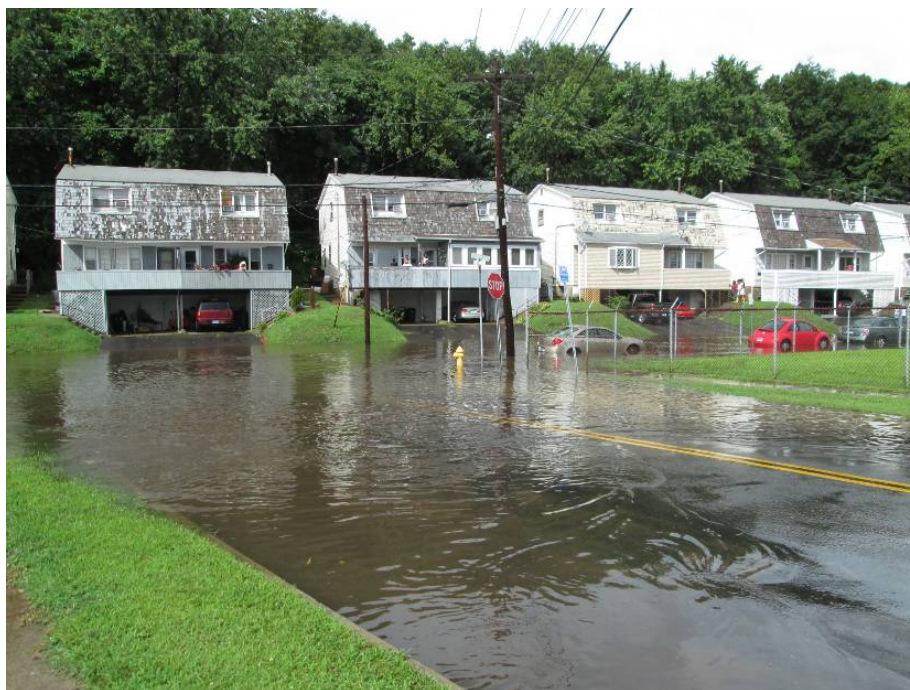
Figure 7: Street flooding in a portion of the neighborhood with inadequate storm drainage.

This intersection is within the CO boundary but no excavation was completed in this portion of the neighborhood.

One issue that this change in project plans did *not* address was the overall poor drainage in the neighborhood. In general, topography in the neighborhood did not promote drainage toward the street, and the storm water system in the neighborhood was known to be inadequate. Despite this being a well-known problem in the city of Hamden, it became a challenge for the project team because property owners claimed that they had never previously experienced street flooding or drainage issues in backyards that were six to eight feet lower in elevation than the street and storm drains. During the season when the town of Hamden received twice the average annual rainfall, property owners frequently called members of the project team to report street flooding after heavy rains and were dissatisfied if they were referred to the local public works department or the project's Community Liaison employed by the CTDEEP and the town of Hamden.
