## Identifying And Managing Risks During Decommissioning Of José Cabrera NPP – 14649

Manuel Rodríguez Silva.

José Cabrera NPP Site Manager. Enresa. c/ Emilio Vargas 7, 28043, Madrid, Spain, mros@enresa.es

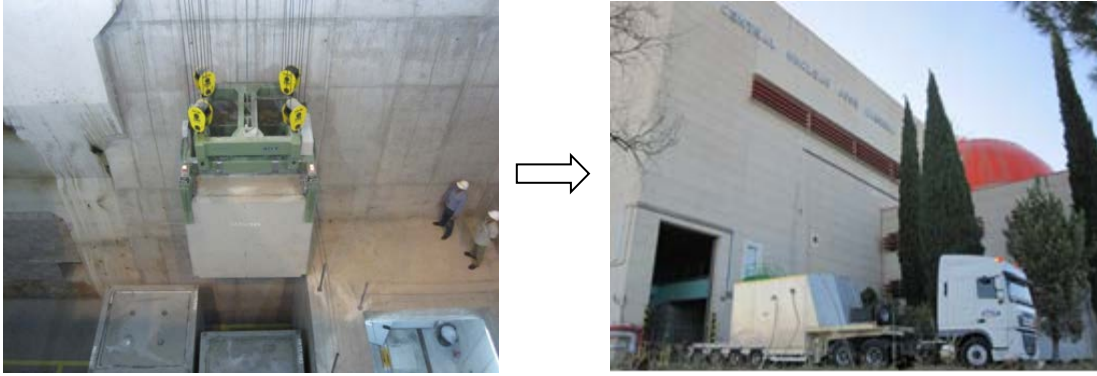
Fig. 5. The waste is packaged in concrete containers for shipment to El Cabril.

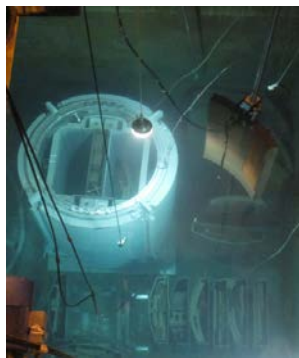
In addition, the parts closest to the reactor core, with activity levels that do not enable storage at El Cabril, are stored in 4 HI-SAFE model special containers, manufactured from carbon steel and high density concrete.

Fig. 6. Special waste load containing the reactor internals.

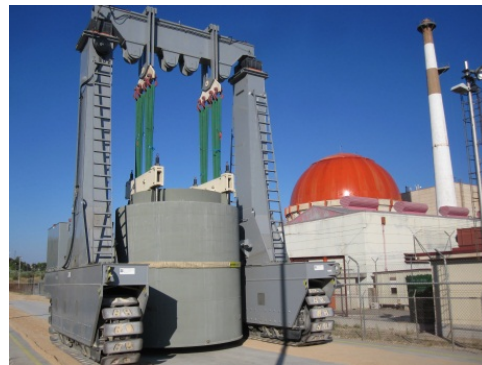
This waste will be kept in the Individual Temporary Storage (ITS) at Zorita together with the 12 containers that store spent fuel from the plant.

Fig. 7. Transport of HI-SAFE container to ITS.

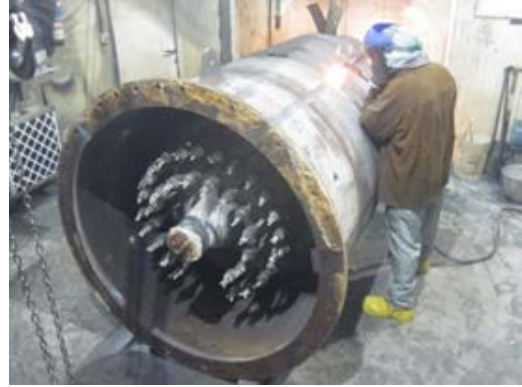
Fig.10. Cutting one of the pieces dismantled from the Pressurizer

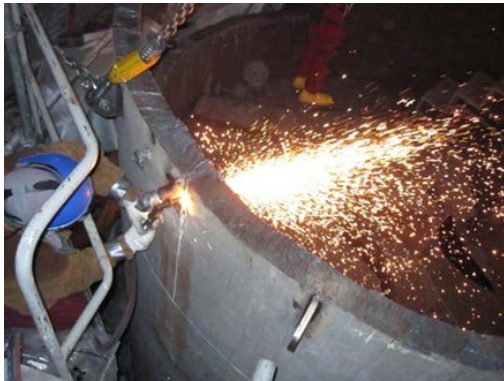
Fig. 11. Steam Generator Segmentation.

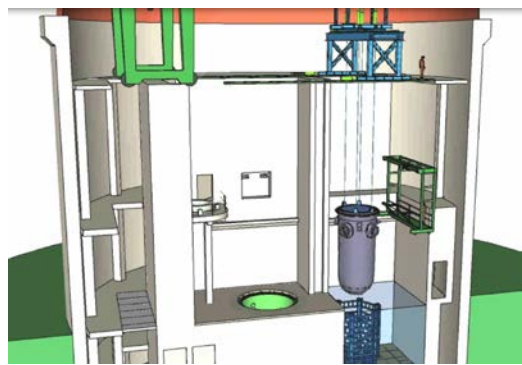
Fig. 12. Engineering plan for segmenting the reactor vessel.

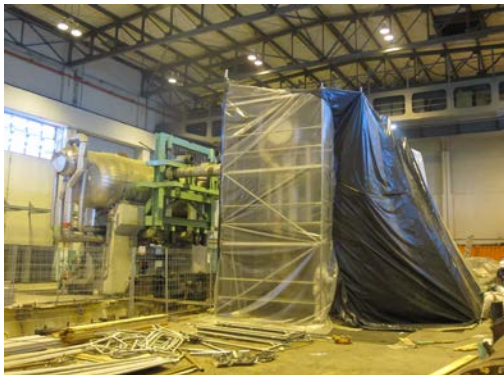
Fig. 13. Asbestos works.

- The actual radioactive waste inventory remaining at the plant, from the operations stage.
- The conservation status of some systems needed for dismantling.
- Incidents occurring during the operations phase.
- Non-standard infrastructure and equipment.
- Undocumented presence of toxic and/or hazardous products (asbestos).

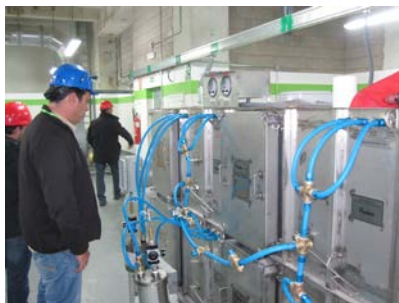
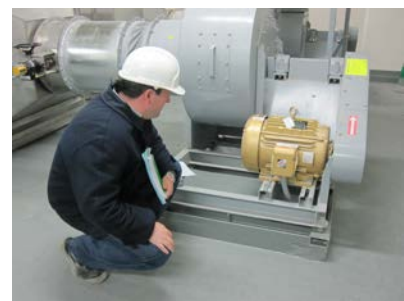
Fig. 15. EAD Ventilation Equipment (Testing).

Fig. 16. EAD Ventilation Equipment (Testing).

- The regulations applicable to ventilation systems at the time the project authorisation were obtained were less stringent than those applying at the time the changes were made, several months later. This resulted in very substantial changes to both the type of equipment to be installed, which had already been contracted, and the applicable test protocols, leading to overruns and delays in implementing these systems.

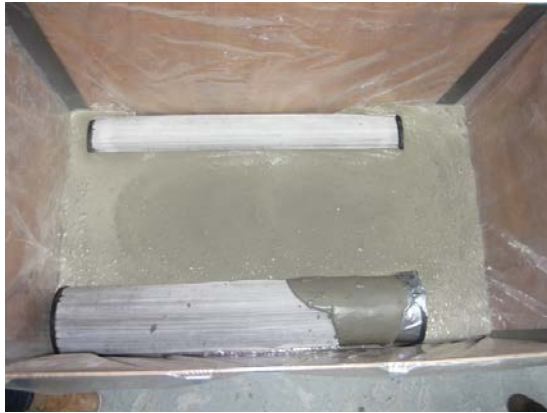
Fig. 17. Filters Testing.

On the positive side, the opportunity arose to channel some waste through different channels, more advantageous than initially contemplated. So, the purification equipment filters for the water from the cavities where the segmentation was conducted have in the end been managed using the same types of concrete containers used for the reactor internals, instead of drums, avoiding numerous manual actions (slicing) and resulting in reducing costs, time and the radiological impact on workers.

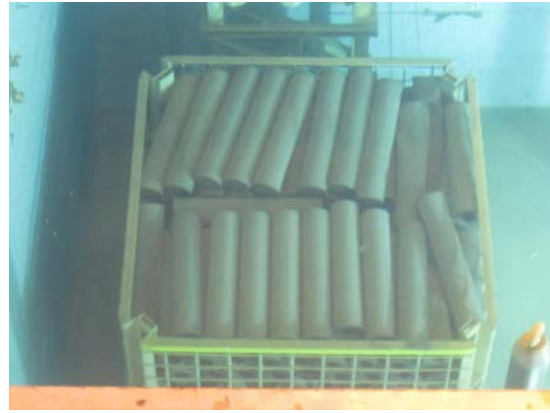
Fig. 18. Waste Basket with filters.

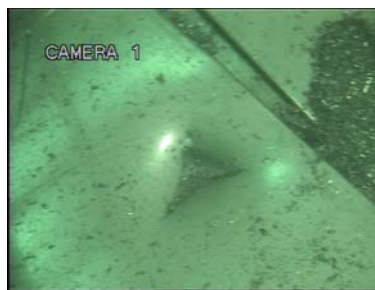
Fig. 19. Liner damage.

One example has been the contingency plan established for possible breaks in the liner of the Spent Fuel Pit during segmentation of the reactor internals. Early implementation of a water recirculation system helped solve two incidents in which large pieces of metal collided with and pierced the liner, causing leakage of water from the cavities.

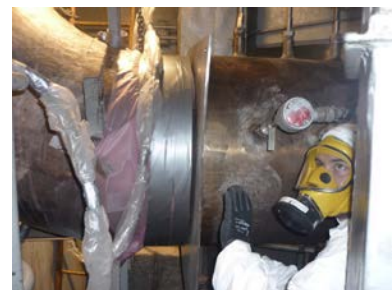
Fig. 20. Primary Circuit Isolation.

This very thorough analysis of the programme led to the segmentation activities on the pressurizer and recirculation pump being advanced by at least twelve months, activities which were initially scheduled to follow completion of the internals segmentation. In an "express" operation, initially not contemplated to take place at that time, before cutting up the internals, the primary circuit was drained and the hot and cold branches isolated, enabling the large component dismantling schedule to be significantly advanced.
