OFFICE OF RIVER PROTECTION

Tank Farms Project

Hanford's Greatest Challenge

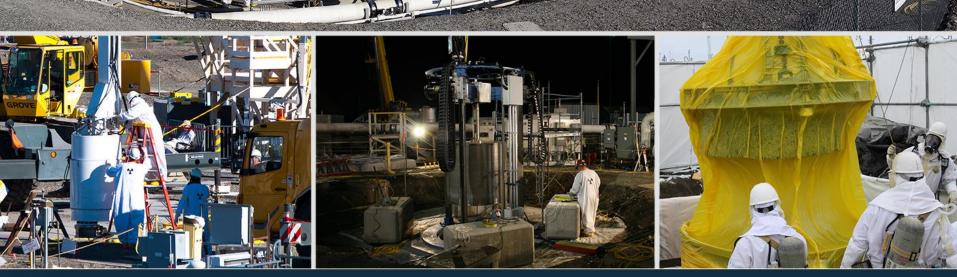
Tank Farms – Complex, Accessible Only from the Surface

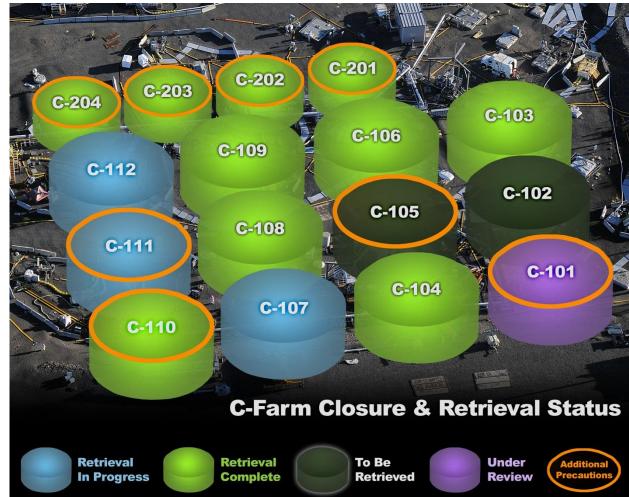
Aerial photograph of C-Farm with graphical overlay that depicts current status of each single-shell tank

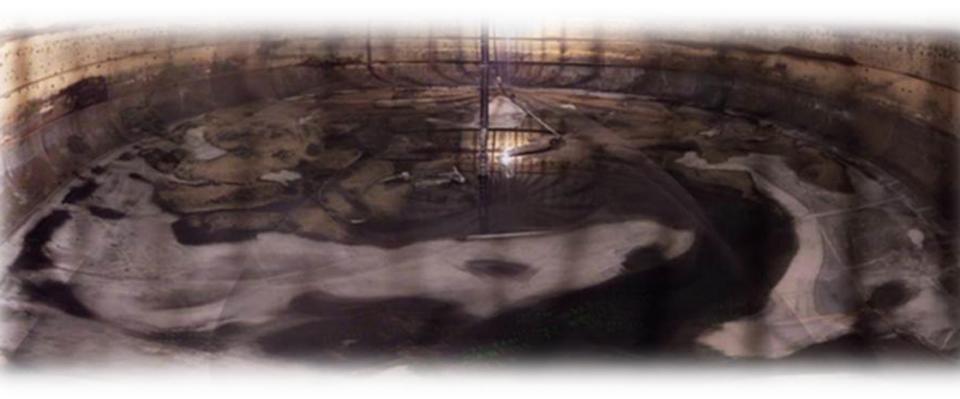
Tank Farms Retrieval Progress – Inside Tank C-110

This composite image of dozens of individual-frame photos taken inside Tank C-110 provides a rare panoramic view of the tank interior

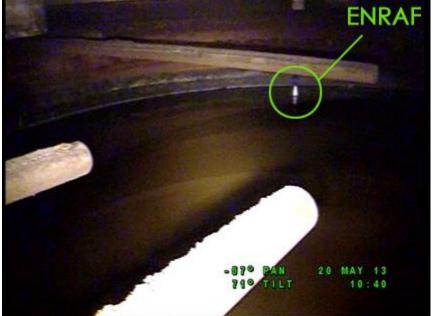
View inside tank T-111 with ENRAF tank level gauge visible

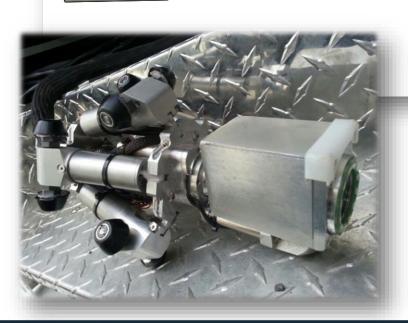
Tank AY-102 – Robotic Crawler

Robotic crawler was navigated through 60 feet of six-inch drain line underneath Tank AY-102
