Finding Balance between Biological Groundwater Treatment and Treated Injection Water – 15237

ABSTRACT

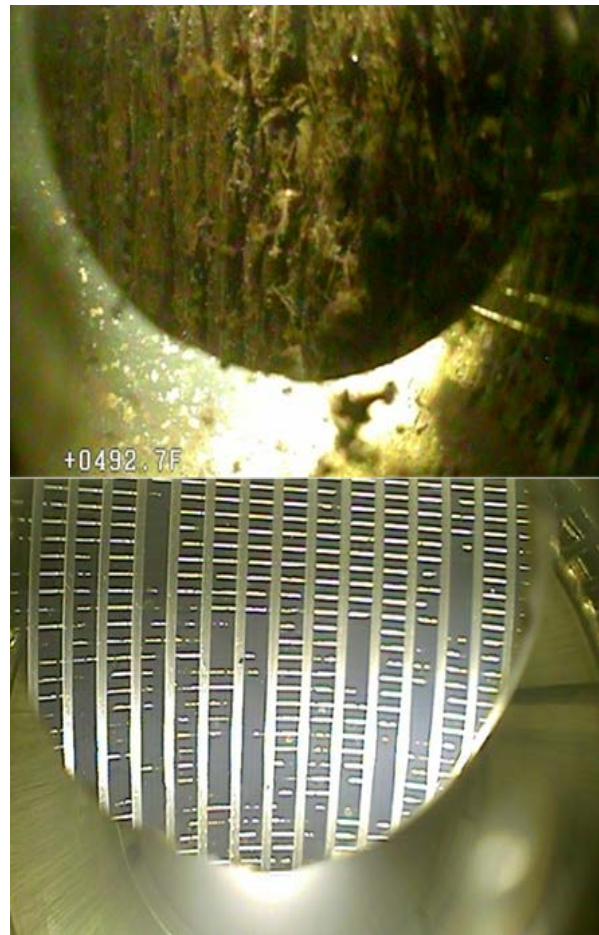
Initially, injection wells lost capacity as a result of biological fouling. As the health of the FBRs declined, unconsumed carbon substrate passed through the FBRs to the treatment plant effluent. During early injection well rehabilitation events, large quantities of biological growth were removed as observed in the video surveys (Fig. 1).

Fig. 1. Injection well screen before rehabilitation and after one rehabilitation in October 2013. Note the clogging metal oxides remaining on the well screen after rehabilitation.

From an injection well standpoint, it is also clear that bacteria and the associated biofilm will clog the injection well as much or perhaps more than the manganese dioxide. Fig. 1 shows the biofilm before and after cleaning. Before cleaning the biofilm occludes the well screen almost entirely. The stringy nature of the biofilm is typical as the EPS is made of polymeric substances. This material is known to clog instrumentation and mechanical equipment at the plant. Note also that the biofilm is readily removed with the exception of a material between the main struts of the well screen. This material is thought to be a corrosion byproduct.

presumably results in byproducts that are carried in the effluent and, under the right conditions, can lead to injection well fouling and plugging (Fig. 1). Effluent metal and nutrient reduction (especially manganese and iron) will decrease the risk of well fouling and precipitation of solids in the injection well filter pack and formation. Chemical rehabilitation will likely be required multiple times per year per injection well given the current effluent water quality, and damage to the filter pack and formation may be (or become) partially irreversible, meaning the well will never return to the specific capacity/injectivity when it was first installed.

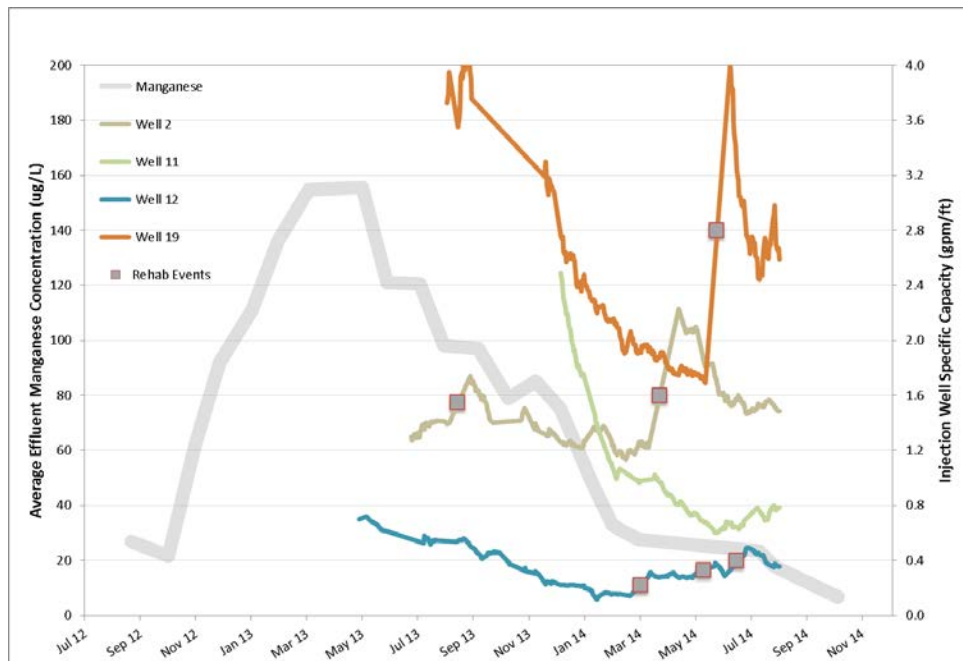
Based on the well performance over time, there is roughly a 3-month lag in the response to improved manganese effluent water quality (Fig. 3). It is expected that the wells will respond rapidly in a loss of

well performance if increases in the effluent manganese concentration occurs, but will then respond slowly (with a gain or stabilization in well performance) when the manganese concentration is corrected and decreased in the effluent (Fig. 3). Note the increase in injection well specific capacity before rehabilitation events.

Fig. 3. Improved injection well performance to manganese effluent water quality.

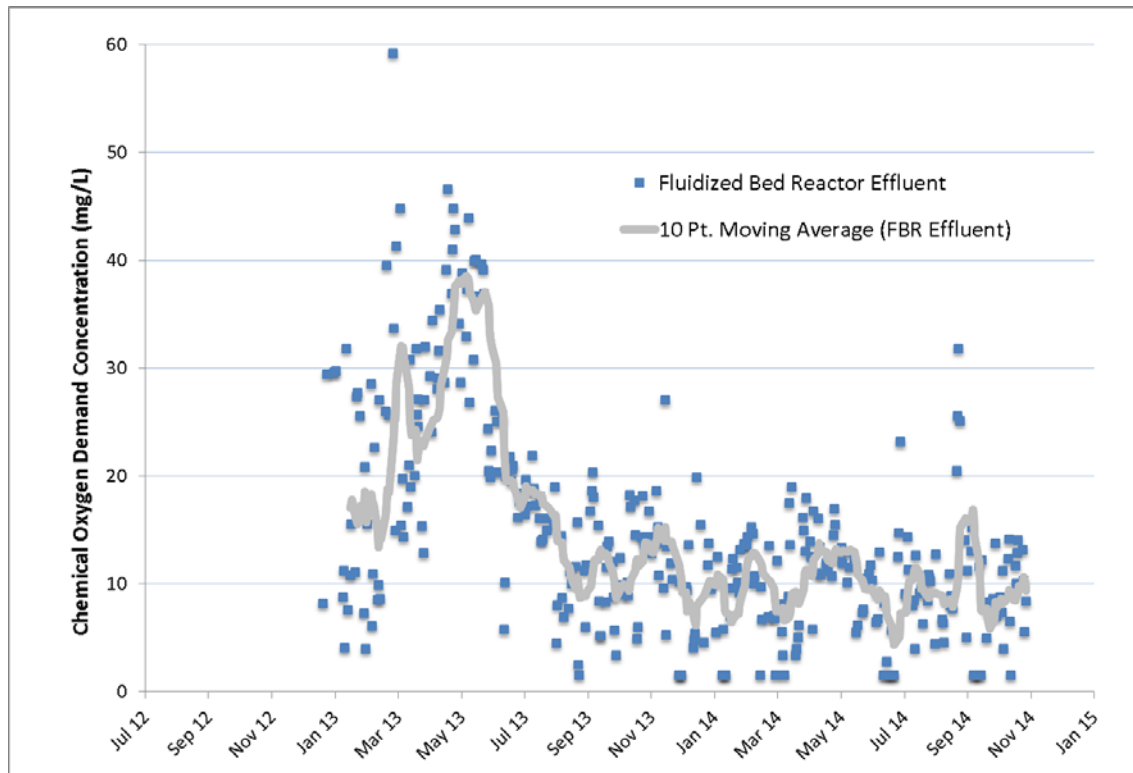
Fig. 4 shows the concentration of COD in the injection water. The concentration peaked at about the same time frame that the manganese concentration peaked.

Fig. 4. Chemical Oxygen Demand in water from Fluidized Bed Reactors. Note injection water COD is 2 to 4 mg/L less than that shown.

Based on the information presented, the authors recommend that injection water contain less than 10 mg/L COD to limit biological growth (and the resulting biofilm) and less than 0.01 mg/L manganese to limit manganese-based corrosion of stainless steel well screens.

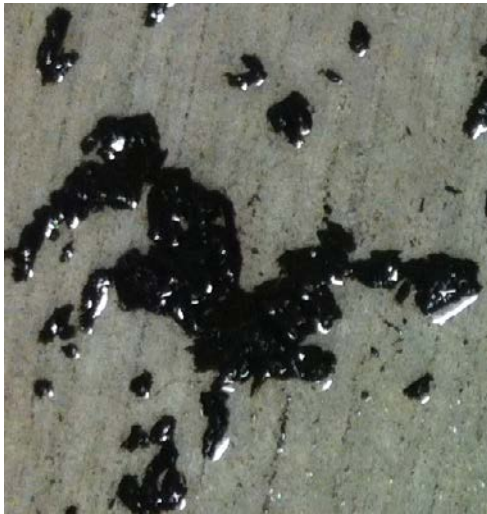
Fig. 5 illustrates the black nature of the foulant. Manganese dioxide forms a black precipitate and is thought to be responsible for the color. Fig. 6 shows the material in Fig. 5 magnified 400x. Much of this material shown is thought to be of biological origin. The particles are likely manganese dioxide. The slimy biomass surrounding the precipitated manganese is mainly extracellular polymeric substances with some bacteria.

Fig. 5. Black gelatinous well foulant removed from injection well.
