## Lessons Learned in the Hot Cell at the Transuranic Waste Processing Center - 15336

### ABSTRACT

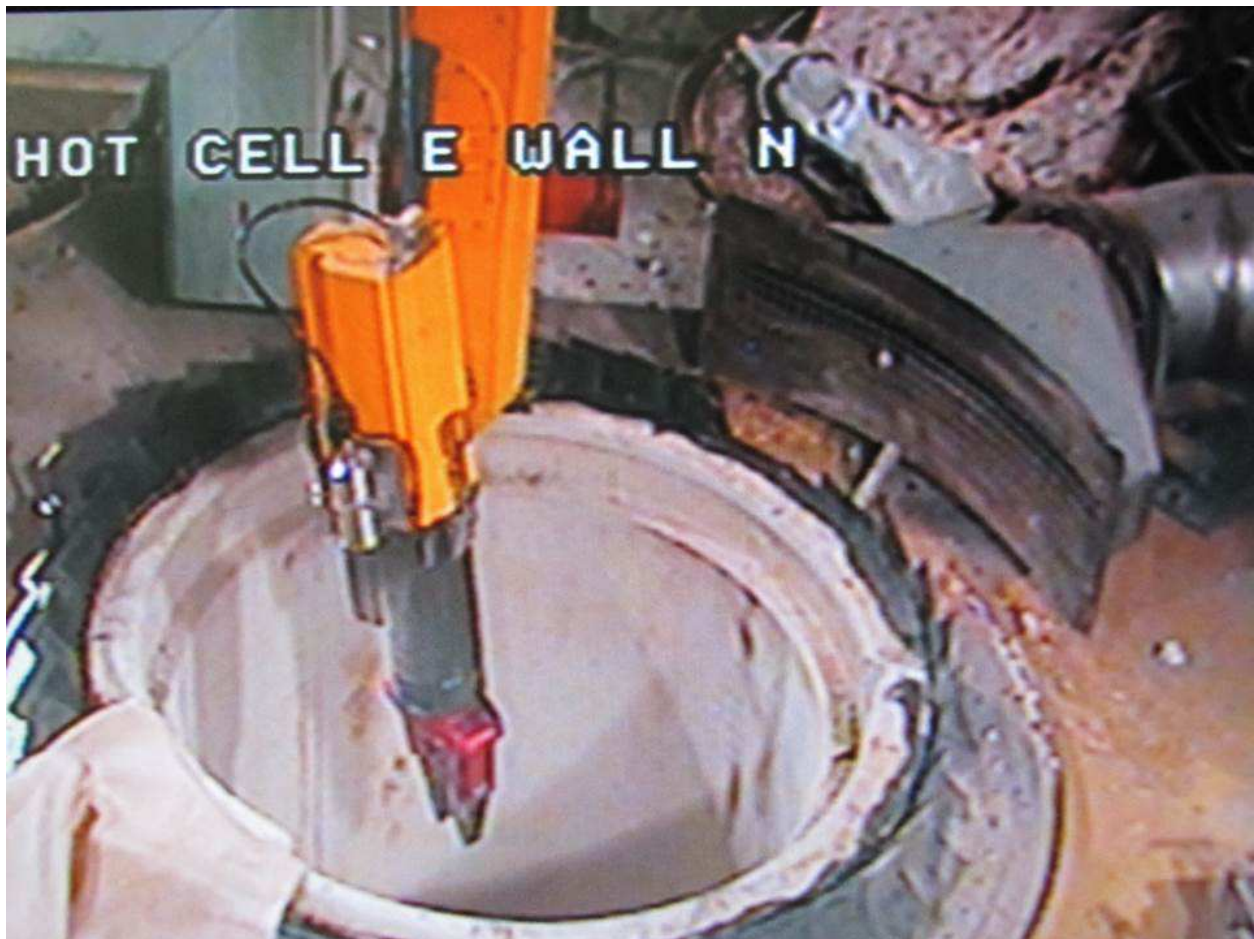
To understand the importance of improving the manipulator reliability and maintainability, it must be stressed that the in-cell manipulator is a single point failure for almost all significant hot cell operations. However, the single most important function of retrieving waste from a RH cask and placement into reach of the four MSMs used to process the waste, overrides all other functions. Without the manipulator in service, waste processing stops. Figure 1 shows the manipulator entering a cask during post outage operations.

**Fig. 1. Post Outage Manipulator Entering a Cask**

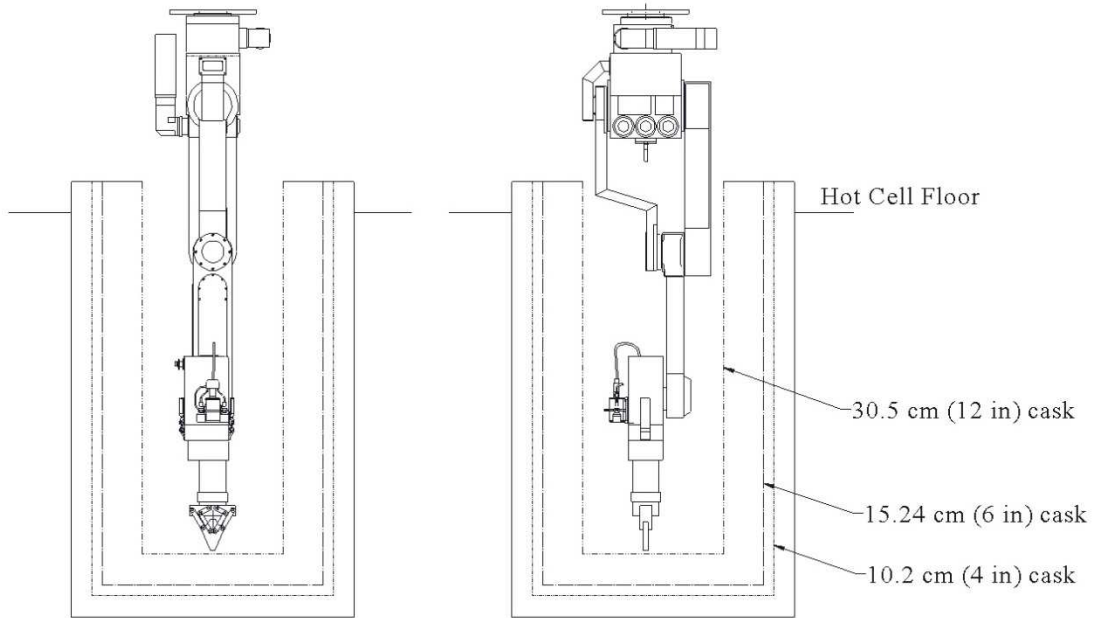
The manipulator, as purchased, was a well-made piece of equipment. The general design of the manipulator enabled it to function in multiple environments but it was challenged by the nature of the TWPC RH waste matrix. In particular, the manipulator is not as well suited for the tasks associated with retrieving waste from inside the small diameter RH concrete cask cavity. The in-service performance history shows that the manipulator regularly impacted the cask side walls at the upper and lower arm. This problem is exacerbated as the waste cask is emptied due to the fact that the widest part of the manipulator must be lowered into the cask in order to reach the material in the bottom. Figure 2 shows the relative sizes of the 10.2 cm (4 in.) wall, 15.24 cm (6 in.) wall, and 30.5 cm (12 in.) wall casks with the manipulator inserted into the cask.

**Fig. 2: Relative size of the manipulator and the casks**

It is a TWPC RCRA permit requirement that the RH waste cask be verified as empty as a part of processing. This includes the bottom of the cask to the wall of the cask (i.e. the lower corner). It can be seen from Figure 2 for a 30.5 cm (12 inch) wall cask there is not much room for moving the manipulator into a position where the lower corner can be cleaned. During the years of waste processing the operations staff tried many approaches to move the waste from the lower corner of the casks into the middle of the cask. These include vacuums, scrapers, dust pans, etc. and all have met with little or marginal success. It is known that cleaning the cask to its lower corner is where the most damage to the manipulator occurs. A current project is approved and underway to build an offset end effector (shown in Figure 13). This end effector will off-set a scraping jaw 38 cm (15 inches) from the centerline of the manipulator allowing the blade to reach the lower corner of a waste cask. The blade operates on a linear bearing so it can remain in contact with the bottom of the cask when closing; this will scrape the material away from the corner and pile it in the center of the cask. We hope to have this and two more end effector types ready to test by the end of calendar 2014.

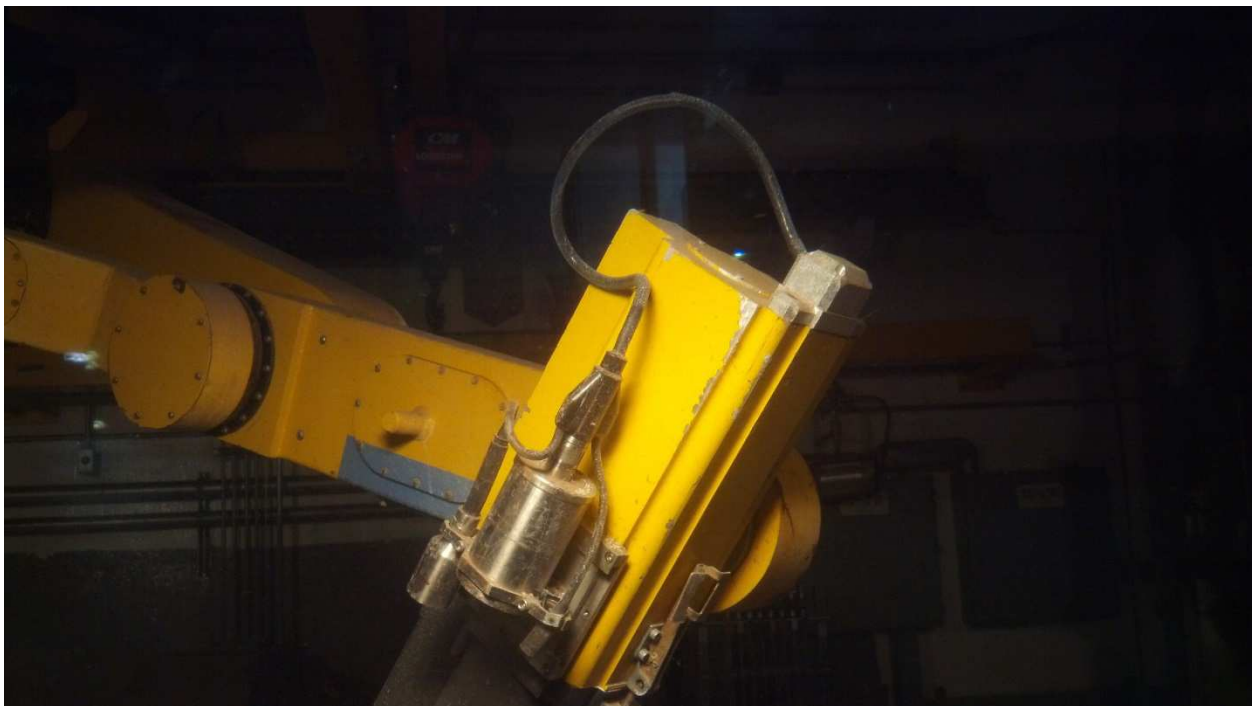
Following a connector failure leading to the wrist mounted camera, a hardened wrist camera connector was developed. The original camera connector was a very good quality MIL- spec connector, but in operation the connector was not adequately protected from the high likelihood of impacting the wall of the cask which caused it to break. As a temporary fix, tape was used to hold the camera connector in position allowing time for a permanent fix to be developed and implemented. Figure 3 shows the newly installed hardened connector. The redesigned mount has been in service since May 2009 and has never failed.

**Fig. 3 Hardened wrist camera connector**

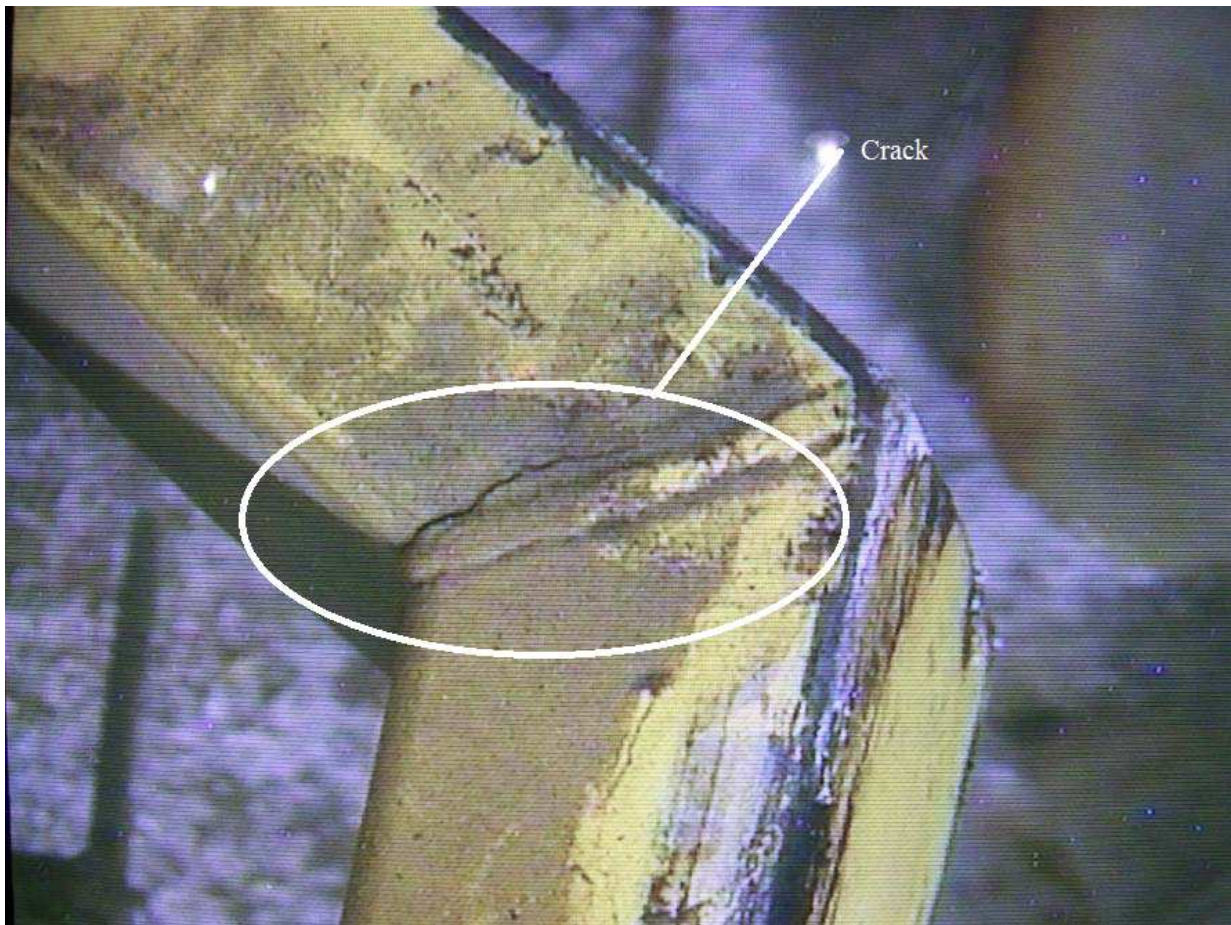
The next in-cell modification was to repair a crack in the “S” shaped tube steel weldment that is part of the upper arm. A picture of the crack is shown in Figure 4.

Fig. 4 Upper arm weldment crack

This structural crack presented a challenge because no welding (i.e., hot work) is allowed in the hot cell. Engineering decided to fashion a “splint” for the cracked region of the weldment. A finite element analysis (FEA) of the affected area was performed using assumed loads [1] and it was determined that there was a stress riser in the location of the crack both on the top and bottom of the weldment. A second FEA model was prepared and analyzed that included the “splint” pieces and the crack. This FEA was used for determining the shear stress between the “splint” pieces and the weldment. Since two-part epoxy adhesive requires use of an acetone wash prior bonding, an acrylic two-part adhesive was selected that developed,

at cure, a shear strength higher than the required shear stress determined from the FEA. The analysis and the fabrication of the “splint” pieces, ordering of the adhesive, and the installation of the containment occurred in parallel. The ends of the crack were drilled (to stop the crack) and the “splint” was bonded directly onto the weldment. The weldment remained in service for 16 months until the manipulator was replaced. A similar modification was repeated on the new manipulator prior to installation into the hot cell, with the luxury of being able to weld the preventative splint onto the new manipulator.

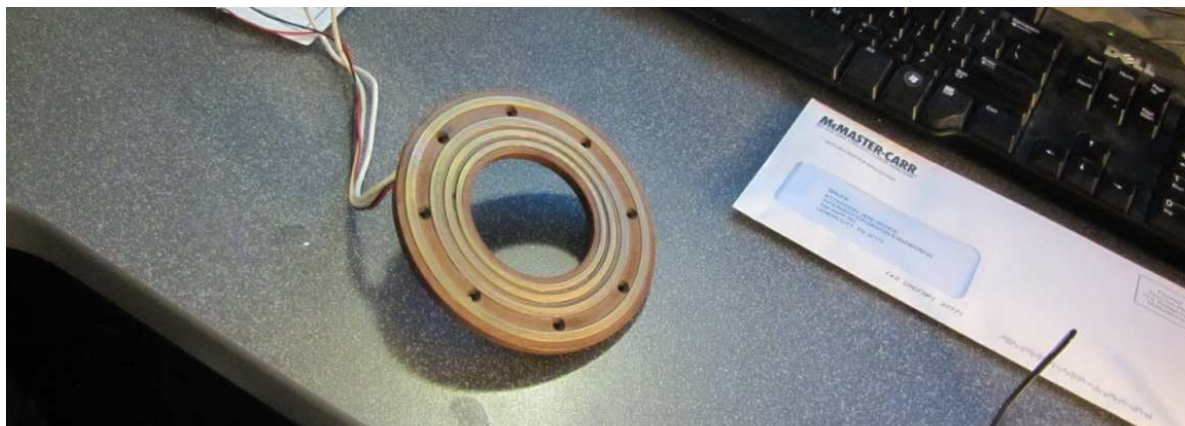
In late October 2011 engineering began design of a different wrist assembly. There had been numerous failures of the existing wrist assembly and ultimately sequential failures occurred to three different wrist assemblies. It was decided that the exiting wrist design could not withstand the rigors required for waste processing in the hot cell. It should be re-stated that the failure mechanisms experienced were not because the vendor supplied wrists assemblies were in any way sub-standard, they simply were not designed to deal with operational requirements and tasks required in TWPC the hot cell. Secondly, and perhaps the more important reason for a new wrist design is that the original wrist assembly was very hard to maintain using the four sets of protective gloves required for a maintenance technician to place hands into the containment. The features designed into the new wrist assembly included use of a face type slip ring for transferring power to the grip motor and clutch, limit switches for the extend/retract function, application of commercially available gearmotors with robust gearboxes, and attributes for ease of maintenance. These design features were derived directly from lessons learned from each of the wrist failure events. The prototype face type slip ring is shown in Figure 5.

Fig. 5 Face Type Slip Ring

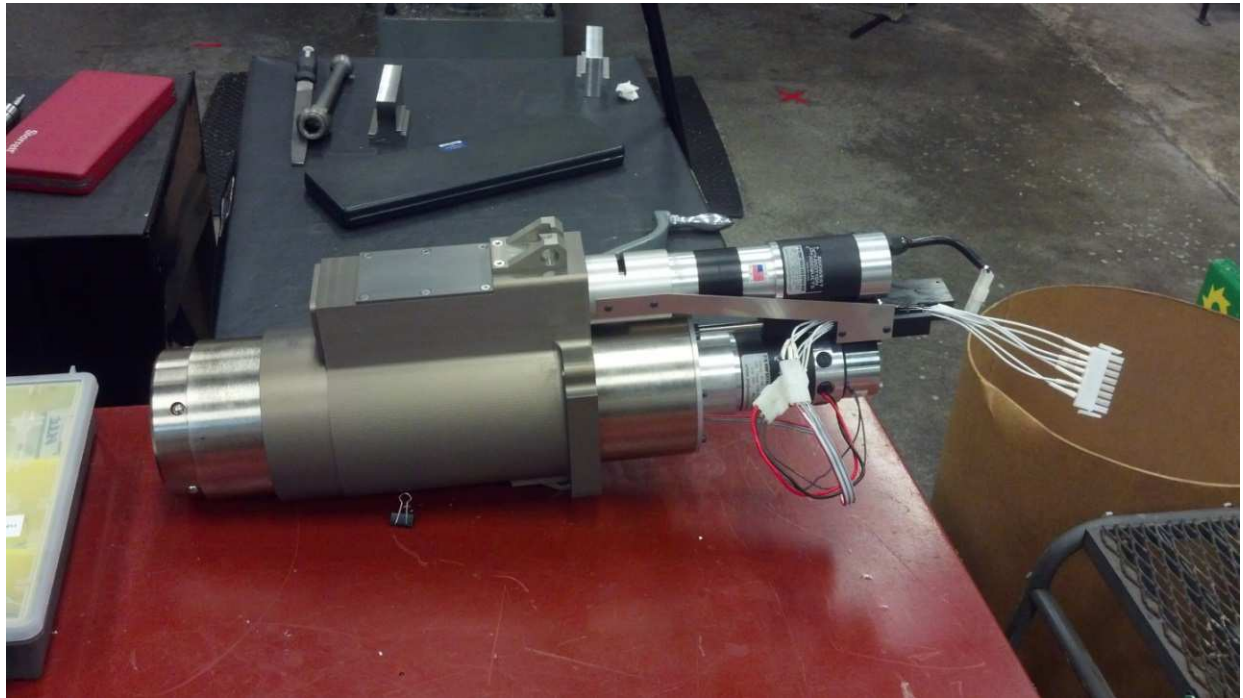
Prior to testing and placing the prototype wrist in service, the maintenance staff assembled and disassembled the wrist several times. It was quickly realized that some of the features were not as easy to re-assemble desired, so a second more modular design was developed. Two of these wrist assemblies were built as spares. Figure 6 shows the final wrist assembly.

**Fig. 6 Final Wrist Assembly**

A prototype wrist was built and tested on the new manipulator and was placed in service with the new manipulator as part of the hot cell outage. Although it was 3.65 inches longer and weighs 15 lbs. more than the original, the new design features and the added strength of the wrist assembly advantageously offset the added length and weight. The new wrist has held up well following restart of hot cell operations with only a single grip gear motor failure in 14 months of operation.

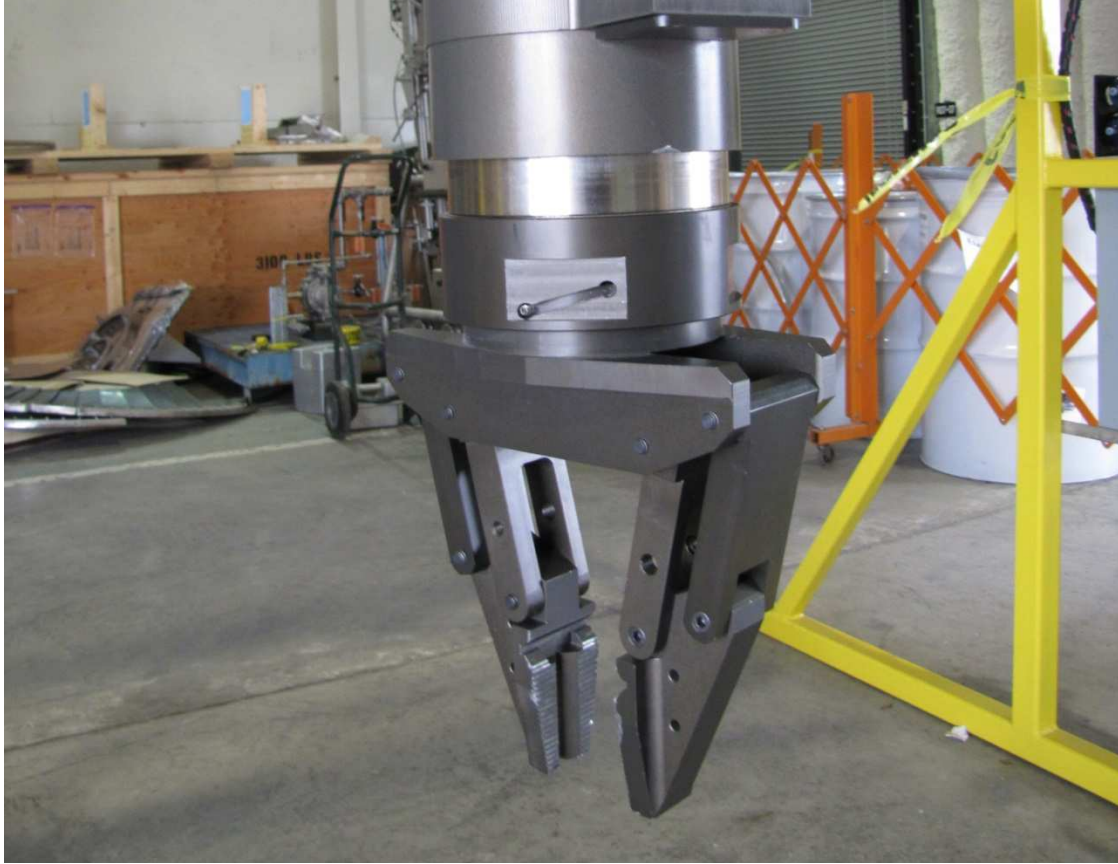
Lessons learned also prompted the engineering staff to re-design the end effector(s). The original end effectors were a struggle to remove and replace due to the push pull nature of the locking collar. Further, it was recognized that the end effectors failed at a notch connection between the linkage that opens and closes the end effector and the acme screw that drives the linkage. Since the arm receives load by the end effector an effort was made to also include what could be called a “mechanical fuse”; a feature that would break when over loaded but at the same time would be easy to replace. The mechanical fuse for the end effector is the bolt that connects the drive plate to the drive screw. If this bolt breaks a new drive screw and bolt can be installed in less than an hour in the maintenance glovebox. To address the difficulty of removing and replacing the end effector a different locking collar was made that rotated from the locked to unlocked position. This allowed the locking collar, when rotated to the unlocked position, to stay in the unlocked position. A parallel acting, and non-parallel acting end effector were designed and tested. Both types of end effectors are currently in service in the hot cell. Another advantage of the re-designed end effectors is the extensive use of anodized aluminum. The end effectors weigh 67% less than the original vendor supplied end effectors while maintaining the strength and corrosion resistance of the original. Figure 7 shows the re-designed parallel acting end effector.

**Fig. 7 Re-Designed Parallel Acting End Effector**

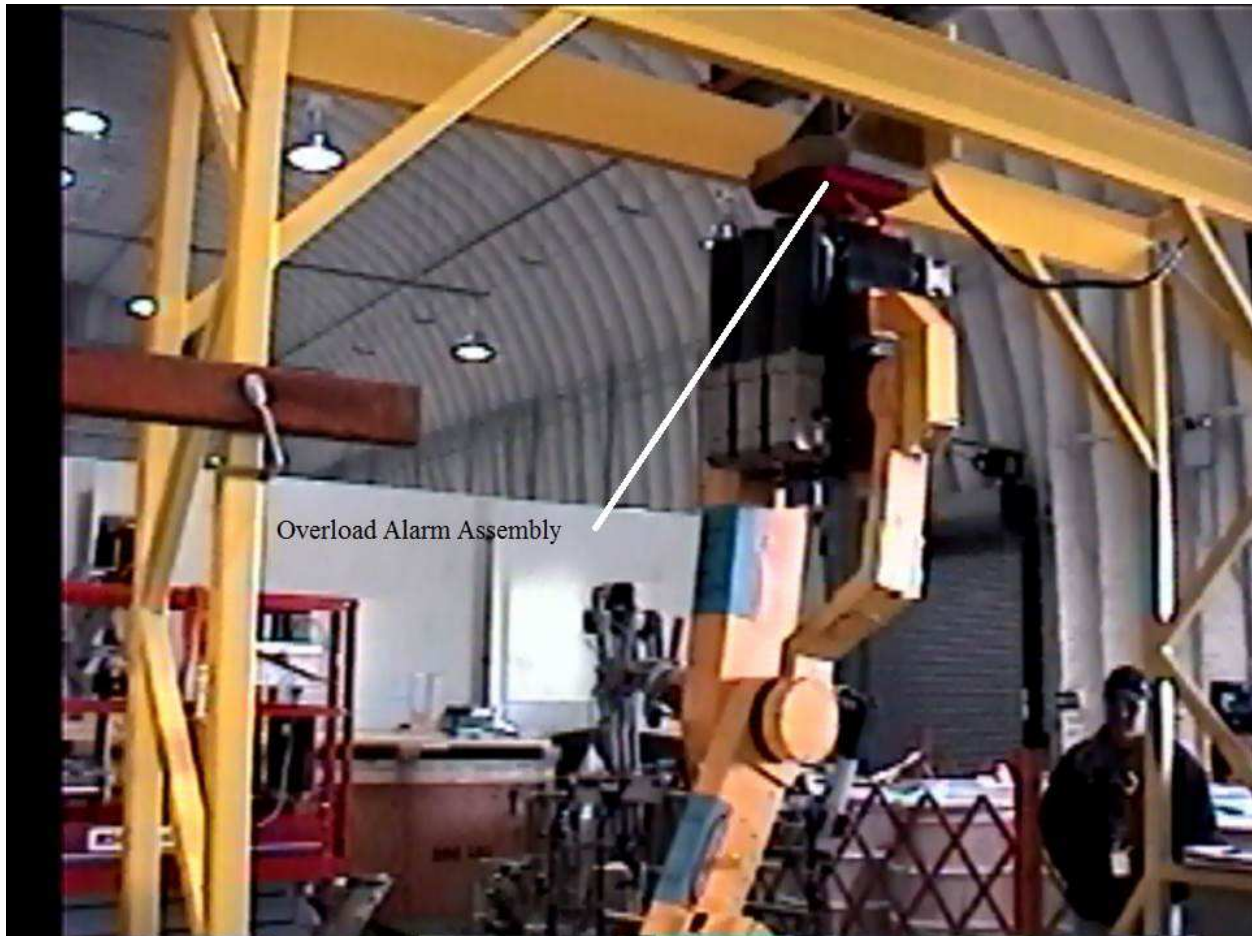
When the manipulator was first placed in service, it was thought that being able to remotely disconnect and re-connect the manipulator would be a valuable feature. This feature was never used by TWPC during the 6 year service period of the original manipulator. Also, as the project became more familiar with the system it was realized that it would require a manned entry into the hot cell in order to remove and replace the manipulator. Based on that experience, the remote disconnect feature was removed and the overload sensing switch installed at that location. Figure 8 shows the lower portion of the overload alarm assembly on the spare manipulator mock-up. The overload alarm is triggered by the presence of excessive bending moment reacting at the point where the manipulator attaches to the mast, and is sensitive to both in plane and out of plane force(s). Operationally, when the overload alarm is triggered a

visual and audible alarm annunciates. When this occurs the operator will move away from the perceived source of the overload until the alarm goes silent.

**Fig. 8 Partial View of the Overload Alarm Assembly**

The final significant modification of the manipulator was the installation of a means to detect an arm overload condition. As supplied by the vendor, the manipulator is equipped with slip clutches for the shoulder, elbow and wrist pivot axes, as well as the shoulder and wrist roll axes. These are well designed and work well, but they can only prevent overloading if the overload force(s) is parallel to the plane of motion of these axes. The manipulator can be overloaded by forces that are perpendicular to the plane of motion, so called “out of plane forces.” These forces can readily be imparted to the manipulator because the manipulator mast is connected to a bridge that moves horizontally north, south, east, and west. TWPC engineering and operations personnel suspected that this out of plane loading is the primary contributor to the wrist pitch joint fail. To preclude failure from out of plane overload, an overload alarm system was designed and tested on the spare manipulator mock-up. The system replaced the original manipulator mounting which included a means to remotely disconnect the manipulator from the manipulator mast.

The electrical connection for the overload alarm was made possible by another minor modification which removed the tool power connector feature from the wrist housing; it was also never used. This meant that the in-place wiring that was already installed from the mast to the manipulator controller could be re-purposed; two of these wires were used to connect the overload alarm to the control cabinet outside the hot cell.

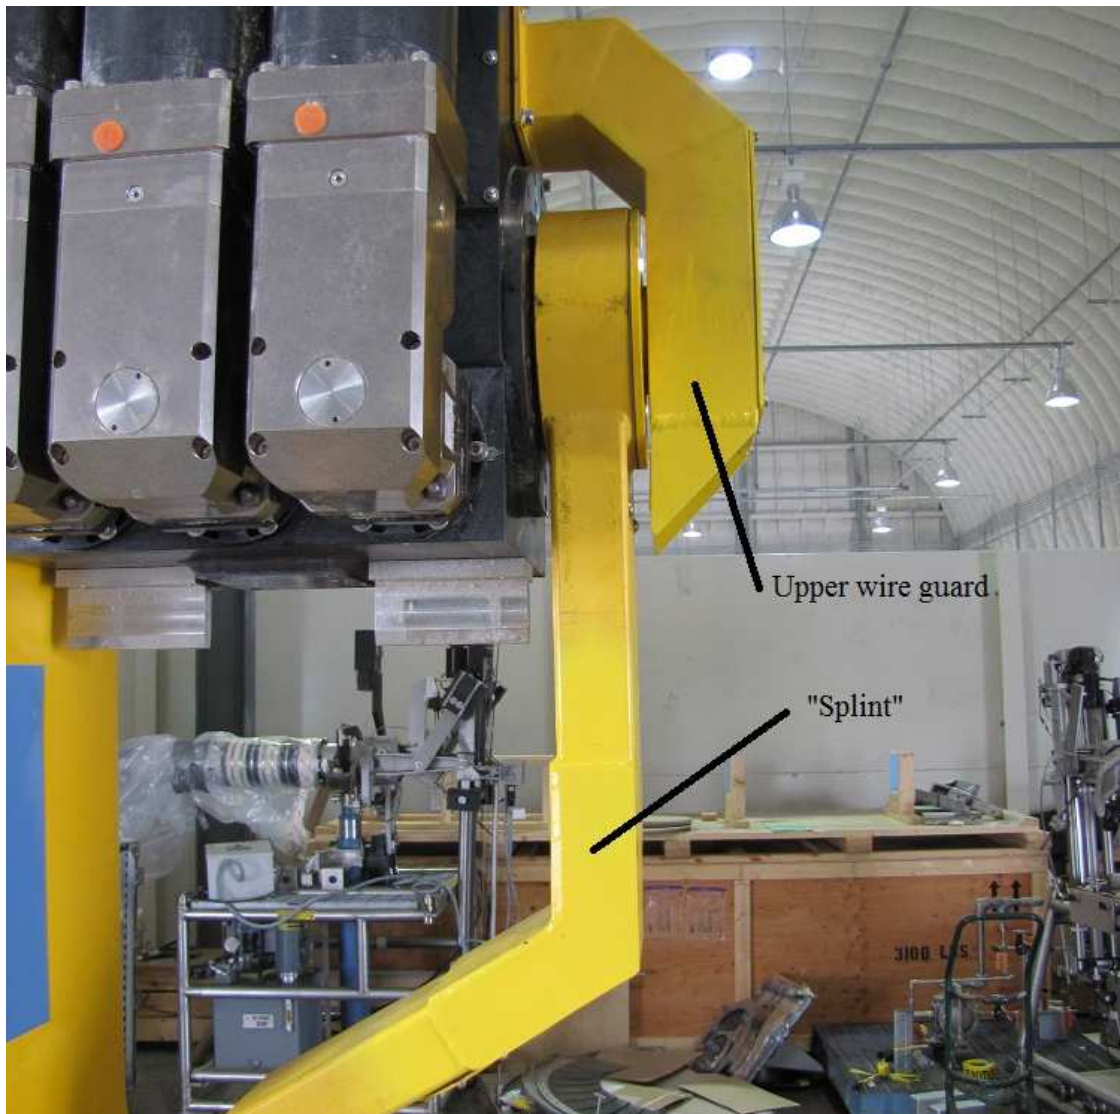
Numerous additional minor modifications were made to increase the ease of maintenance. For example, the remote connect connector used for connecting the wrist wiring to the arm wiring was replaced with a more friendly and reliable molex™ connector. The remote connect feature was a good idea, but when a wrist repair is performed it was difficult to trouble shoot following reinstallation. Should the wrist not work, it was very difficult to determine whether it was nonfunctioning wrist or if it was not functioning because the connector improperly mated. Another simple change was made to prevent the upper wire guard from getting knocked off. The mounting screws were modified from #6-32 to 1/4 -20, and beveled the end of the wire guard. The wire guard has not been knocked off post outage.

Fig. 9 Other Modifications

During the service life of the original manipulator, maintenance had to change the drive belts twice. To change the drive belts the lower and upper arm covers must be removed. All of the arm covers were secured by over one hundred button head cap screw of various sizes. The button head screws would get

abraded as a function of working in the cask. Many of the screws had the sockets worn down to the point where the screws could not be removed. The solution to this was to change all the cover mounting screws to one size, and use hex head screws. Additionally, an in-line set of MIL-spec connectors was installed in the wrist and camera wiring harnesses in the center of the lower arm weldment. This change was required because when the lower arm drive belt needed to be changed, the wrist would have to be pulled out and the two wiring harnesses removed from the wrist housing and most of the lower arm. These activities were time consuming and exasperating for the maintenance staff. With the new connector in place they only need to be de-mated and the wiring harnesses pulled out of the lower part of the lower arm in order to facilitate a belt replacement.

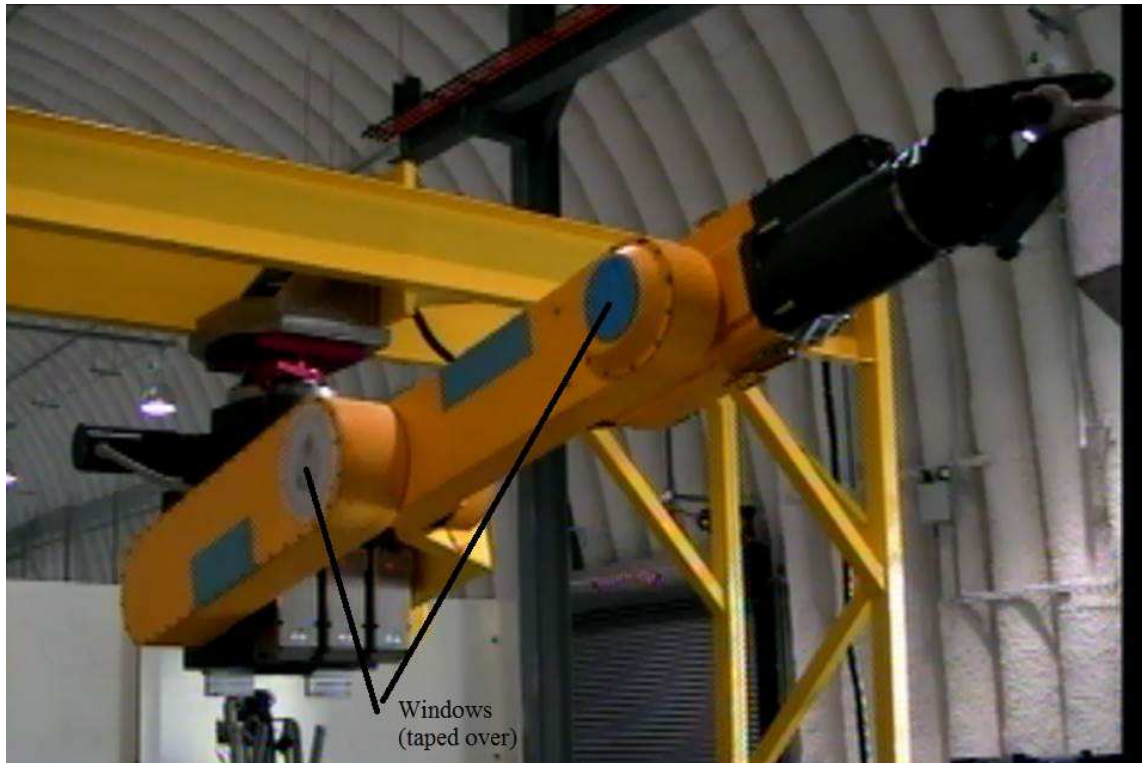
Also in order to facilitate maintenance on the belts, TWPC installed polycarbonate windows over one of the two pulleys and pulley sets in the upper and lower arm so that the belt movement can be observed from outside the hot cell. These windows allow the operations and maintenance staff to observe whether the belts are loose or not tracking on the pulleys correctly. This in-turn provides a predictive tool for the maintenance staff. Figures 9 & 10 show some of these modifications.

**Fig. 10 Belt Windows**

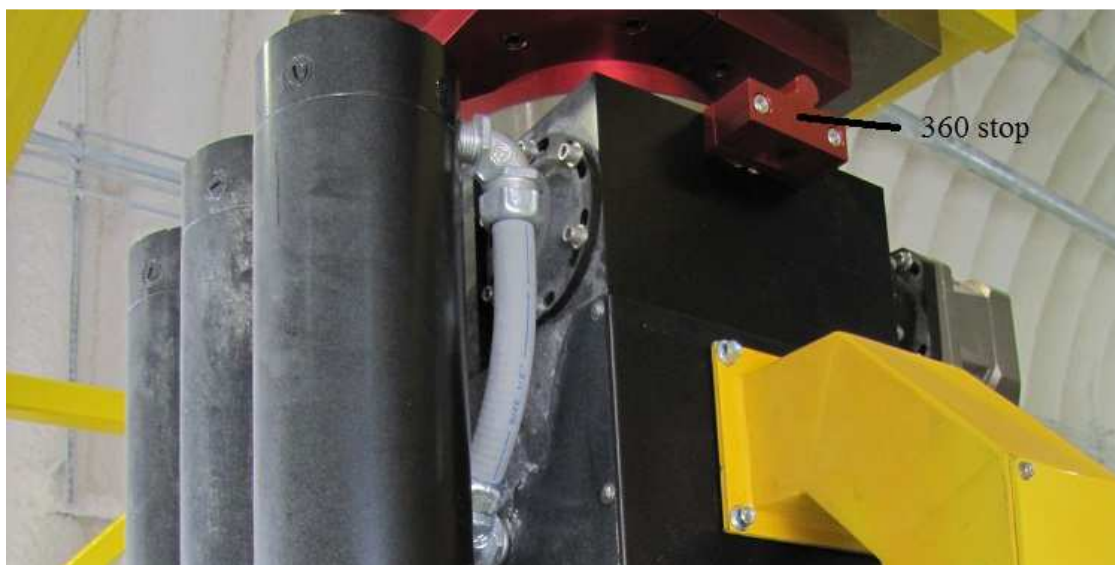
The last minor modification was to change the original shoulder roll hard travel stop. The original stop limited the shoulder rotate function to 330 degrees creating a shadow area that could not be entered unless the manipulator pitches were inverted, but in doing so it would create the same shadow on the opposite side of the manipulator. The hard stop was re-designed to allow a full 360 degrees of motion. The 360 degree hard stop is shown in Figure 11.

**Fig. 11 360 Degree Stop**

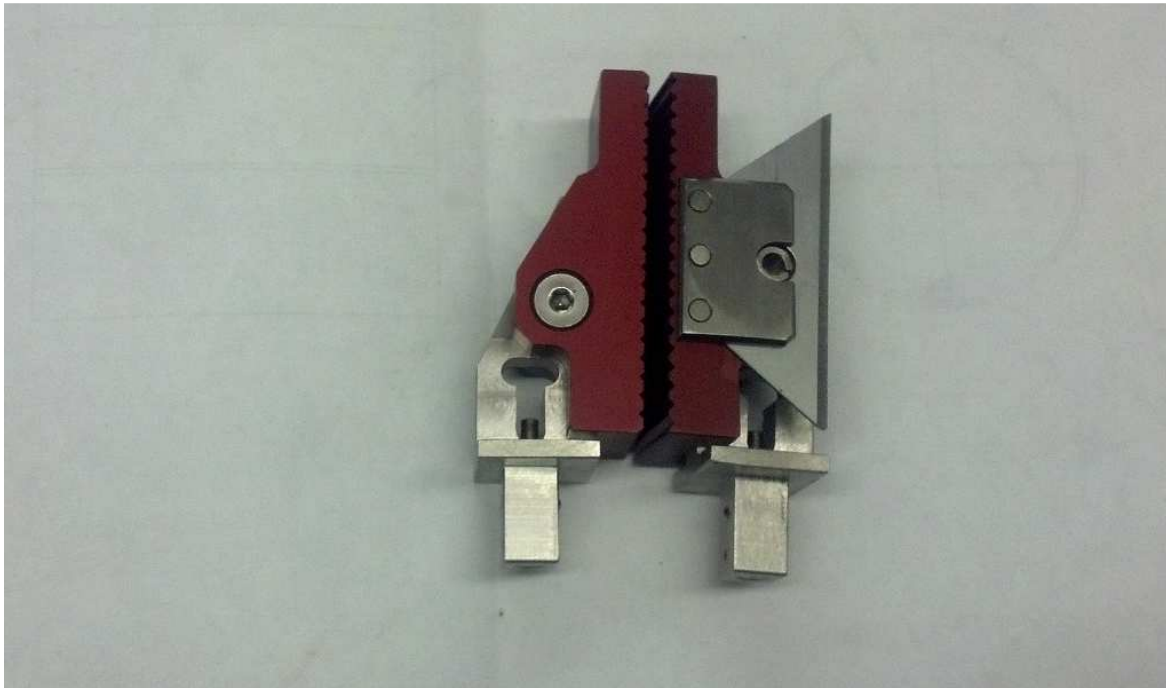
The last lesson learned relates to the ability of the manipulator to grip thin, slippery surfaces such as plastic sheets and bags. While it may be easy to physically grab a plastic sheet with the manipulator end effectors, it is entirely another thing to be able to pull on it with necessary force to move or lift. Some of the RH waste casks have been filled with lots of plastic bags and plastic sheeted items. Even when exerting a tight grip force, both smooth and serrated manipulator jaws that did not intermesh demonstrated a tendency to slip when pulling on plastic. To address this issue the design of the t-bar jaws was revised to make them intermesh. Similarly, TWPC's MSM tongs were reverse engineered and designed with intermeshing fingers. One of the MSM fingers contains a spring loaded utility knife attachment that allows a utility knife blade to be installed onto the finger. When a lot of plastic bags and sheeting are being processed in the hot cell, it saves time to be able to invert the MSM hand and cut the plastic. The MSM tongs and fingers are shown in Figure 12.

**Fig. 12 Intermeshing MSM Jaws with Knife Holder**

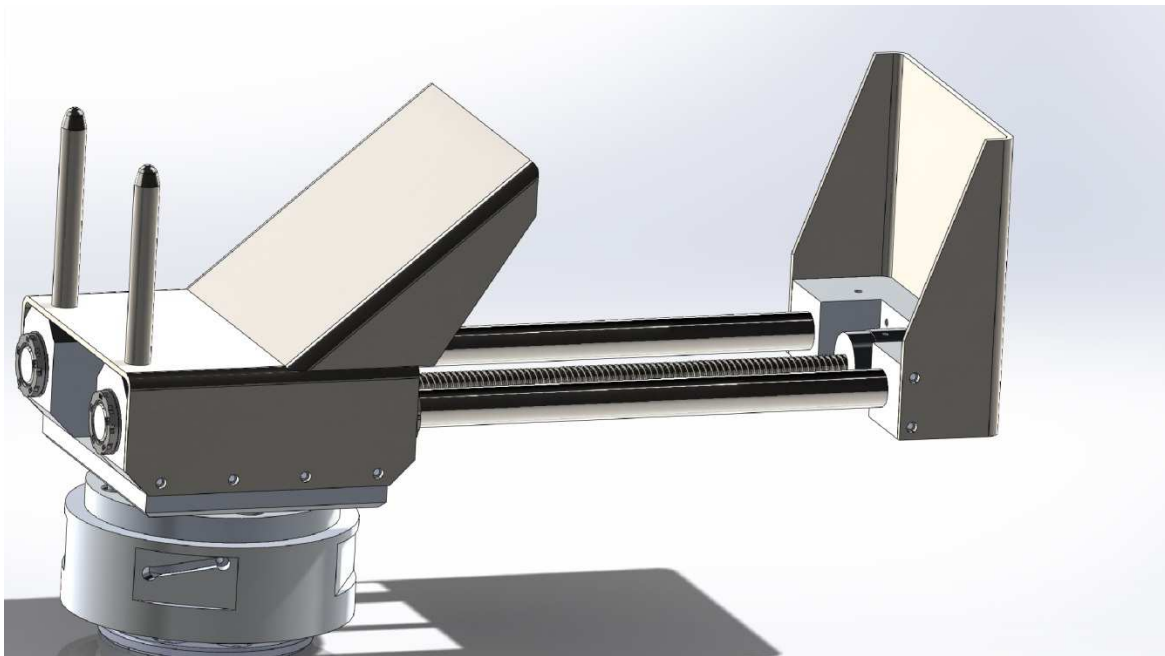
**Fig. 13 Offset End Effector**

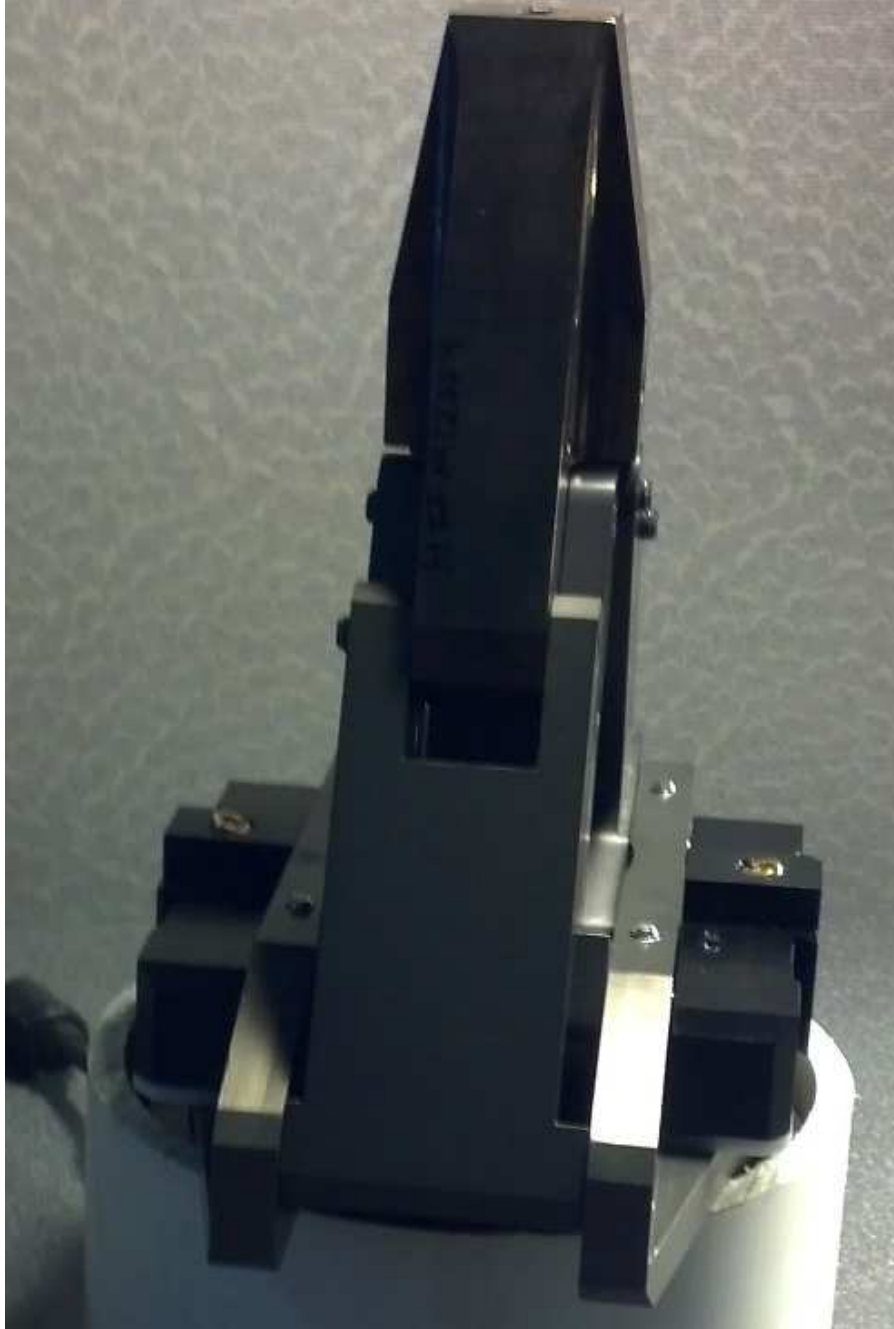
Another project is to attach battery powered range finders to the end effectors that can be seen through the wrist camera (Shown in Figure 14). These will allow the operators to gather 3D information from the 2D wrist camera. Testing will begin in December 2014.

Figure 14: laser depth modules
