# SRS Aligning Mission Needs and Aging Infrastructure: Liquid Waste Perspective

*Waste Management Symposia 2015*

*Savannah River Site March 17, 2015*

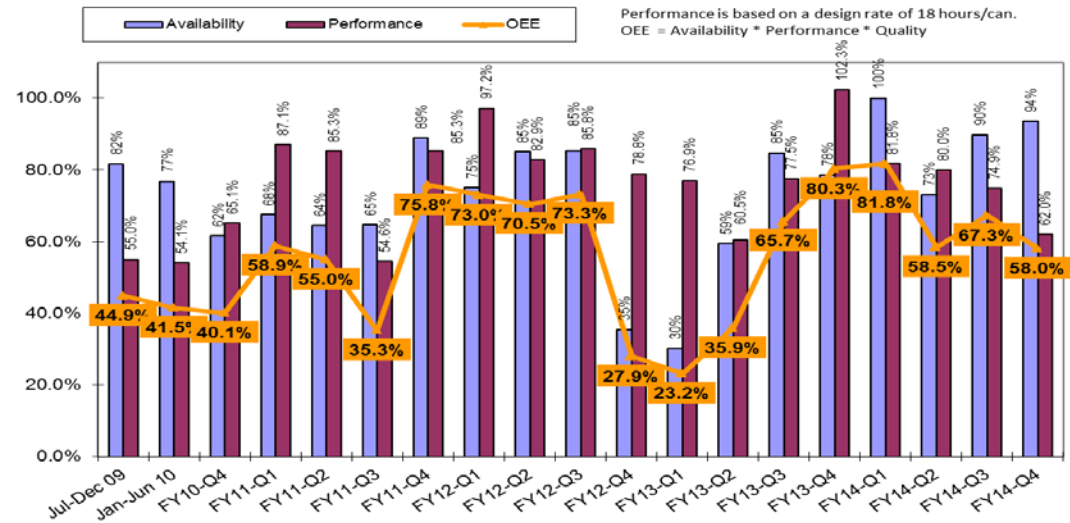
DWPF Overall Equipment Effectiveness Indicators

- Availability in FY14 was markedly improved over FY13
- 90% availability or above for three quarters
  - FY14 2nd Quarter affected by weather conditions

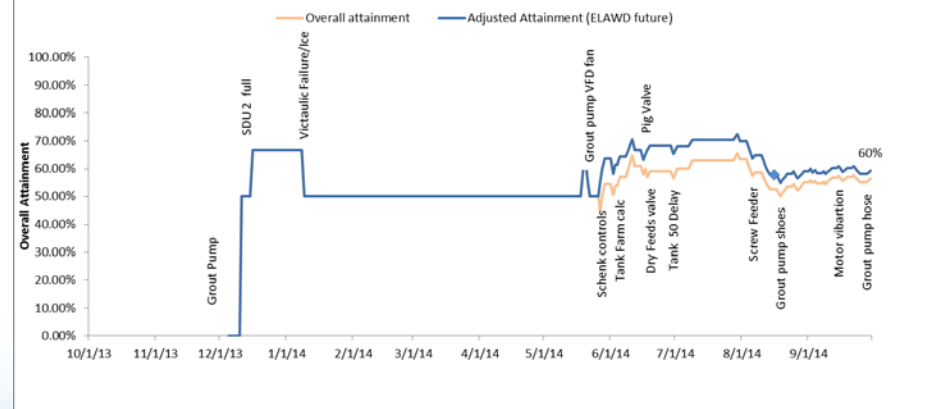
Saltstone Overall Attainment 2014

- Daily run effectiveness based on run duration (availability) and quantity produced (performance) on planned run days

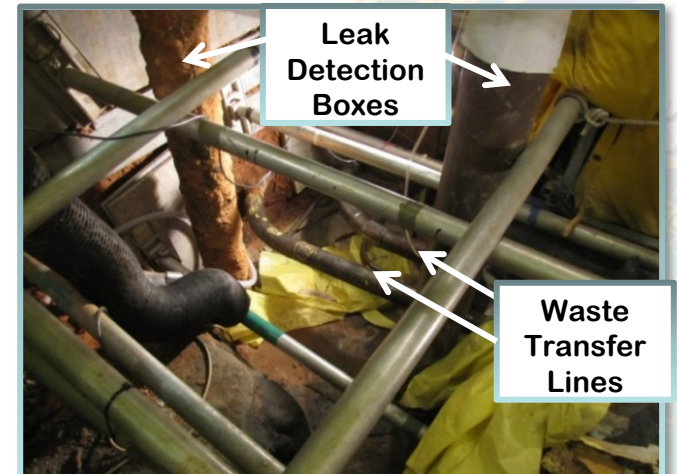
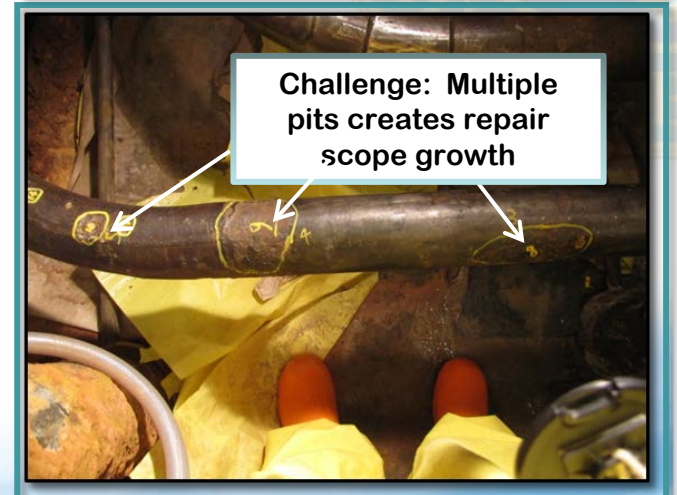
- Waste Transfer Lines = stainless steel core pipe inside a carbon steel "jacket"
- Failures detected in F-Tank Farm jackets for two waste transfer lines that are nearly 50 years old.
- Both transfer lines critical for inter-area transfers between both Tank Farms
- Transfer lines 13' below grade at failure locations
- Lines difficult to excavate due to radiological conditions, other piping interferences, shoring requirements, digging restrictions near transfer lines, etc.
- Pitting corrosion is occurring along the jackets making repairs difficult to scope.
- These specific cases are representative of the likely material condition of tank farm transfer line jackets of that age.

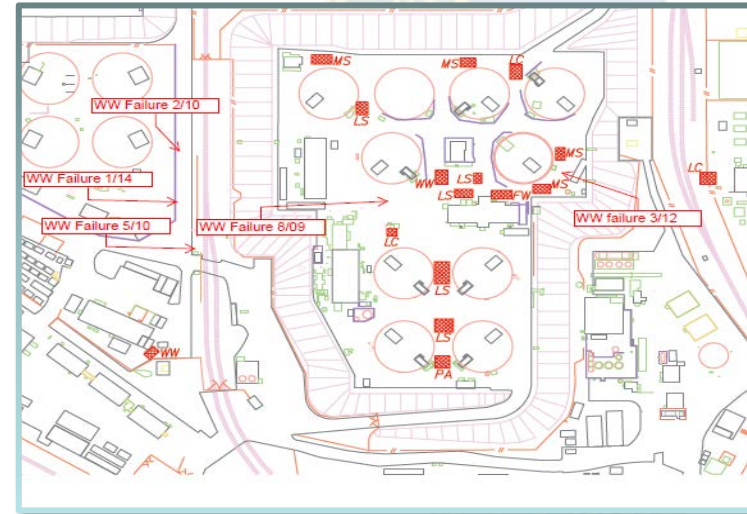
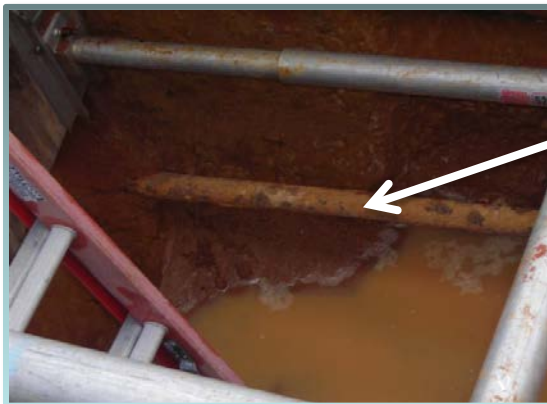
## H-Tank Farm East Hill

2013 failure of 2" carbon steel Well Water line on H-Tank Farm West Hill impacting 3H Evaporator operations

- Most tank farm Well Water headers are now over 50 years old
- Well Water lines critical to Tank Farm processes
- Well Water lines have been a significant problem in the last 5 years for H-Tank Farm
- Difficult to excavate due to piping interferences, shoring requirements, digging restrictions near other utility/process lines and in radiological areas

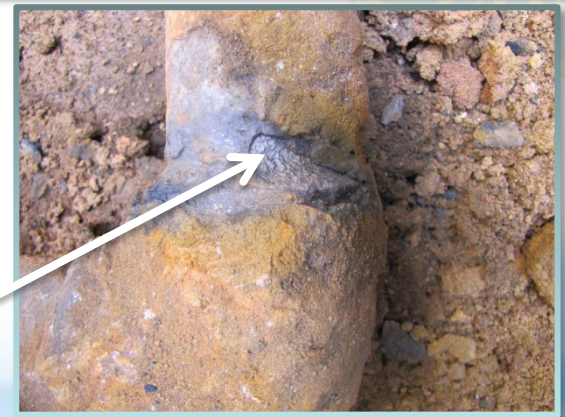
Appearance of carbon steel well water lines after approximately 30 years of service.

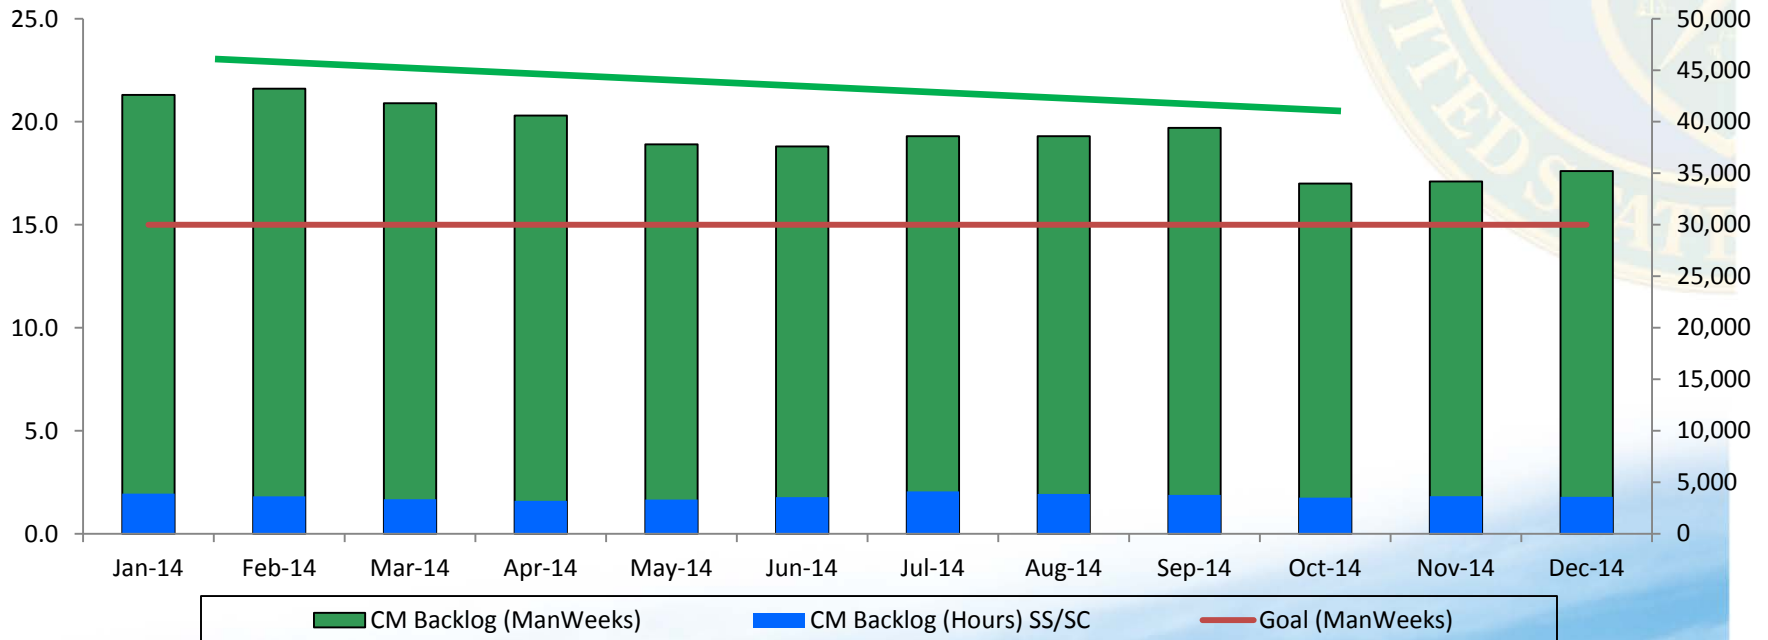
## Open Corrective Maintenance Work for SRR Crew Facilities

Reduction in Corrective Maintenance Backlog by almost 5 weeks

- Improved efficiencies in planning and execution
- Additional field execution resources
- SS/SC CM Backlog (Hours) maintained low

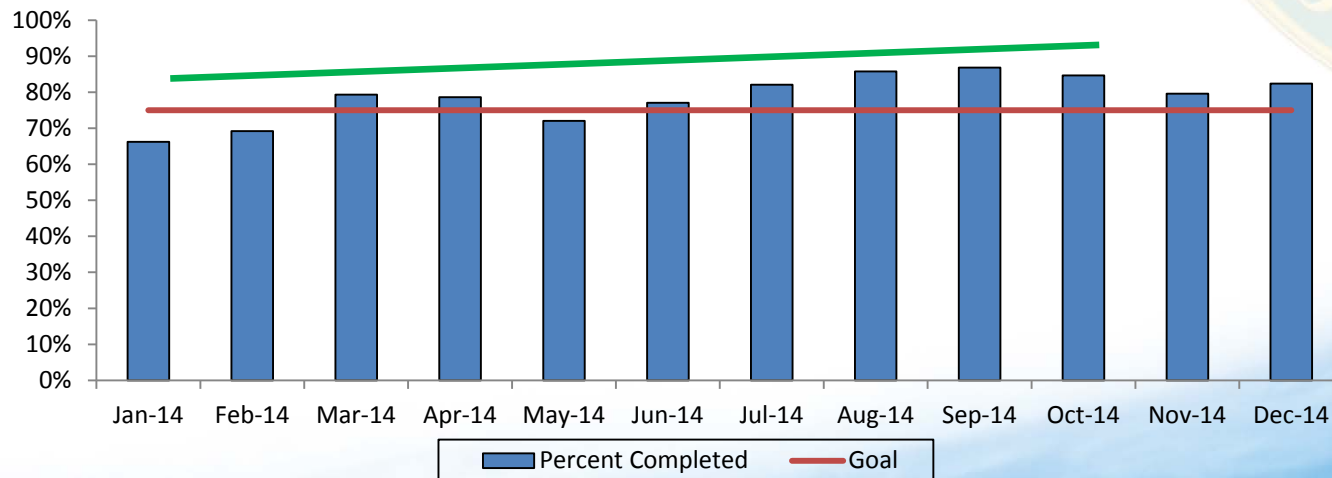
SRR Work Window Schedule Performance  
Scheduled Task Completed

Approximately 10% increase in schedule effectiveness (tasks completed as scheduled)

- Simplified work construction
- “Locking in” planned work two weeks before planned execution
- Visual Management tool
