Advancements in the H-Canyon Exhaust Ventilation System Inspections at the Savannah River Site – 16030

The periodic inspections of the H-Canyon Exhaust Tunnel are performed remotely. The 2015 remote Tunnel inspection has been the most successful inspection to date. This presentation highlights the continued lessons learned with the most recent 2015 remote Tunnel inspection. These lessons learned are applicable to Facilities considering or performing remote inspections.

The Recovery Crawler Project was tasked with determining if the 2014 Inspection Crawler could be retrieved, perform the retrieval if feasible and complete the inspection of the remaining sections of the exhaust tunnel that were not previously performed. The objectives for the project were met, the Inspection Crawler was deemed unusable and left in place and the Recovery Crawler performed the complete 143 meters (470 feet) of tunnel inspection and an additional 55 meters (180 feet) of exhaust tunnel inspection not previously completed.

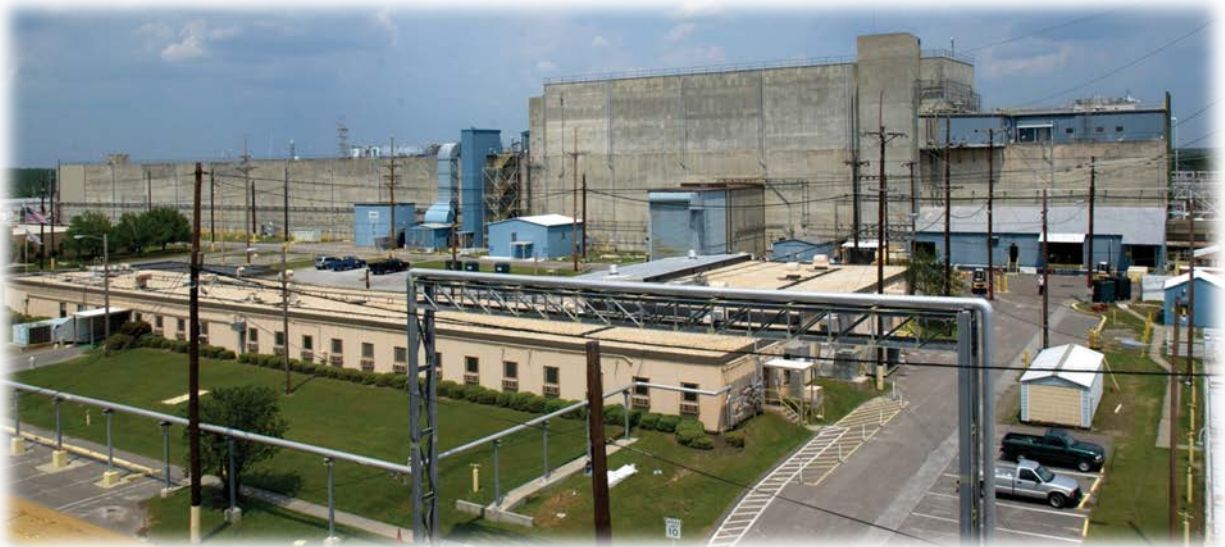
Fig 1. H-Canyon Facility

The H-Canyon facility (see Figure 1), located at the Savannah River Site (SRS) in Aiken South Carolina is a DOE owned chemical processing facility that is designed to reprocess Plutonium, High Enriched Uranium and other radioactive materials. This facility includes a ventilation system that directs contaminated air away from the facility and filters the air in a Sand Filter System through an Exhaust Tunnel. The facility is a Safety Class (SC) structure with a Seismic Design Category 3 (SDC-3) designation.

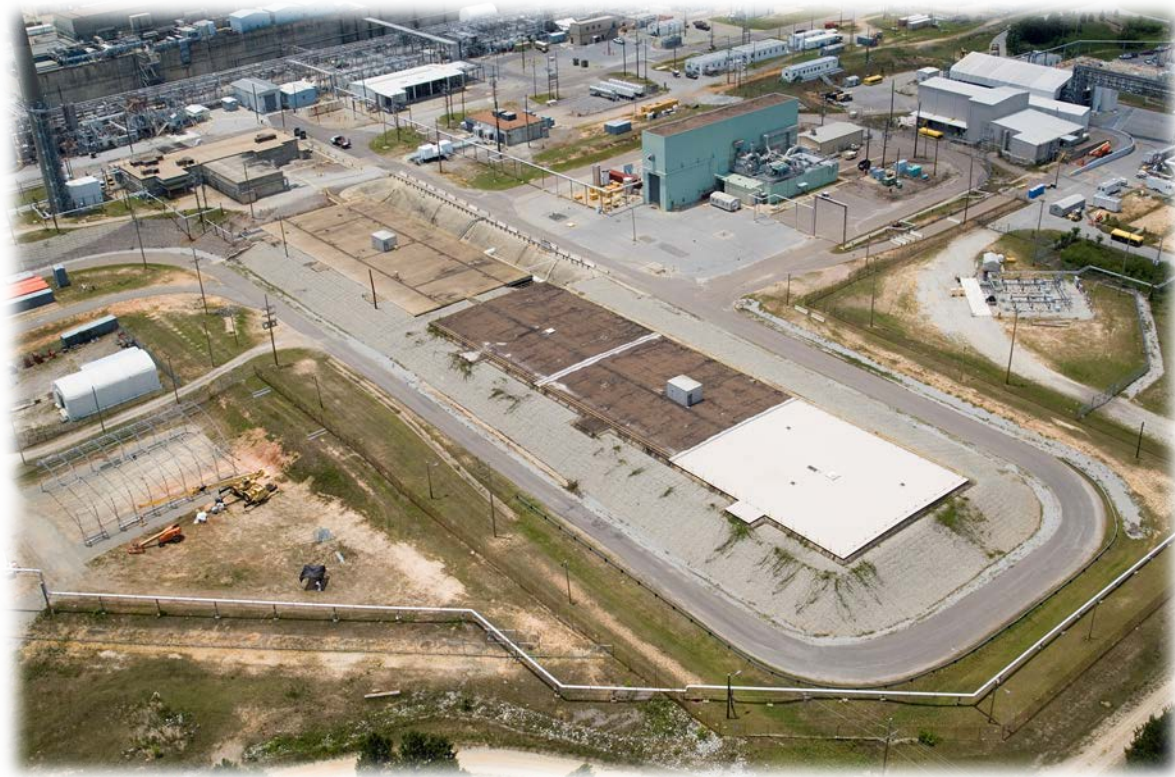
Fig. 2. H-Canyon Sand Filter Facility

The H-Area Canyon Exhaust Tunnel is a reinforced concrete structure, whose purpose is to contain and direct the exhaust air flow from the Canyon process areas to the Sand Filter System (See Figure 2). The Sand Filter System removes the radionuclide particles from the air stream prior to release to the environment. The tunnel is part of original construction and has been in operation since the 1950's Canyon Operations. The concrete tunnel walls were painted with acid resistant paint to protect against the chemicals that would be in the exhaust air stream from the Canyon processes.

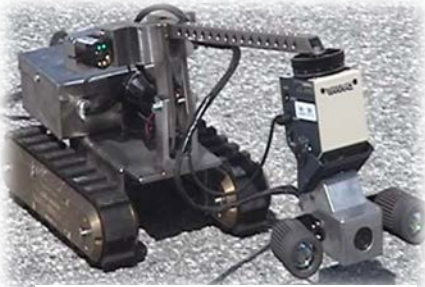
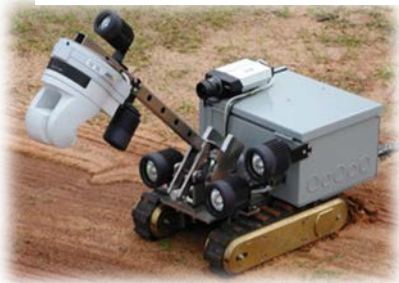
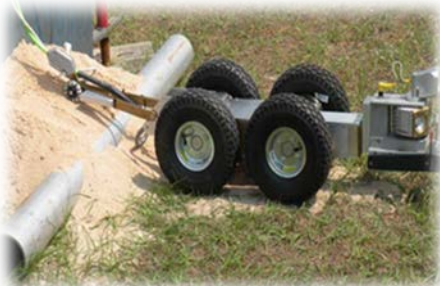
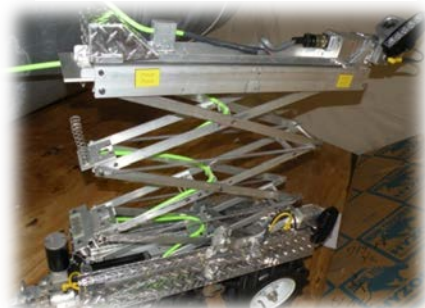
In early 2014, a remote crawler was built in coordination with robotic equipment experts from the Savannah River National Laboratory (SRNL). Crawler unit operations demonstrations were completed in a mockup environment, similar to that expected in the H-Canyon Exhaust Tunnel. In June 2014, the H-Area Operations and Engineering, with assistance from the SRNL robotics personnel, successfully deployed the remote crawler and inspected over 300 feet of tunnel structure from the 294-H Sand Filter towards the 221-H Canyon building before it toppled onto the tunnel floor. This inspection coupled with the previous 2011 inspection results; provided Structural Mechanics with a nearly total inspection of the areas of concern for the tunnel. The results of the inspections were evaluated and a comprehensive report detailing the inspection and the structural analysis to confirm Tunnel safety basis requirements was completed in December 2014. (See Figures 3 -6 for the evolution of the crawler systems in H-Canyon)

Fig. 3. – 2003 Crawler

Fig. 4. – 2009 Crawler

Fig. 5. – 2011 Crawler

Fig. 6. – 2014 Inspection Crawler

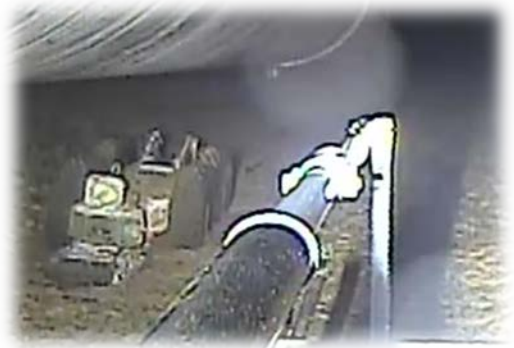
Fig. 5a. – 2011 Crawler under Duct

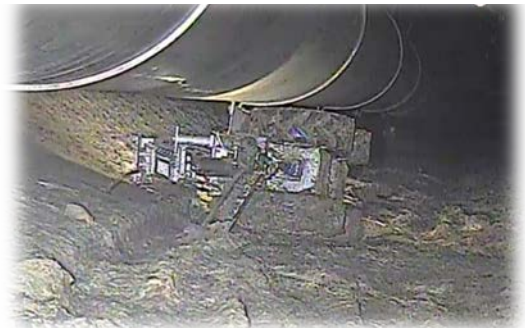
Fig. 6a. – 2014 Crawler under Duct

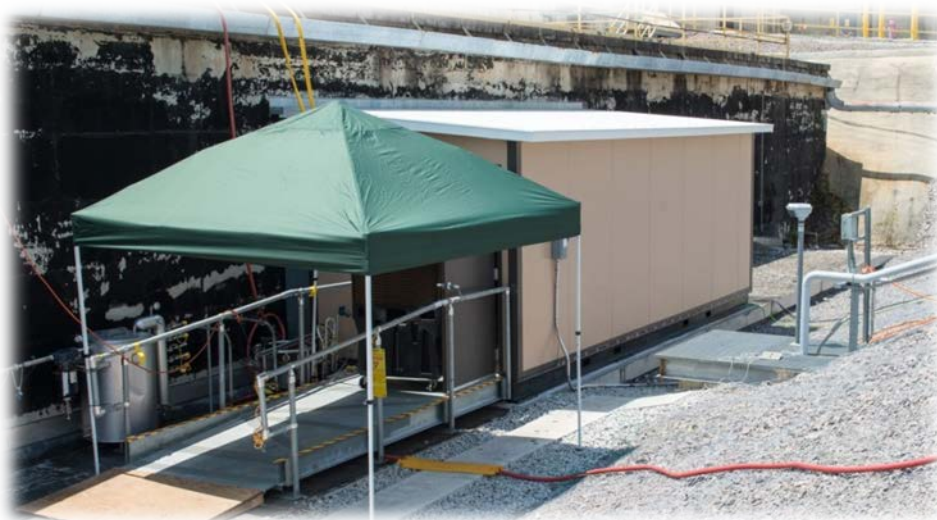
The containment hut (Figure 8) is a fabricated building that provides an entrance, a transition area (vestibule) for support activities and a work zone (Manway room) for direct interface with crawler components (Figure 9) and the exhaust air stream. The work zone was set up as an airborne activity area because of the direct access to the exhaust tunnel air stream. The workers were protected from the exhaust air stream as the air was directed from the inside of the building into the manway and into the exhaust stream. The Permanent hut is mounted on the suction side of the exhaust tunnel.

Fig. 8. – Permanent Hut for Crawler Work

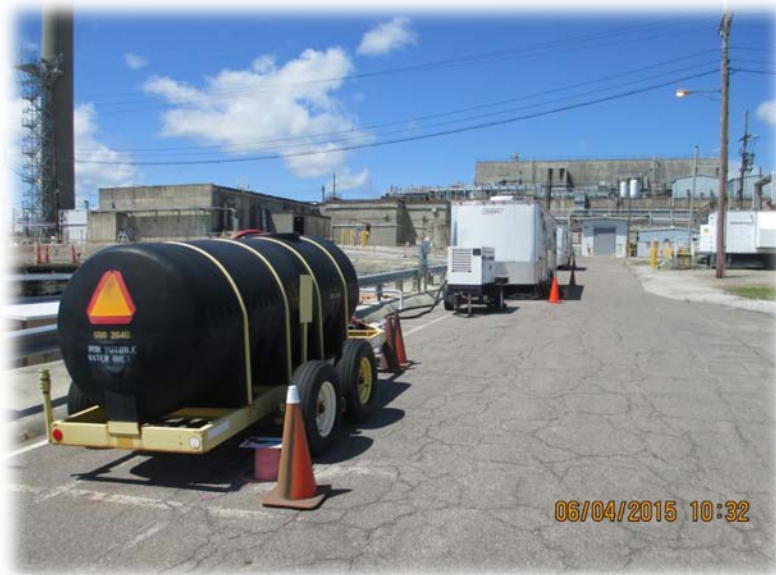
- Control trailer - for crawler operations
- Monitoring trailer - for visitors and guests and act as a cool down location for workers
- Two portable generators – one for the permanent hut, the other for the control/monitoring trailers
- Portable breathing air - for respiratory suit use
- Water buffalo – to supply decontamination water for the spray wand (described later)

Figure 10 shows the major components used in support effort with exception to the portable breathing air supply to the area.

Fig. 10. – Support Equipment for Crawler Inspection

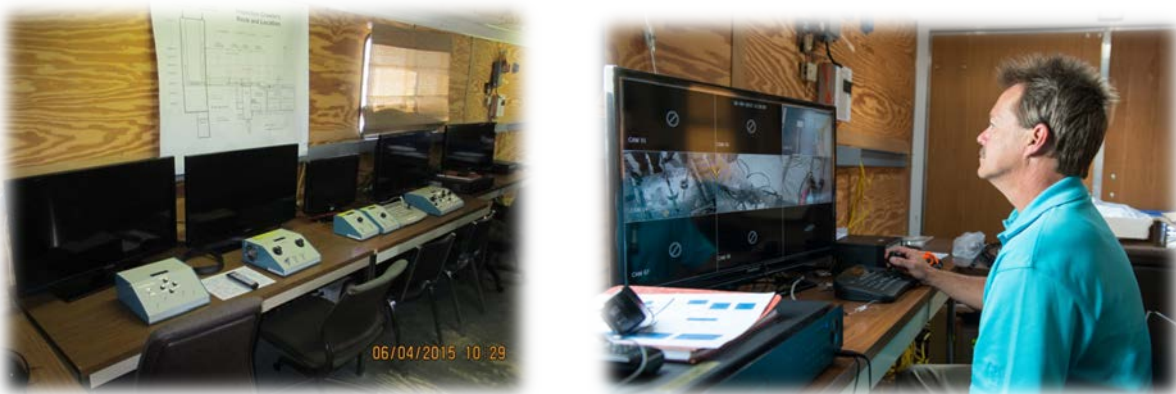
Since the recovery effort involved the operation of not one, but two crawler systems, the need existed to have two separate control stations with independent operators for each of the units. A crawler drive system has two major operating stations; one for the main unit to control the wheels, lifts and camera drives and the other to control the cable spooling and retrieval. This could have been made to work in conjunction with each other off a universal drive system, however, that was cost prohibited by the available project funding for the effort. Figure 11 a&b shows the two main drive stations and the video control station for the various camera views available to the engineers monitoring and directing the effort. The monitoring station feeds were shared to the separate monitoring trailer for guests and visitors and recorded on a Samsung Digital DVR system for a detailed review by structural engineers.

Fig. 11 a&b Control and Monitoring Equipment for Crawler Work

The crawler controls included independent wheel controls (forward and back), which allowed for skid turning. The controls also included video unit drives to position the cameras and zoom for the lens and lift functions to control the forklifts on the recovery crawler and the scissor lift on the 2014 Inspection unit.

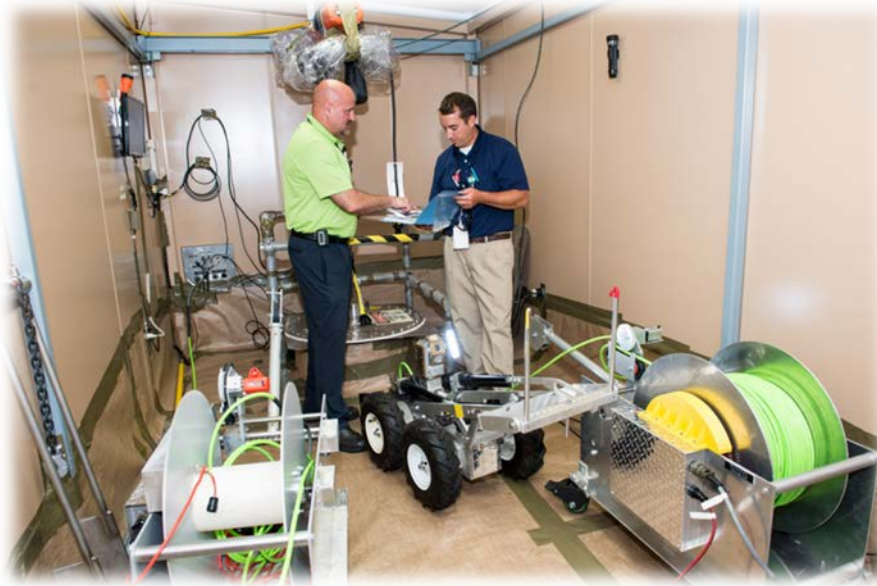
The Manway room is a 5.2 meter by 2.4 meter (17'x 8') work space (Figure 12) that housed the overhead hoist system, the bulkhead control (Figure 13), the Manway, the fall protection, crawler cable reels, video display and lifting devices.

Fig. 12. Manway Room inside Permanent Hut

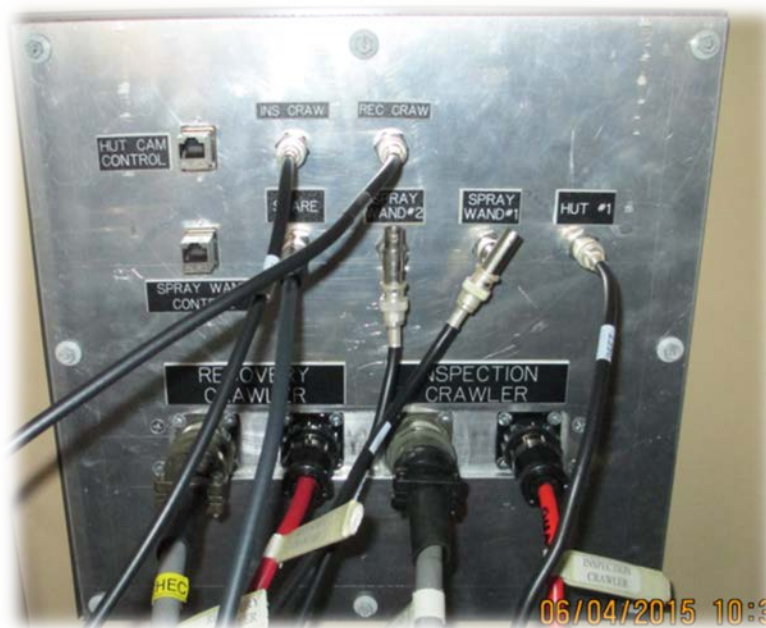
Fig. 13. Crawler Bulkhead inside Permanent Hut

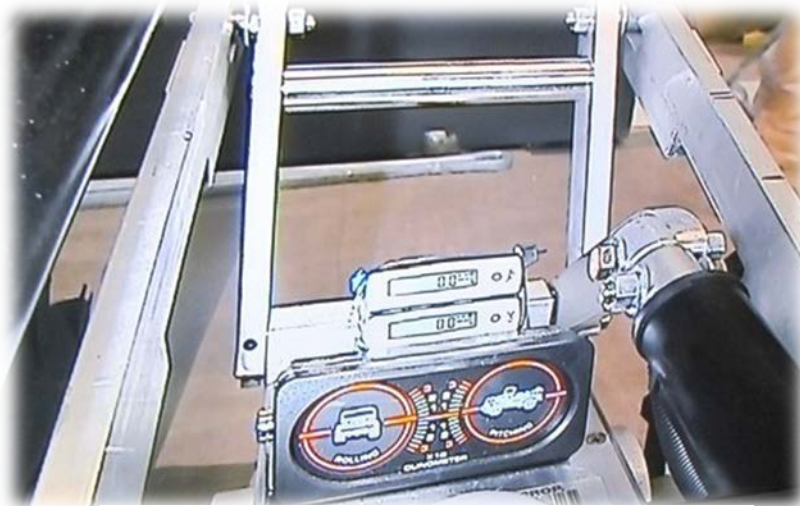
One of the improvement made to the crawler system from the past experiences involved the addition of an incline-o-meter system, to monitor tilt and pitch of the crawler and a dual Electronic Pocket Dosimeter (EPD) display, of Beta and Gamma radiation measurements, to allow for monitoring/characterization of the tunnel as the crawler traversed the area (Figure 14).

Fig. 14. Recovery Crawler Indications

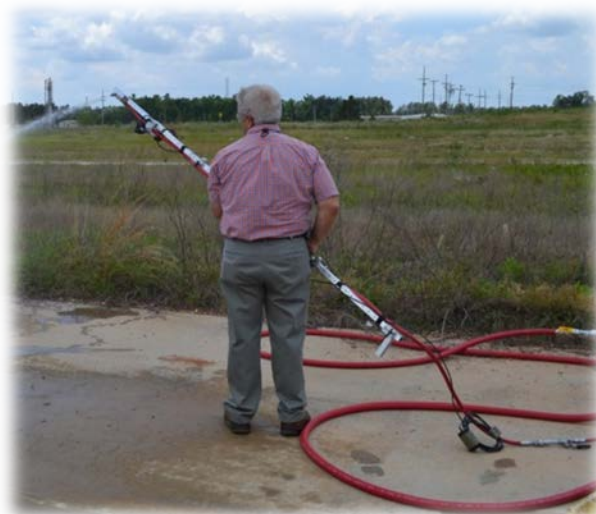
To assist with the decontamination of equipment, when the crawler(s), cabling and rigging equipment were to be removed, a spray wand device (Figure 15) was developed. This collapsible spray wand was custom designed by the Savannah River National Laboratory Robotic Engineers to be able to remotely clean the components while inside the exhaust tunnel proper and provide lighting and video feeds to the operators performing the decontamination effort. Water was supplied from a 1000 gallon Water Buffalo with a system designed 175 psig supply pump and recirculation process. The process was established to allow for constant water pressure to be applied when needed and recirculation capability when spray was not applied.

Fig. 15. Custom Spray Wand

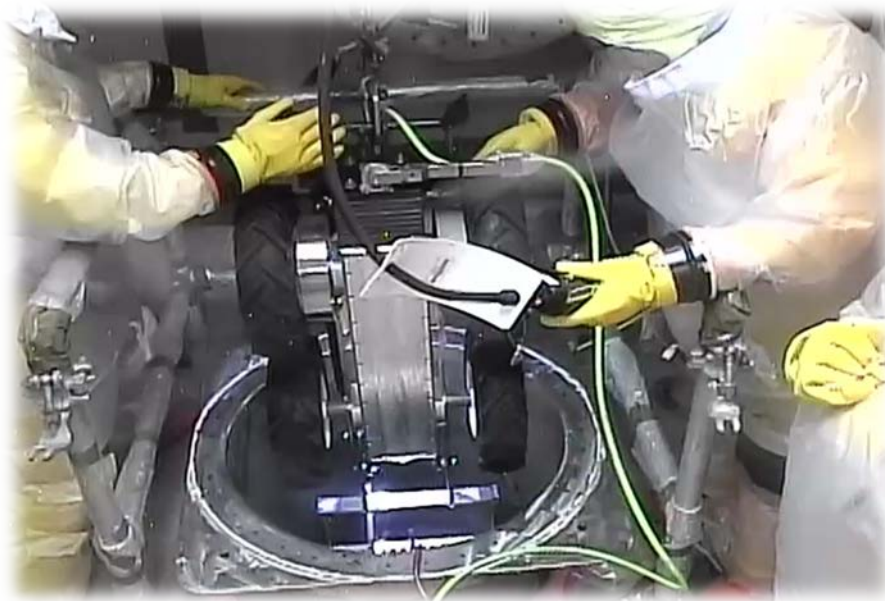
On June 9th, 2015 the facility entered into a reduced exhaust fan configuration and Limiting Condition of Operations. Tunnel vacuum conditions and permanent hut building ventilation conditions were monitored. When these conditions were determined to be satisfactory, recovery operations commenced. The Recovery Crawler (RC) was inserted into the exhaust tunnel via the Manway inside the permanent hut (Figure 16). This insertion required coordination between the SRNL drivers inside the control trailer and the riggers performing the insertions. SRNL positioned the forks down for insertions, up following movement through the Manway and to the tunnel floor and then back down for the travel through the tunnel. This was to ensure the forks were not damaged with the vertical insertion process.

Fig. 16. Vertical Insertion of the RC through the Manway

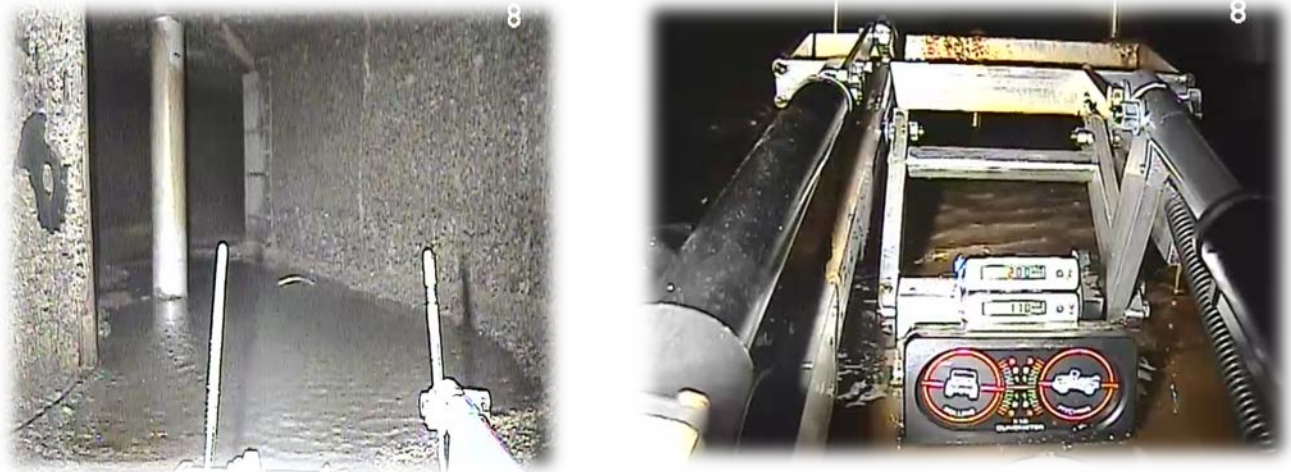
Once equipment conditions were verified, then the recovery actions could commence. In order to reach the fallen Inspection Crawler (IC), the Recovery Crawler (RC) had to traverse numerous obstacles. The first obstacle was a 0.3 m – 0.6 m (1'-2') deep water/sand hazard at a low point in the tunnel (Figure 17 a&b). The crawler had to climb a 2.5 – 5.1 mm (1-2") lip and around a concrete support pole obstruction.

Fig. 17 a&b. Water Hazard inside Exhaust

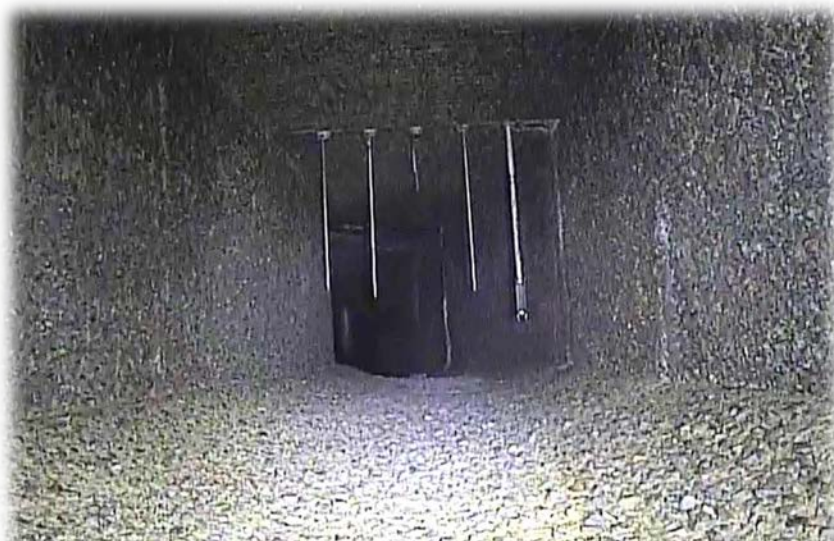
After the water hazard was cleared, the crawler ascended the tunnel slope that had a rise of 1.8 m (6') over a 27.4 m (90') run to reach the top of the main tunnel leading to the 221-H Canyon (Figure 18)

Fig. 18. Ramp up from Sand Filter inside Exhaust Tunnel

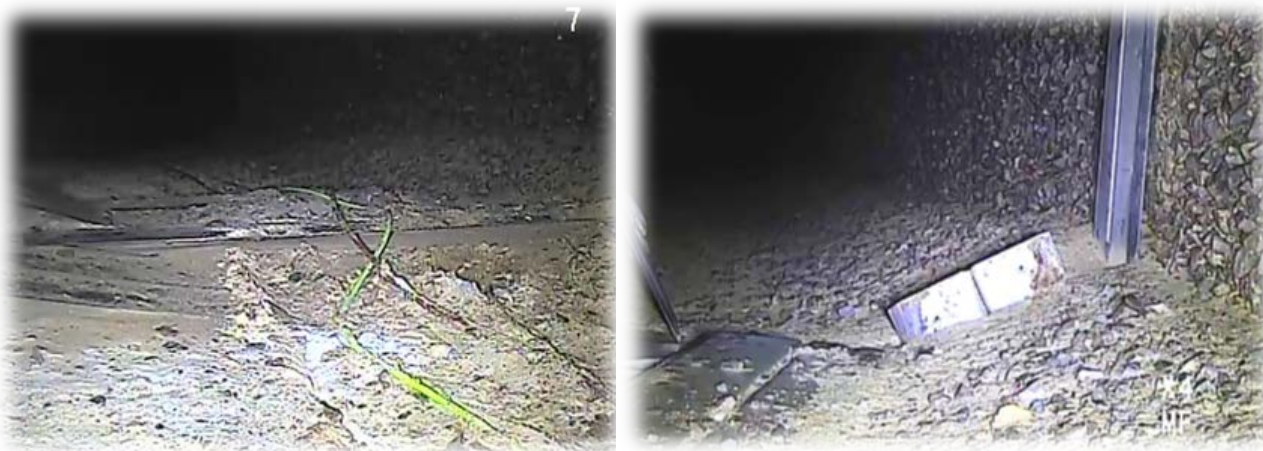
Once traversing the sloped exhaust tunnel section leading to the 221-H building, the hazards encountered changed to debris and expansion joint cover plate construction obstacles (Figure 19 a&b). The expansion joints are constructed with a small lip 76 mm – 152mm (2" - 3") high. The expansion joints had cover-plates attached to the walls, however, several of the plates had fallen to the ground below. The cover-plates became an obstacle as concrete debris had piled up around the plates acting as a barrier to movement. In some cases, the crawler would have to travel around these and in other cases; the crawler could push the plates out of the way. In addition, if the crawler wheels drove over the plates, the wheel would lose traction and not allow for forward movement. (Note: If time had allowed, the recovery crawler would have been used to move the debris out of the way all together, however, because of the need to minimize the recovery task and the Limiting Condition of Operation durations, debris removal was not performed)

Fig. 19 a&b. Expansion Joint Debris inside Exhaust Tunnel

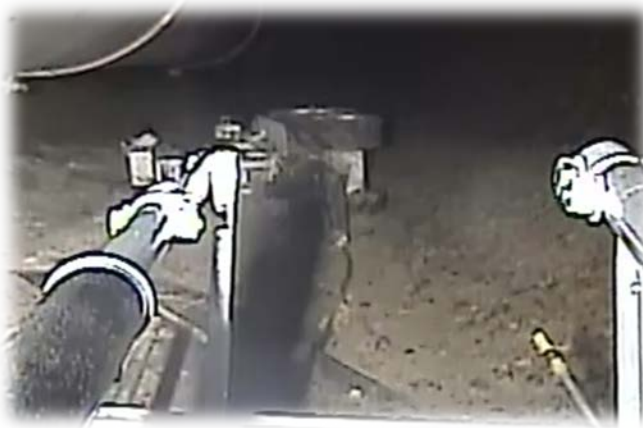
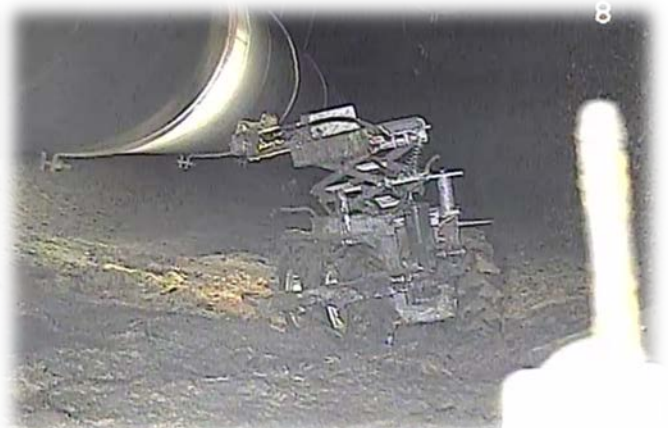
After passing the expansion joint area, the RC could be moved to the IC area for the inspection and recovery actions. In 2014, when the IC fell, the project team had a general understanding of how the unit was laying in the tunnel. The RC footage (Figure 20a) showed that the location was nearly accurate to the prediction. The only difference was that the scissor lift on the IC was not as extended as believed and it was not as much under the 914 mm (36") duct as expected. After several iterations, including dragging of the IC back several feet and pushing the back of the unit, the RC was able to lift and push the IC to the wheel position (Figure 20 b), where the IC driver was able to assist using the operable wheel drives on the IC. Once on its wheels, the RC was used to perform a more thorough inspection of the IC unit.

Fig. 20 a. Fallen IC inside Exhaust Tunnel Fig. 20 b. Restored IC inside Exhaust Tunnel

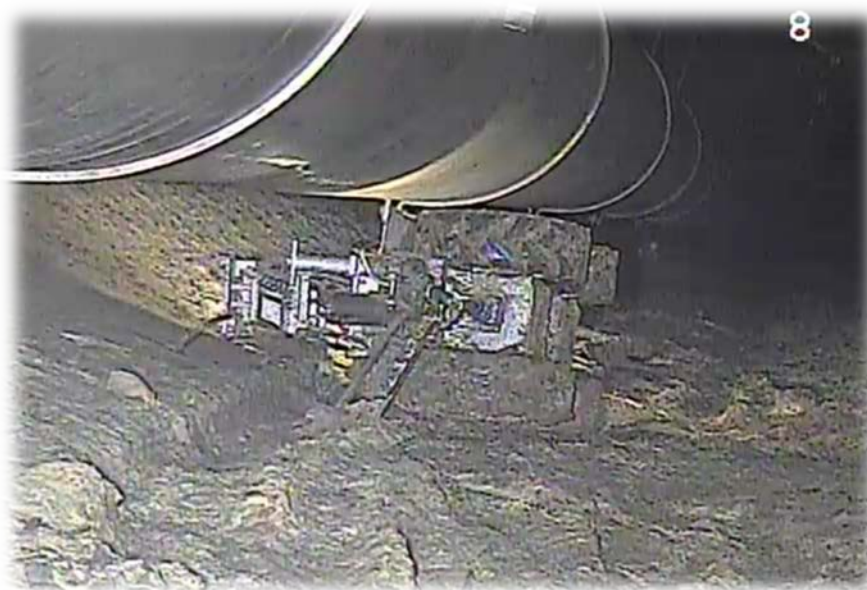
The IC was investigated for operability and it was found that the scissor lift was corroded and stuck and would not lower. This precluded a removal action, since the manway opening was too small for the extended scissors and the special lift tool would not fit over the scissor mechanism as extended. In addition, both camera units were significantly degraded and the main camera drive arm was stuck in the outer most position. It was determined that the crawler could not be reused and it was left in the tunnel (Figure 20 c)

Fig. 20 c. Final Location of IC inside Exhaust Tunnel

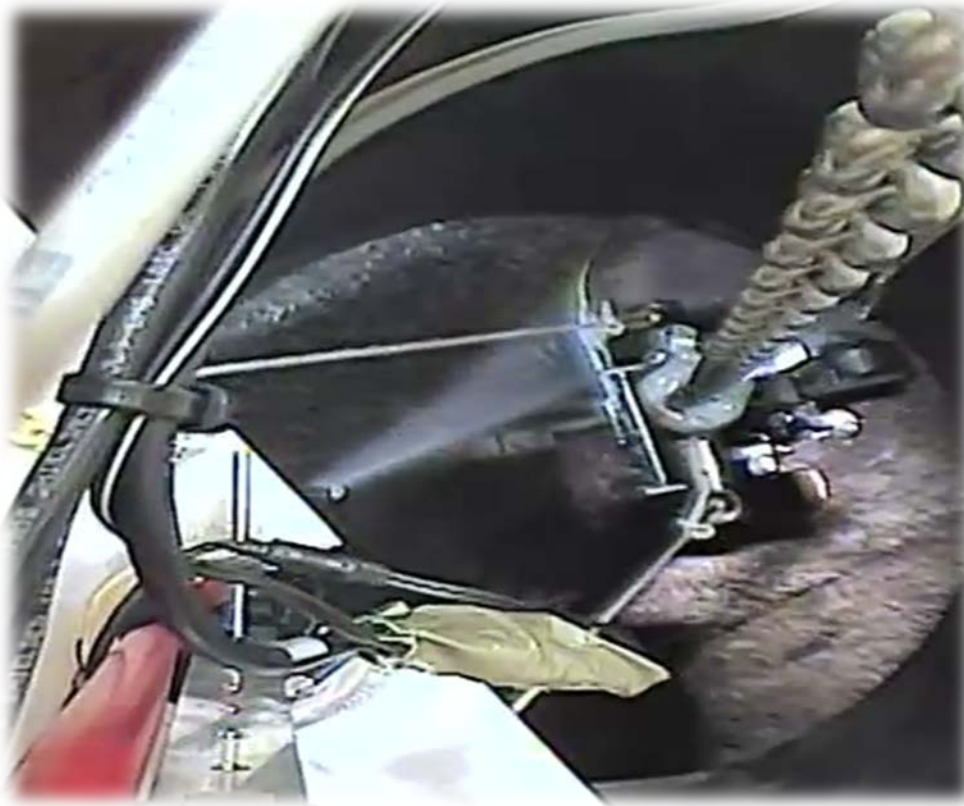
The Recovery Crawler was then used to complete the inspection of the tunnel area, and traveled past the location of where the Inspection Crawler had fallen. The inspection covered the entire 143 meters (470 feet) of tunnel and returned to the Manway location, where it then traveled in the opposite direction for an additional 55 meters (180 feet) to inspect the tunnel along the north wall of the sandfilter building. This addition area was not previously inspected by video means and it provided some valuable information to the Structural Engineers for evaluation. The crawler was then returned to the Manway location, where the Rigging personnel successfully attached to the lifting points in the 56.4 kph (35 mph) wind in the tunnel on the first attempt. The crawler was lifted to the position just under the Manway lower lip where the spray wand was used to decontaminate the unit (Figure 21)

Fig. 21. Decontamination of the RC inside Exhaust Tunnel
