**Final Closure of the Maxey Flats Low-Level Radioactive Waste Disposal Site
– 16088**

Mark Day *, Tim Hubbard **, Te-Yang Soong ***, Pam Scully ****,
Scott Wilburn **

ABSTRACT

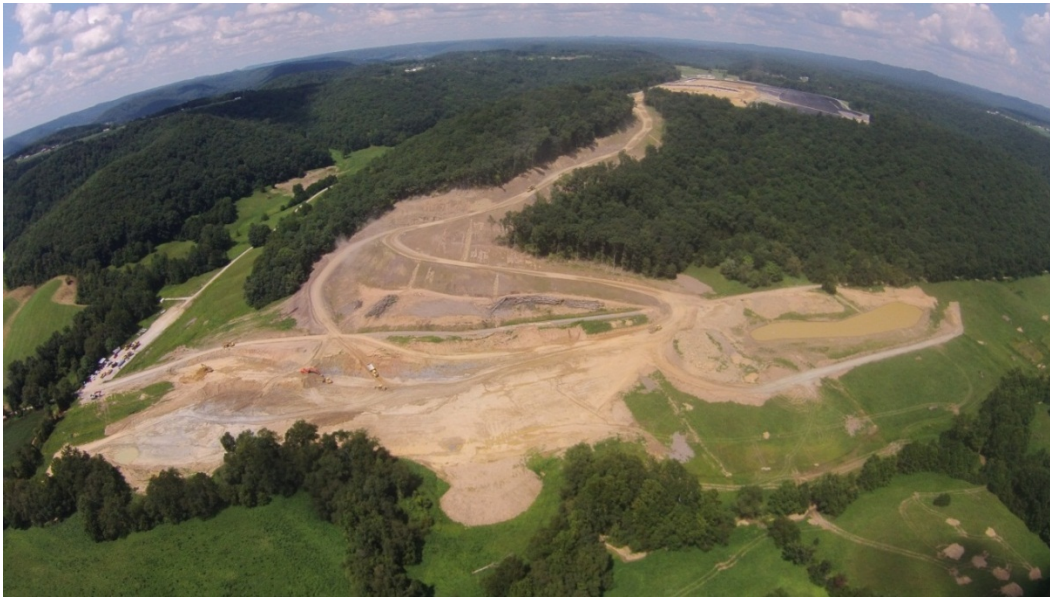
Fig. 4. Ridge Haul Road.

Construction vehicles were prohibited from using the highways and roads around the site, so it was necessary to construct a temporary ridge haul road (Fig. 4) to transport materials from the valley borrow areas to the ridge top for construction of the FCP cap.

The construction of the ridge haul road was a key element in the overall remedy at MFDS and significantly lowered the hauling cost of borrow materials. Its design and construction were extremely challenging due to the topographic conditions at the MFDS. Construction on the ridge haul road was completed in June 2015. Following construction of the FCP cap, the ridge haul road will be converted into a standard site road.

The upper road was 38 feet wide, which allows for two-way traffic. For safety purposes, the traffic pattern adopted put the full trucks on the uphill side of the two-way stretch. This is opposite to normal driving in the US, requiring drivers to keep in constant communication with other road users to ensure that no conflict occurred. The lower loop road was restricted to one-way traffic flow.
