Regulatory Compliance of H Retention Basin Using Rhombo Balls – 16151

M. H. Jackson, A. W. Wiggins, O. D. Stevens, S. L. Stinson
Savannah River Remediation LLC

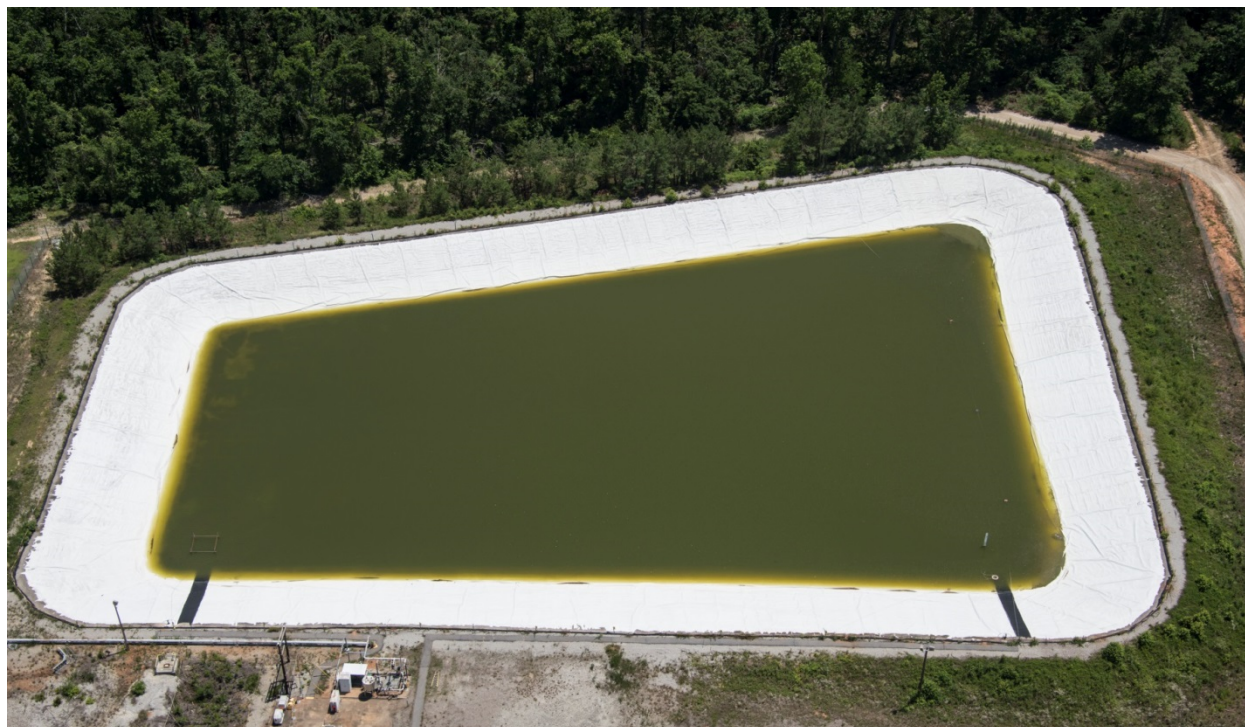
Fig. 3: Algae Laden 281-8H Retention Basin 7/29/2013

The HRB has had recorded pH values over 8.5 for many years. The higher pH readings coincided with multiple blooms of algae in the basin. The constant blooming and dying of algae along with the influx of blown leaves and plant debris, various basin animal excrement and sediment from the storm water received from the tank farms had developed 2.5cm to 10 cm (1 to 4 in.) of organic sediment along the basin floor. The decaying organic matter was providing a substantial food source for the ever growing algae blooms. See Fig. 3.

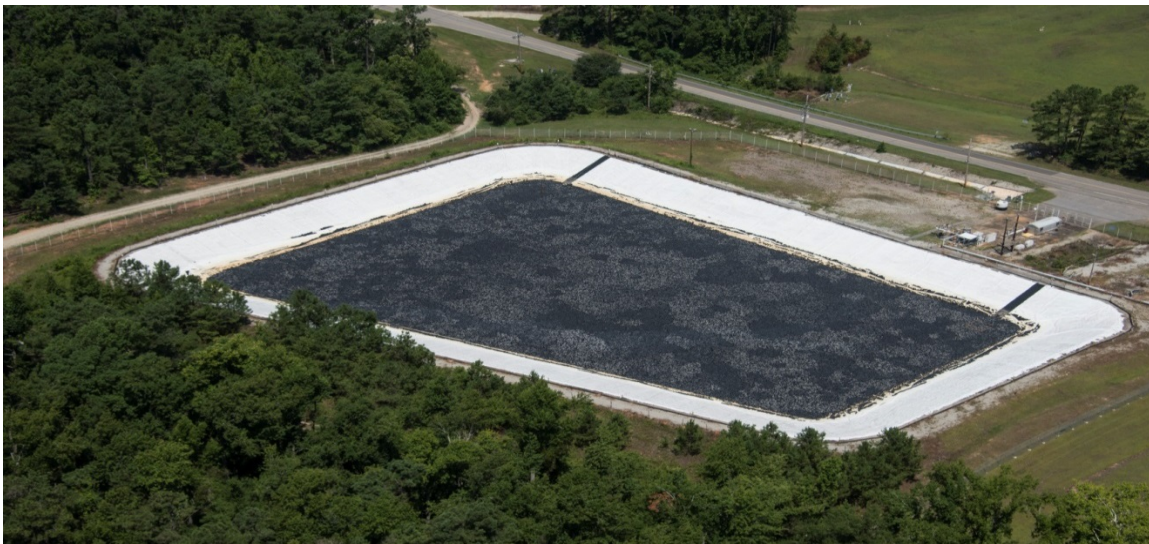
Option 3, the Rhombo floating cover and the biological digester, was selected as the team's final solution to the HRB's high pH issue. The cover was chosen to block the sunlight and prevent photosynthesis Fig. 7 is a picture of the 241-8H retention basin filled with the Rhombo cover.

Fig. 7: Rhombo covered 241-8H Retention Basin
