## **High Angle Remediation of Legacy Mercury Contaminated Soil at LANL - 16276**

Scott Muggleton\*, Peter Gram\*, Todd Haagenstad\*\*, and John Branch\*\*

\*TerranearPMC, LLC.

\*\*Los Alamos National Security

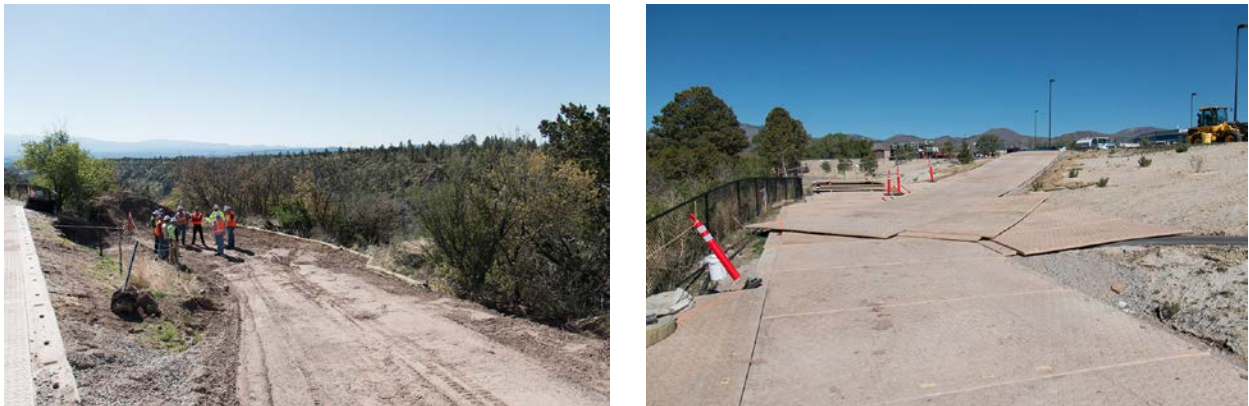
Figure 2. Lower access ramp and crane pad (left) Industrial matting over pedestrian path and upper access ramp (right). Photos courtesy of Los Alamos National Laboratory.

Prior to mobilization of heavy equipment (May 5, 2015 to May 11, 2015), two temporary access ramps and a crane pad were built to support crane mobilization (Figure 2). Industrial matting was installed atop the access ramp to further support the crane and to protect the landscaping and asphalt pedestrian path located on private property (Figure 2). After the access ramps were built and approved by crane experts from our crane subcontractor, The Team mobilized a Crane Service, Inc. owned and operated Link-Belt ATC-3275 275-ton hydraulic-boom all-terrain crane and rigging with full counterweights (156,000 lbs) Figure 3. A Critical Lift Plan (CLP) meeting and associated checklist were completed prior to the "critical" lift of the spider excavator. The spider excavator was successfully lifted and placed at the work site on May 11, 2015 (Figure 4). A second CLP was implemented to hoist personal to and from the work site using the crane and certified man-basket.

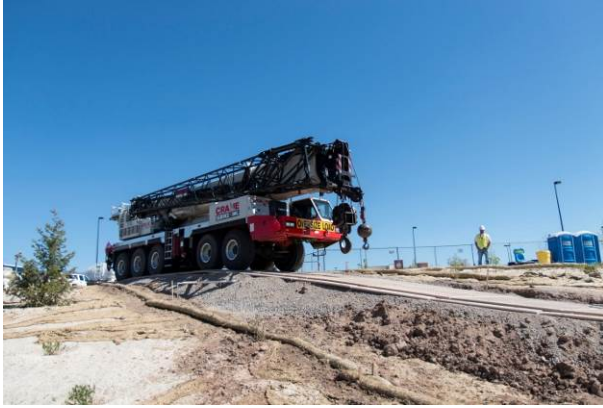
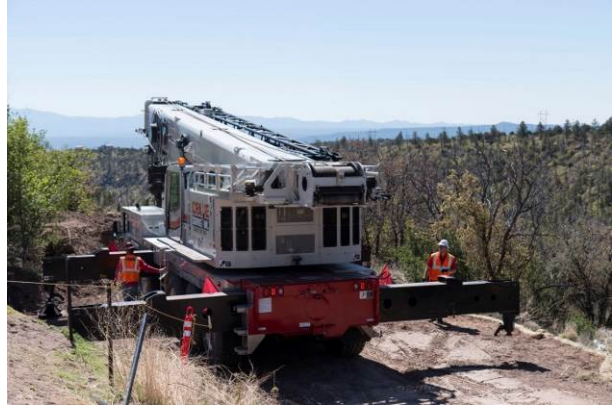
Figure 3. Linkbelt ATC 3275 being mobilized to the Upper Los Alamos Canyon Aggregate Area Remediation Site.

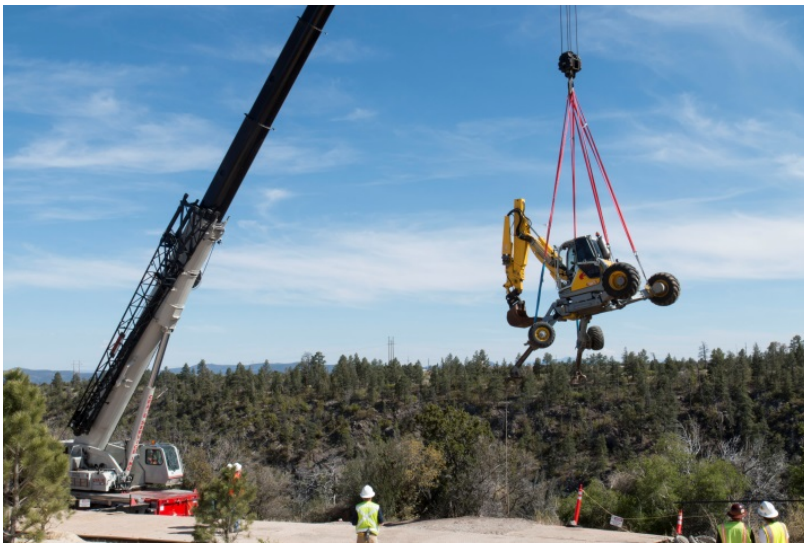
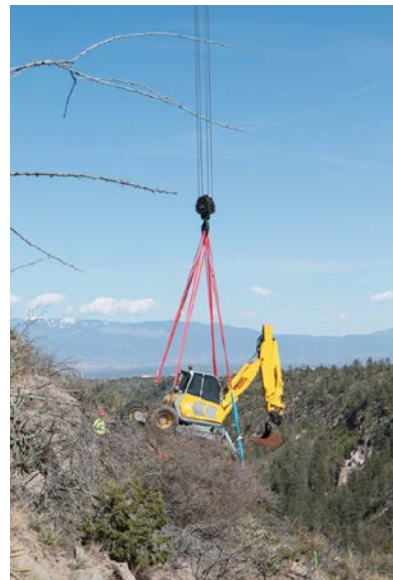
Figure 4. Photos of Linkbelt ATC 3275 lifting and lowering the Menzi Muck Spider Excavator to the excavation site. Photos courtesy of Los Alamos National Laboratory.

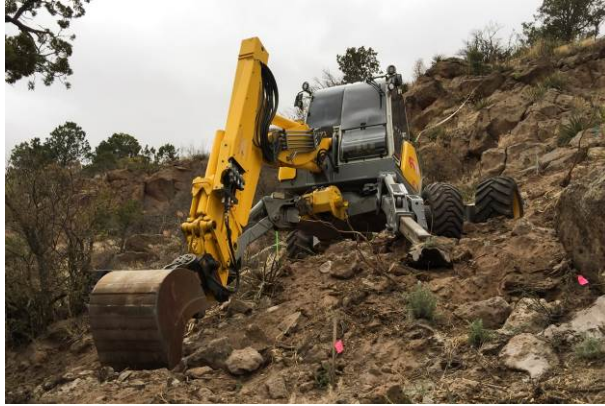
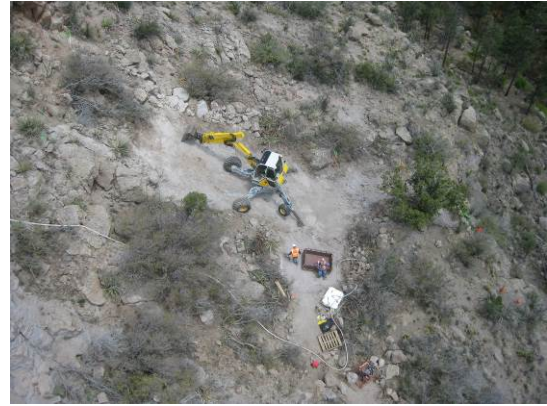
Figure 5. Menzi Muck 91-E spider excavator positioned on the SWMU 32-002(b2) excavation site.

Once the surface of the site was prepared, excavation was completed in one sustained effort. A total of approximately 158 yd<sup>3</sup> of mercury-contaminated soil was removed from the site at depths ranging from 2 ft bgs to 5 ft bgs using the spider

excavator between May 12, 2015 and May 19, 2015 (Figures 5 and 6). To ensure worker safety, downside ground personnel remained a safe distance from the edge of the excavation during excavation and the filling of waste containers. The spider excavator was used to place material excavated from the site into IP-1 rated 1.77 yd<sup>3</sup> soft-side waste bags at the point of generation (Figure 5). A loading frame was used to easily and safely load the waste bags. The downside team collected the specified waste characterization samples as each waste container was filled. The containers were closed and secured in accordance with manufacturer specified procedures and made ready for transport to the selected off-site disposal facilities in accordance with LANL waste packaging and shipping procedures and off-site facility WACs. The crane was used to hoist the bags from the excavation site and place them on a flatbed truck for immediate delivery to the LANL waste staging area at TA-21 off public property (Figure 7). At the end of each work period, excavation was secured and the downside team returned to the topside staging area using the crane and man-basket (Figure 8). Unpackaged waste was not handled outside of the DOE excavation area. This process resulted in handling the waste containers a single time from the point of generation to transport to the waste storage area reducing the materials handling risks.

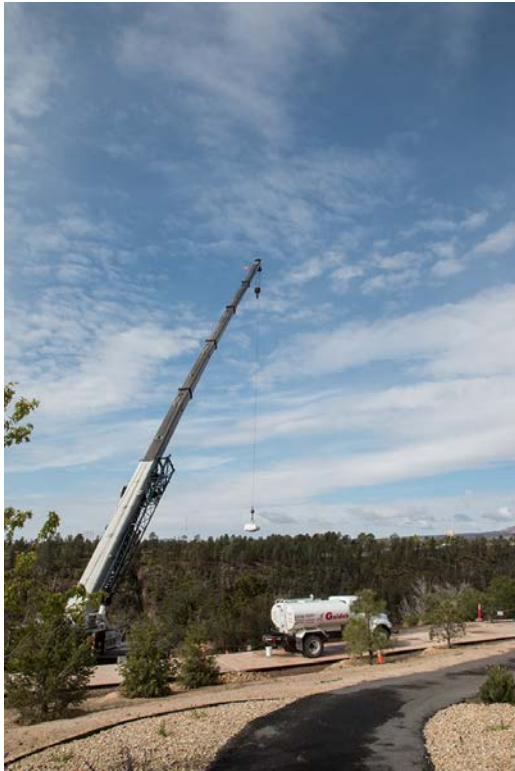
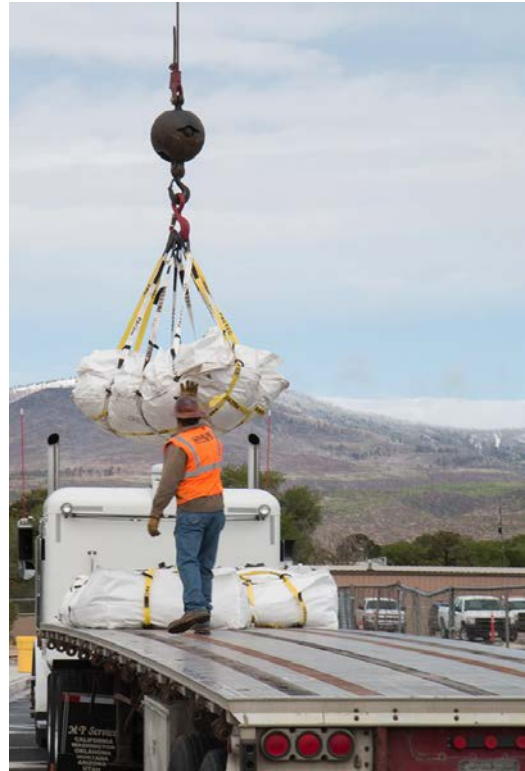
Figure 7. Hoisting from the excavation site and placement on flatbed for immediate delivery to the LANL waste staging area off public property.

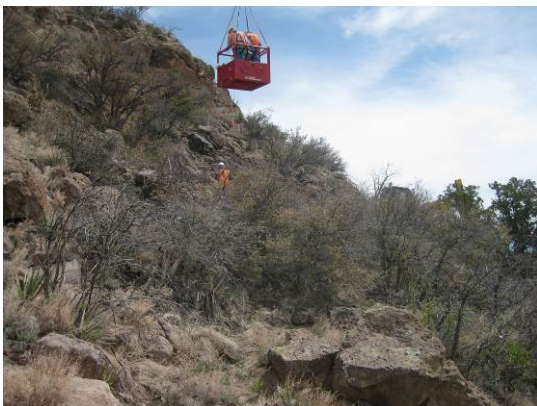
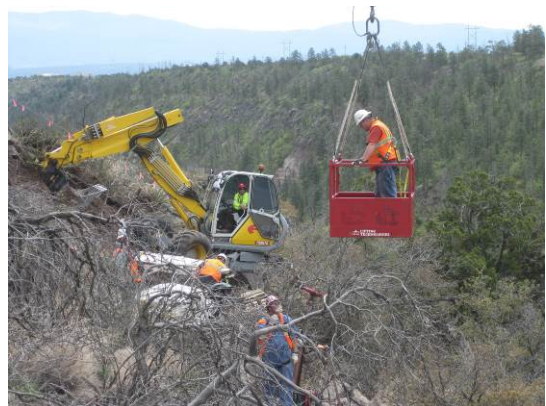
Figure 8. Hoisting personnel in man-basket at SWMU 32-002(b2) excavation site.

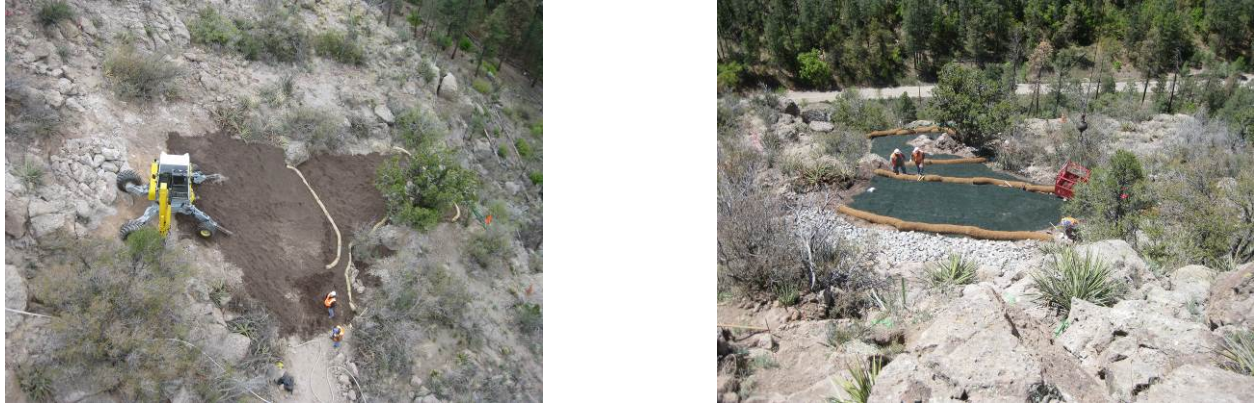
Figure 9. Site restoration at SWMU 32-002(b2) excavation site.

Backfilling and site restoration of the excavation site, crane pad, and temporary access ramps were planned in accordance with the SWPPP and in collaboration with LANL SWPPP experts. The crane and a 2 cubic yard cement bucket were used to transport backfill materials to the excavation site. Approximately 107 yd<sup>3</sup> of certified clean backfill material was used to fill the excavation area (Figures 9 and 10). Backfill was installed in 6" lifts, wheel-rolled, and compacted. Approximately 24 yd<sup>3</sup> of topsoil was placed atop the backfill and 24 yd<sup>3</sup> of angular rip rap ranging

between 6 in. and 2 ft was placed at the break in slope at the northern end of the excavation (Figures 9 and 10). Additional rip rap was placed in areas disturbed by remediation activities. The area was fertilized, reseeded, and 400 yd<sup>2</sup> of erosion control matting was placed on top of the site. Four rows of coconut erosion control logs (Coir Logs) were installed to further prevent and/or control erosion (Figures 9 and 10).

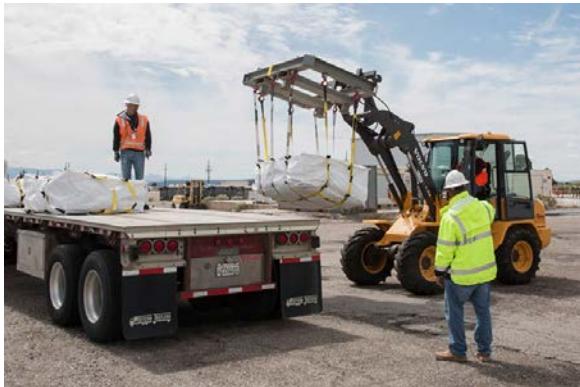
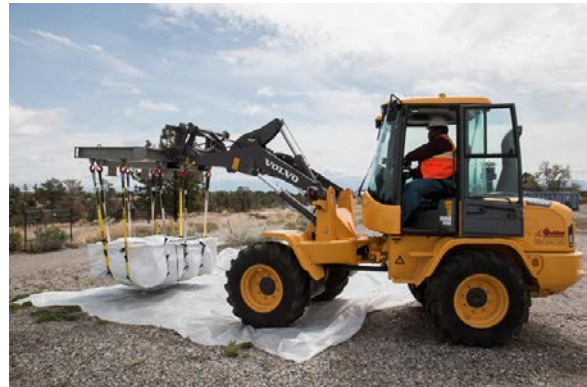
Figure 11. Waste staging at TA-21.

The waste arrived (Figure 11) at the LANL owned waste storage area at TA-21 for staging while the waste samples were being analyzed. The waste bags were lifted off the transport using the custom designed lifting frame and stored on bermed visqueen to prevent storm water run-on/run-off from the waste storage area. The bagged waste was also covered with heavy tarps in order to minimize exposure to the elements and possible subsequent waste bag degradation.
