## **Large Cask, Small Building, AREVA's Safe MLLW Disposal Solution Despite Facility Limitations – 16295**

### **ABSTRACT**

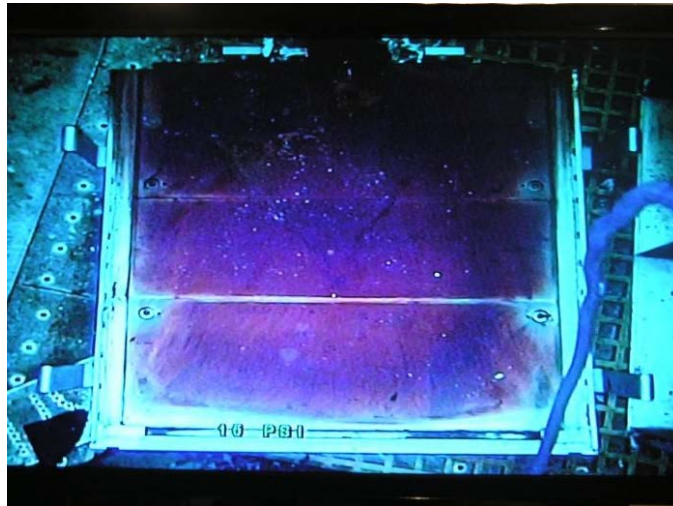
Fig. 1. West Shield Plate on the Pool Floor

The reactor grid plate was much thicker than expected, was sitting on a slightly elevated component crib, and had bolts in three of the four outer corners which extended outside of the component envelope by several millimeters. The team was unable to determine if the bolts were threaded into the grid plate or were set in thru-holes. The team had to assume the bolts were threaded and develop a plan to cut the bolts once they were accessible. The east shield plate measurements were as expected. The west shield plate, as shown in Figure 1, resulted in a configuration change that created the need for size reduction prior to placing in the liner insert. The west shield plate was found to have two tabs welded to one end that were not previously documented on drawings. Each tab was approximately 12 mm thick, 50 mm wide and 50 mm long. The west shield plate was also welded or bolted to a tray which extended approximately 25 mm beyond the plate edge on two sides, making the plate 50 mm wider than previously documented. There were four tabs welded to the tray which extended another 25 mm beyond the edge of the tray. The tabs also extended between 102 mm and 152 mm upwards and had a dogleg on them extending farther out. The tabs were approximately 5 mm thick and 38 mm wide. This configuration was not reflected on any drawings or previously provided photos and was large enough that the plate would not fit into the liner insert without modification.

The tabs on the west shield plate needed to be cut off or bent to allow the four components to fit into the liner. The material of the tabs could not be determined since they were not shown on any drawings. AREVA assumed the straps were stainless steel to be conservative. Since these were found just before implementation began, several mitigation methods were studied and pursued in parallel. Mockup tabs were also manufactured so that the various mitigation methods could be tested in the AREVA training facility before being implemented in the field.

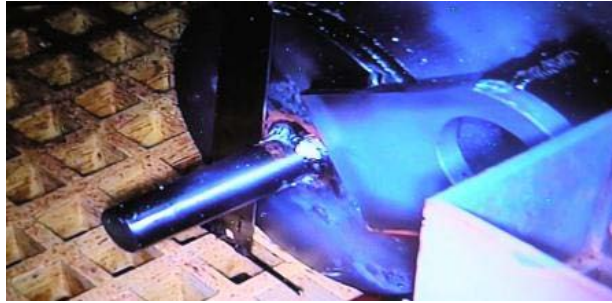
Fig. 2. Lead Counterweight with Lifting Lug

The lead counterweight was found to have a lifting lug on each end of the component with a large circular hole cut in it as shown in Figure 2. The plan to pick

up this component was changed from a clamping device to a hook that would be inserted into one of the two circular openings as a result of this finding.

The counterweight was picked up using one of the two lifting lugs discovered during the measurement campaign. An eye hoist hook without a safety latch was connected to the crane and lowered into the water. The hook was positioned using long-reach poles. The counterweight was moved over the liner insert and lowered into the desired location.

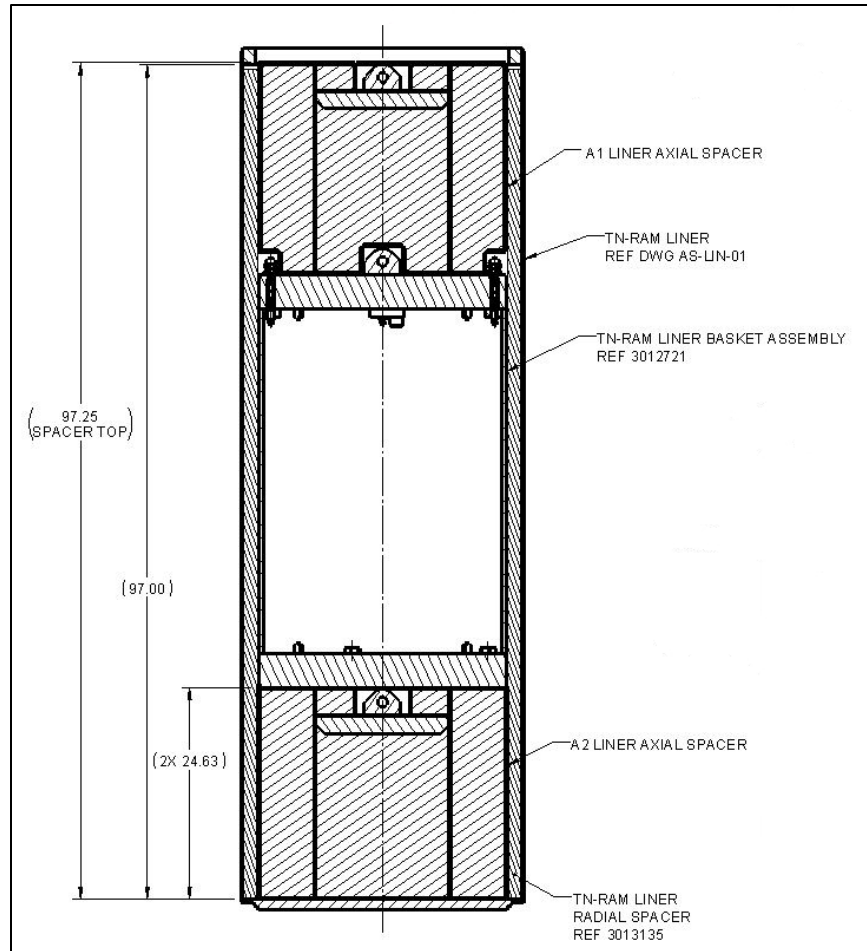
Fig. 3. Liner Assembly with Insert and Spacers

A new approach to using the cask and disposal liner was developed to overcome the physical limitations of the facility. A 1.23 m tall liner insert was designed and fabricated specifically to package the four irradiated components. This liner insert was designed such that it would fit inside the disposal liner with axial and radial spacers as shown in Figure 3. The liner insert was placed on the floor of the 9 m deep pool to facilitate component loading. The shipping cask with disposal liner was staged on a Goldhofer adjacent to the reactor pool just inside one set of loading doors. The cask and disposal liner were up-righted from the trailers outside of the building using a mobile crane and loaded onto a Goldhofer which was driven into the building through the door opening.

Based on client provided data on source terms, the liner insert was designed with a 101.6 mm thick lid and bottom surface and a 12.7 mm wall thickness. AREVA designed a shield bell to provide shielding to workers to achieve ALARA conditions. The shield bell was fabricated from spare 88.9 mm thick reactor coolant piping. Rolled steel plate 38.1 mm thick was welded to the outside of the pipe to achieve a total thickness of 127 mm. MICROShield analysis determined that this shield bell thickness combined with the liner insert thickness would result in a dose rate of 660 Micro Sieverts/hr at a distance of 6.1 m from the shield bell when the loaded liner insert was removed from the pool.

The axial spacers were made of steel plates and pipe structural members. Vermiculite was added to the internal cavity of the axial spacers for void filling.

Inert insulation blankets were cut into strips and inserted around the inner wall of the disposal liner to fill the radial voids in the annulus between the inner wall of the disposal liner and the outer wall of the liner insert.

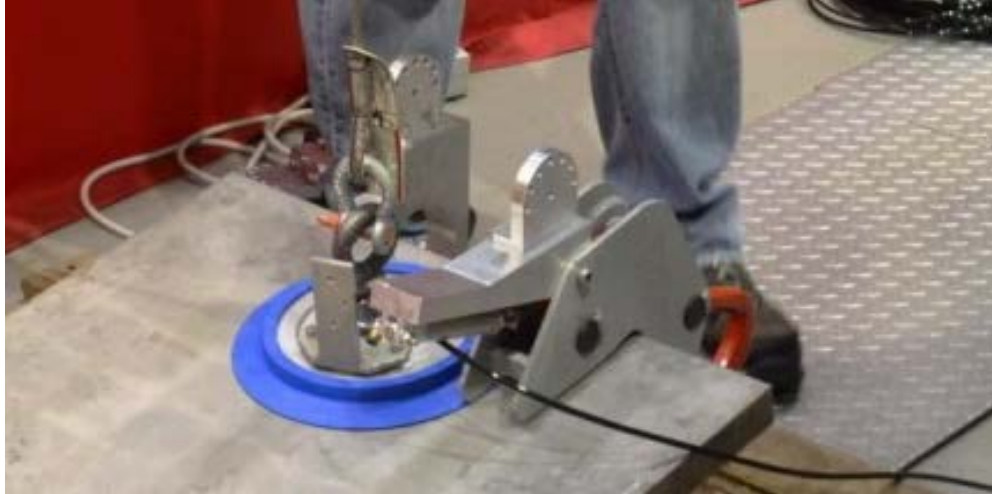
Fig. 4. Plate Clamp with Pneumatic Cylinder

AREVA designed and fabricated tools to pick the plates up off of the pool bottom and load them into the liner insert for disposal. A pneumatic suction cup as shown in Figure 3 was chosen to lift one end of the plates 100 mm to 150 mm off the pool bottom as a contingency if the existing rigging on the shield plates could not be used. A wedge was designed to be inserted under the raised end of the plate to hold it up during a tooling change. AREVA modified a plate clamp by adding a pneumatic cylinder which pushed on the cam to ensure the cam was actuated before lifting as shown in Figure 4 to pick the plates up off the pool bottom.

Using long-reach poles, the clamp was positioned to grip the middle of the plate. Before lifting, the pneumatic actuator was energized to engage the cam with the plate.

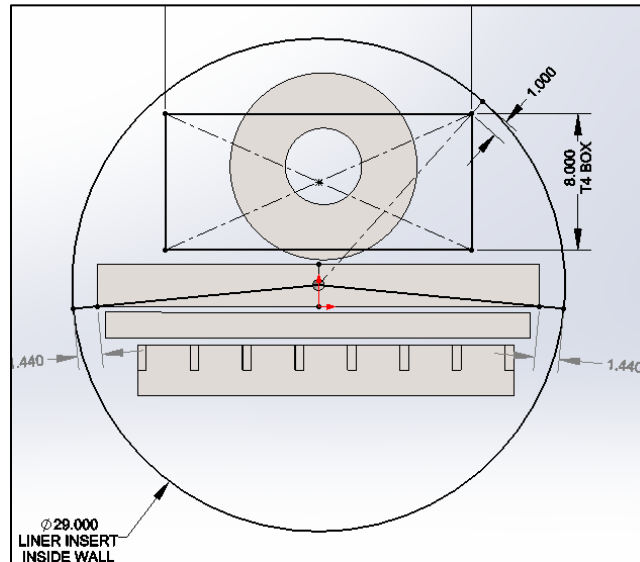
Fig. 5. CAD Loading Model

AREVA started with client supplied images and dimensions to design and fabricate mockup components to determine the optimum packaging arrangement and learn how to manipulate the components 9 m under water. AREVA developed a CAD model as shown in Figure 5 to determine the optimal loading of the liner insert. These mockup components were used for practice in the AREVA training facility pool to determine the best way to lift the plates from flat on the bottom of the pool.

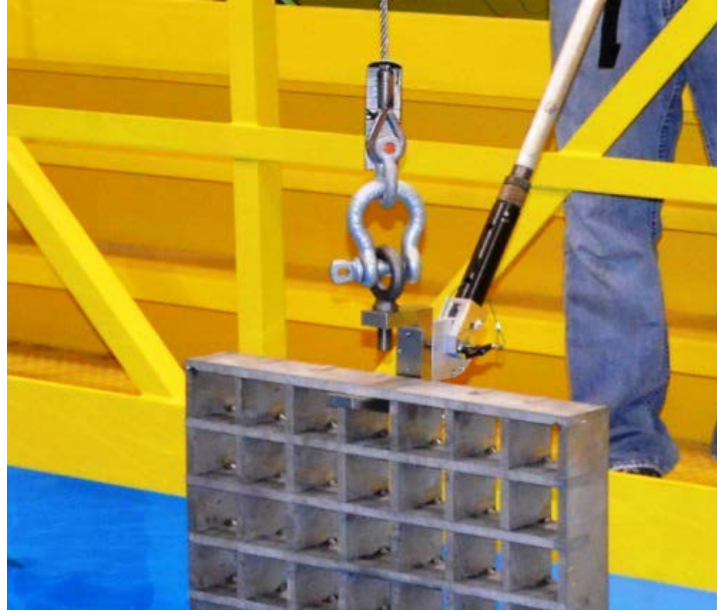
Fig. 6. C-Block Lifting Device on Mock-up Plate in Practice Pool

A new lifting device was designed, manufactured, and load tested to move this component. A 'C-Block' was fabricated to fit into the grid openings which allowed the plate to be lifted in a level position. The tip of the lower lip has a raised portion to ensure the grid plate is held securely during movement as shown in Figure 6.

The grid plate was initially lying horizontally in a crib on the pool bottom. A standard plate clamp was used to lift one end of the plate enough to insert a custom-designed 'C-Block' into one of the grid openings. A wedge was inserted under the raised edge using long-reach poles once one edge was lifted high enough. The rigging was retracted and the 'C-Block' was installed while the plate was rested on the wedge. The 'C-Block' was positioned using long-reach poles and the plate was lifted. When the plate was positioned in the correct location in the liner insert, the 'C-Block' was disengaged.

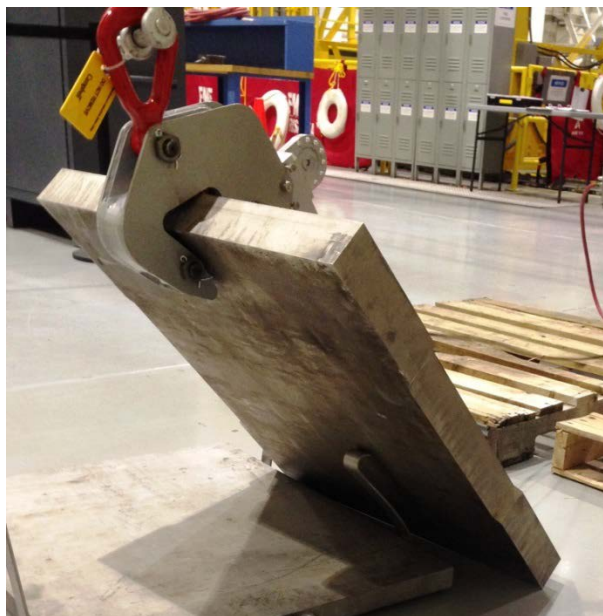
Fig. 7. East Shield Plate Used to Bend Tabs (Mock-up Practice)

The east shield plate was picked up first and used to bend down the tabs on the west shield plate as shown in Figure 7. Each strap was bent individually and then the east shield plate was placed completely flat on top of the straps to flatten them as much as possible. The east shield plate was then lifted, positioned over the liner insert and lowered into the container in the prescribed location. The plate was placed into the insert and the pneumatic cylinder was disengaged which freed the plate clamp from the plate. The west shield plate was then loaded into the liner insert. The final irradiated component loaded was the lead counterweight.

The preferred mitigation plan, identified after the tabs were discovered, was to use the east shield plate weighing 231 kg to bend the tabs on the west shield plate over by lowering it down on each of the four tabs. The advantage of using this plan was that it did not introduce any new equipment to the pool which could be contaminated. It was also the simpler of the two processes and it provided fewer opportunities for upset conditions and resulted in the least impact on the previously planned operations.

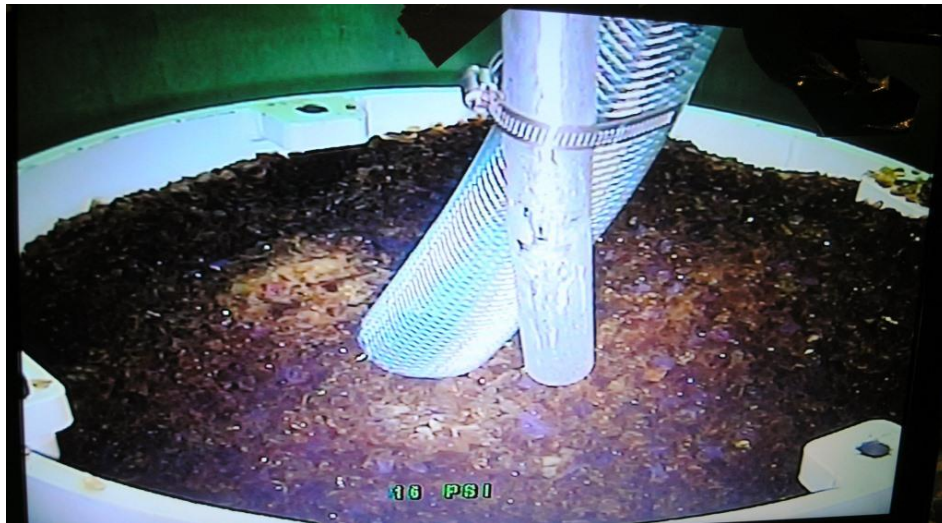
Fig. 8. Glass Beads

Recycled glass beads were added to the liner insert while still under water through a hose routed from the bridge deck above the pool as shown in Figure 8 after all components were loaded into the liner insert. The hose was attached to a pole to

provide control of the end of the hose to fill in all the voids. A large funnel was used to ensure all of the glass beads went into the hose instead of falling into the pool. Orange beads were used to allow the team to see them under the water. Once the glass beads filled the insert to the lid mating surface, the lid was placed on the liner insert for closure to ready the liner insert for removal from the pool.

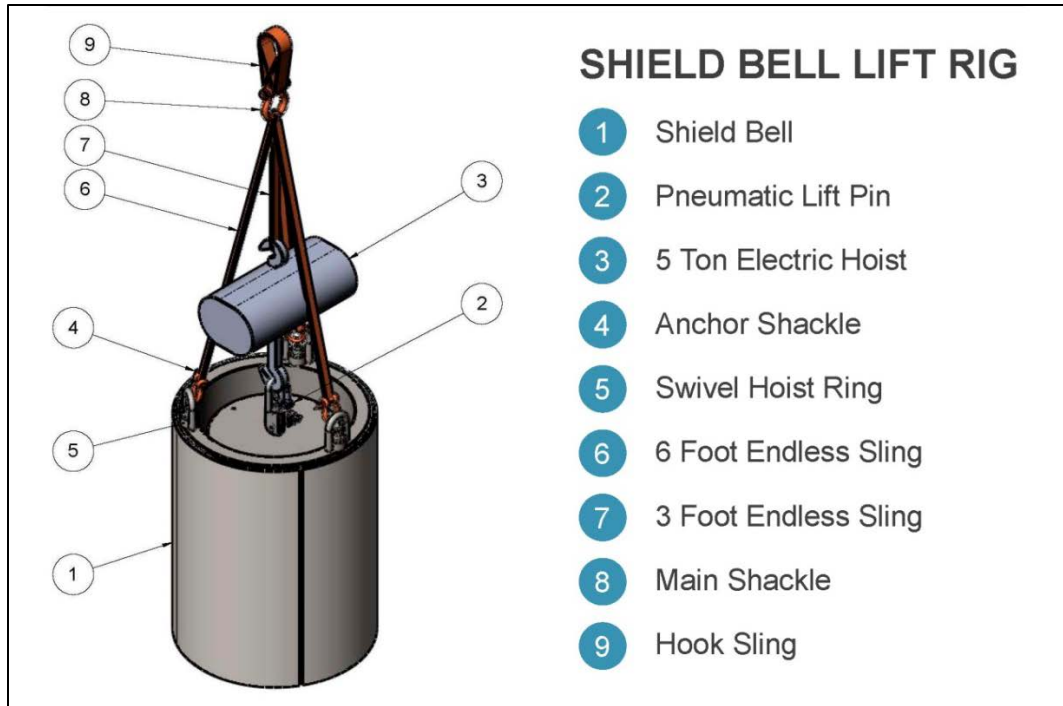
Fig. 9. Shield Bell/Liner Insert Lifting Rig

The shield bell was lifted and lowered into the reactor pool 100 mm to 150 mm to provide personnel protection when the liner insert was lifted from the pool into the shield bell. The liner insert was lifted from the bottom of the pool into the shield bell using a 5-ton chain hoist mounted to the bridge crane hook as shown in Figure 9.

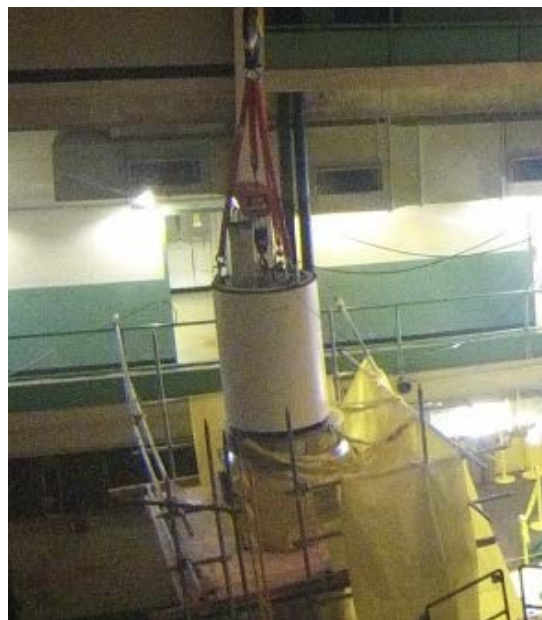
Fig. 10. Liner Insert Moved to Cask

The liner insert was slowly lifted into the shield bell allowing water to drain through weep holes designed into the bottom of the liner insert. A wire screen in the weep holes prevented the glass beads from passing through the holes. The shield bell and liner insert was then maneuvered across the room to line up with the shipping cask which was staged adjacent to the reactor pool as shown in Figure 10.

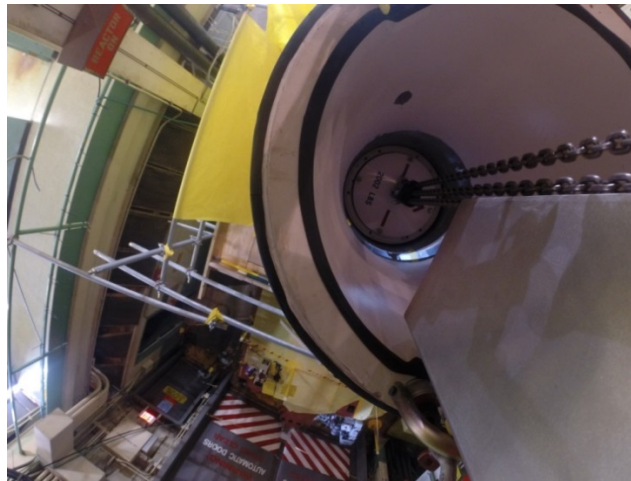
Fig. 11. Liner Insert Lowered from Shield Bell to Cask

The shield bell/liner insert assembly was aligned with the shipping cask remotely with the aid of GoPro cameras mounted to the 5 ton hoist. The liner insert was lowered into the disposal liner that was previously placed in the shipping cask as shown in Figure 11. The top axial spacer, disposal liner lid and shipping cask lid were installed to complete packaging.
