**Evaluation of Computed Tomography Techniques for Material Identification  
in Low Level and Intermediate Level Waste.  
16648**

Stephen Halliwell, VJ Technologies Inc, 89 Carlough Road, Bohemia, NY 11716,  
USA.

**INTRODUCTION**

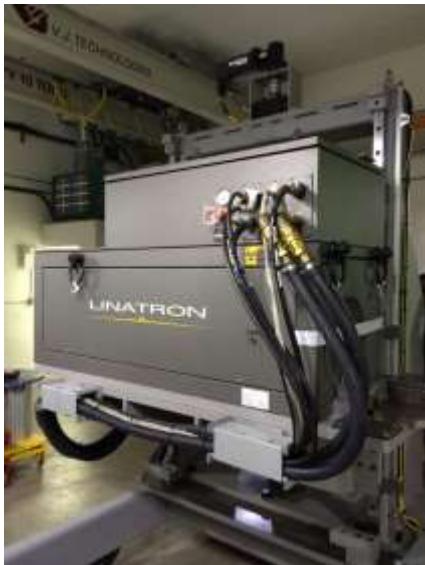
**Figure 2 – VARIAN M9A LINATRON**

The high energy x-ray source used in the tests was a VARIAN M9A model which can produce high energy spectra at 6MeV and 9MeV. This is shown in Figure 2.

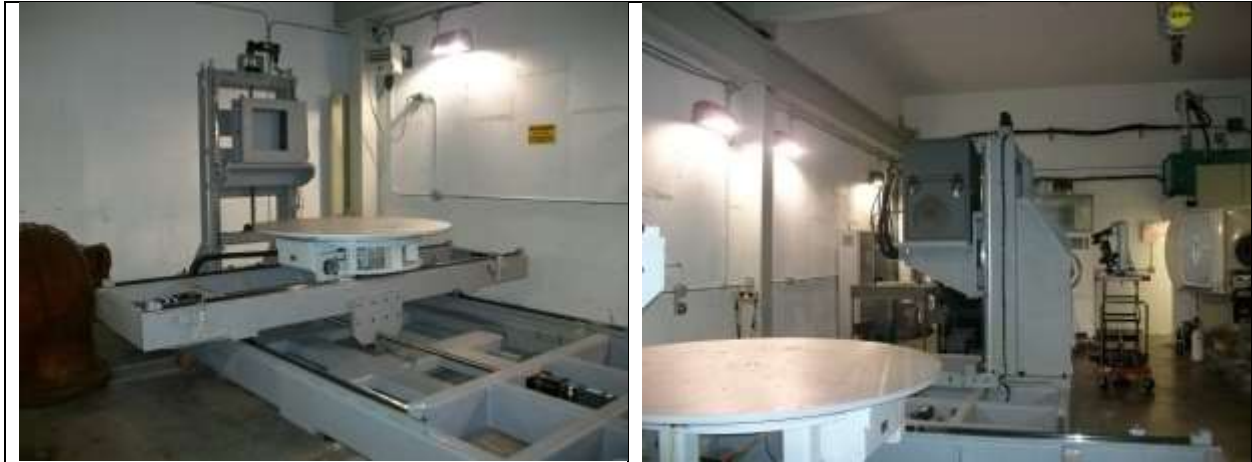
**Figure 3 – Tomography hardware with the digital detector array.**

The tomography hardware with the Digital Detector Array is shown in Figure 3. The manipulator includes 4 independent axes: X, Y, Z and rotation. The manipulator

has a high-precision turntable, which can handle up to 4,545 kg, and specially designed to acquire tomography data.

The detectors and the high energy x-ray source were at a source to detector distance of 4,369mm, with travel of +/- 1,100mm on the X-axis, 1,000mm maximum travel on the vertical Y axis and continuous 360 degree of rotation with the rotary axis.

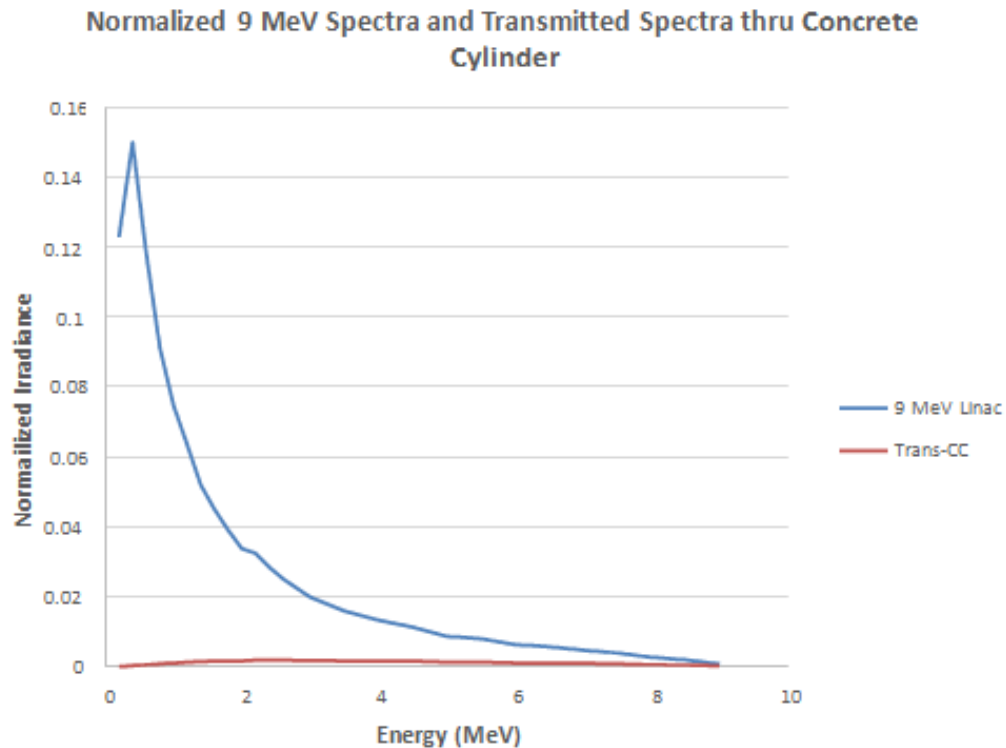
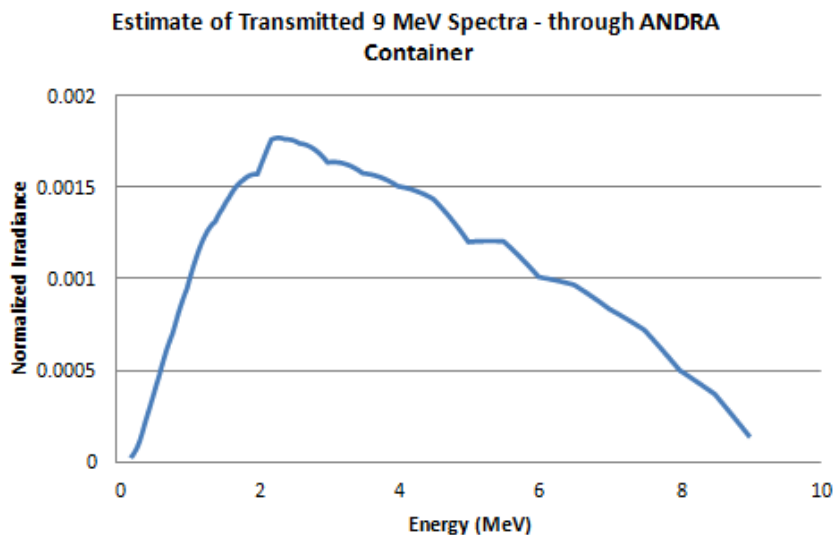
**Figure 6 – Estimated 9 MeV LINAC spectra and spectra after transmission through ANDRA container.**

The challenges for CT inspection in this context derive from the substantial attenuation due to the container, the material and the shape, which determines the energy range available for the inspection of the contents of the inner drum. Figure 6 includes a plot of a normalized 9 MeV spectrum, and the same spectra after attenuation through the center of the Concrete container.

In addition, type of CT data acquisition described in this paper, the exact state of the spectrum will change with horizontal position of the detector panel – as acquisition towards the tangents of the concrete cylinder will be much more attenuating than through the center of the cylinder.

This plot of spectra did not include the use of an x-ray beam filter. In describing the problem, it was considered best to leave the choice of filter open. Filter selection varied for the different chord lengths through the drum and the specific detector used.

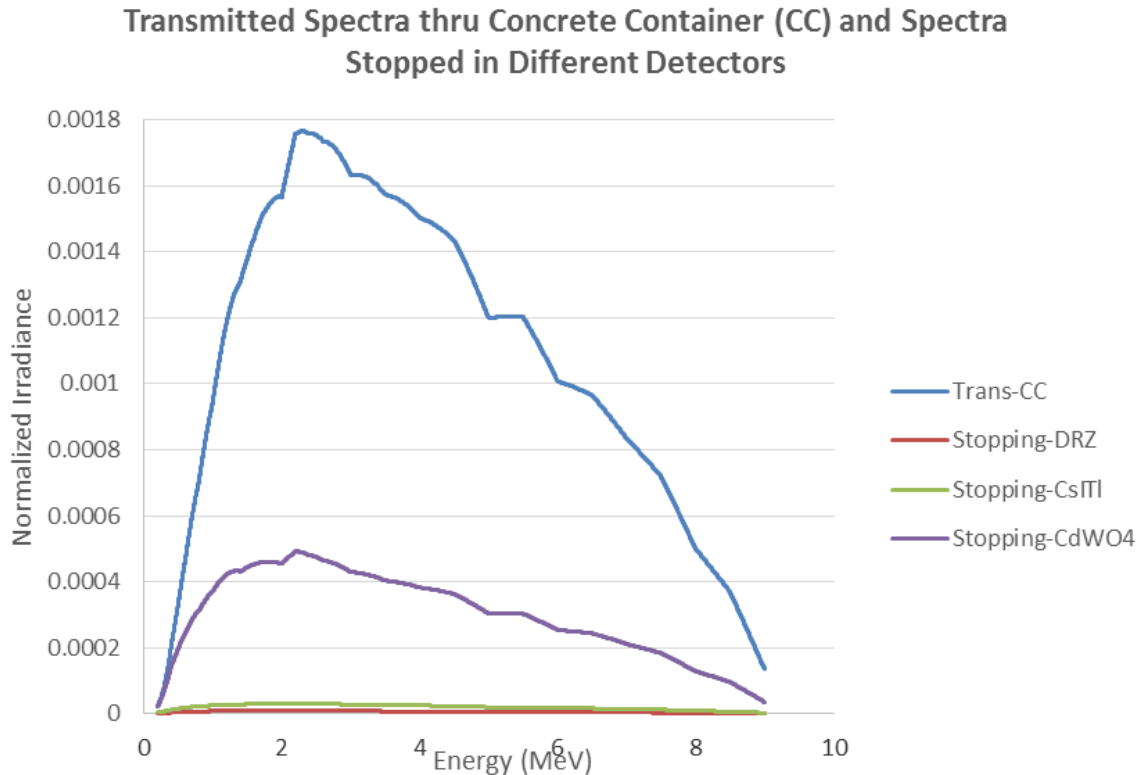
**Figure 7 – Transmitted 9 MeV spectra and comparison of stopping power for different scintillators.**

The Digital Detector Array had a 1mm Cesium-Iodide Thallium- Doped scintillator (Density ~ 5gm/cc). The Linear Detector Array had 1cm Cadmium-Tungstate scintillator crystals. Figure 7 shows plots of the relative difference in stopping power for different scintillators for the transmitted 9 MeV spectrum.

Notice the much reduced stopping power in the 1mm CsITl as compared to the 1cm CdWO4 scintillator. This results in a higher contrast sensitivity being achieved by the Linear Diode Array, but better spatial resolution and overall faster scanning being achieved by the Digital Detector Array.

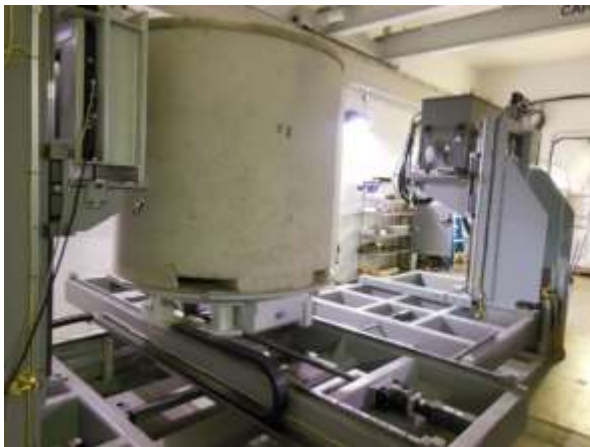
**Figure 9 –Concrete Cask in position for data acquisition for translate-rotate scanning**

Figure 9 shows the hardware for the Digital Detector Array data acquisition. The source to object distance was 3,327.4mm resulting in an x-ray magnification of 1.31.

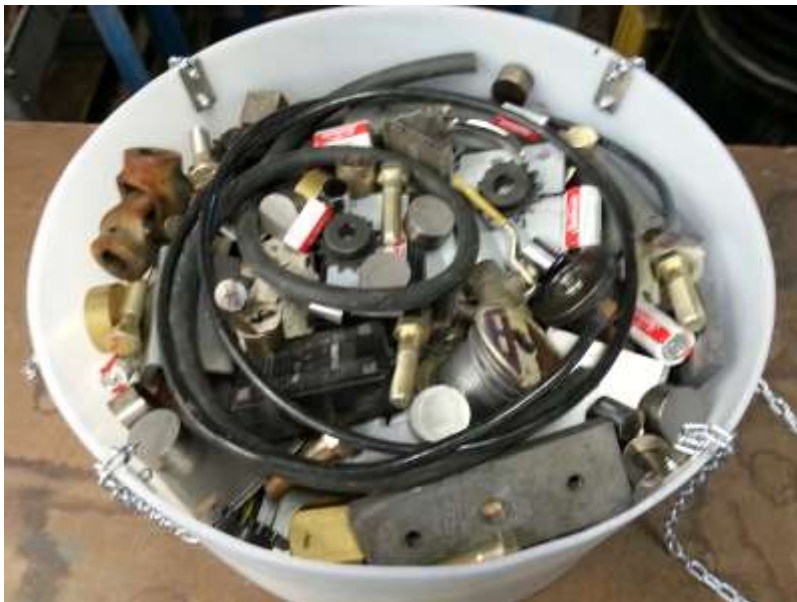
**Figure 10 –High-Density section of the drum**

The CT results were then reviewed for each of the three types of waste, high, medium and low, density. Figure 10 shows a photo of the high density waste.

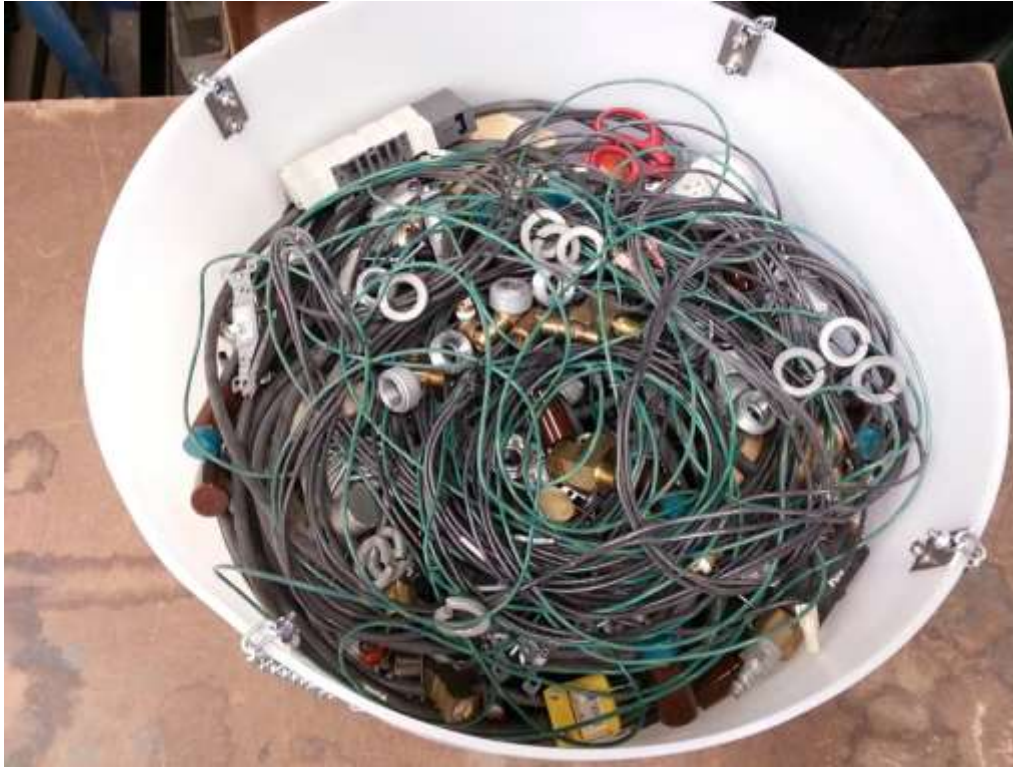
**Figure 27 – Materials in the top section of the Medium Density section**

Figure 27 shows the materials in the top section of the Medium-Density section of the drum for reference.

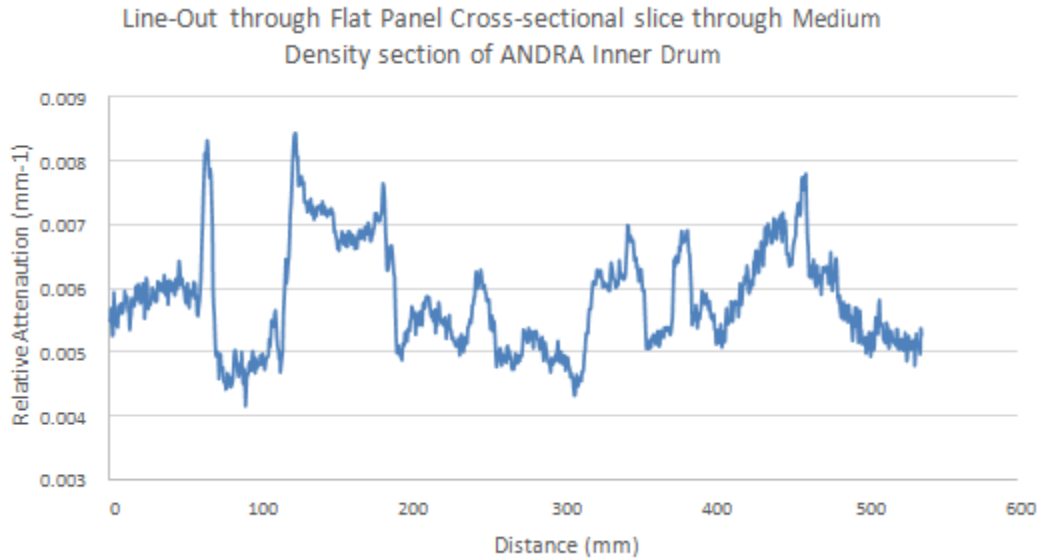
**Figure 28 – Cross-sectional slice through Medium-Density section of Inner Drum and Line- out from image showing differences in measured material values from the Digital Detector Array (Area Detector) CT data.**

The area detector volumetric data plotted from the line-out covers a roll of lead, two carbon-steel parts, and some copper wire. The attenuation value of the lead is a little higher than the steel and copper materials, but the voxel-value differences are low, and the noise is considerable.

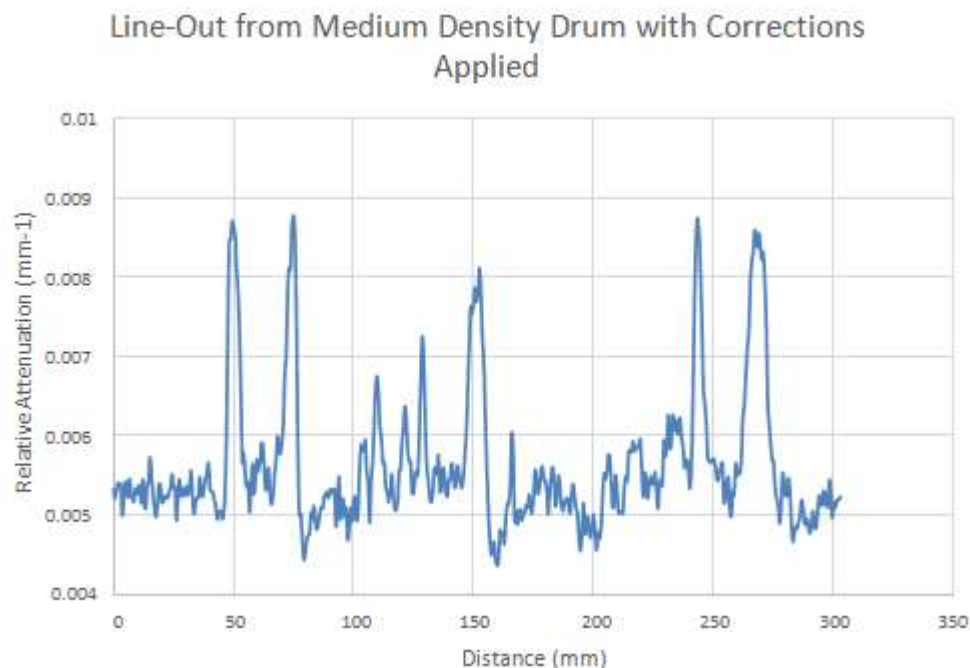
**Figure 31 – Cross-sectional slice through Medium-Density section of Inner Drum and Line- out from image showing differences in measured material values from the LDA CT data.**

The voxel-values obtained from Line-out through the data from the LDA shows more fidelity for materials discrimination. The line-out traverses, a brass part, then steel, then gravel, then brass. The brass is higher in voxel value than the steel, and the gravel. Also, the double-peaks at the start and the end of the line-out nearly match in voxel value, indicating this scan measures the value of brass similarly regardless of its position in the volumetric data.

Both the Digital Detector Array and the LDA CT scan data distinguishes materials by voxel value. In both cases the line-outs show that the higher density materials include a higher measured attenuation value. While the absolute scale is bound somewhat by the ROI correction, the differences between the two different types of scans are important. First, and as expected, the LDA is cleaner, the steel and copper components are distinctively higher than the surrounding materials, and from the line-out are far above any local noise variation. Second, while the Digital Detector Array cross-sectional slice includes more noise, the artifacts also detract from the measured differences in the CT data. The Digital Detector Array data includes a bit of a “cupping” artifact which impacts the value of the CT voxels dependent on position not on the material. Second, the overall difference in measured material range is smaller for the Digital Detector Array.
