Remediation of Occupied Commercial Property Subject to Widespread Radium-226 Contamination: Update from Wm2012 Paper -16652

Philip Sinclair, Ben Smee, Lewis Miffling
Amec Foster Wheeler, UK

Summary of Work

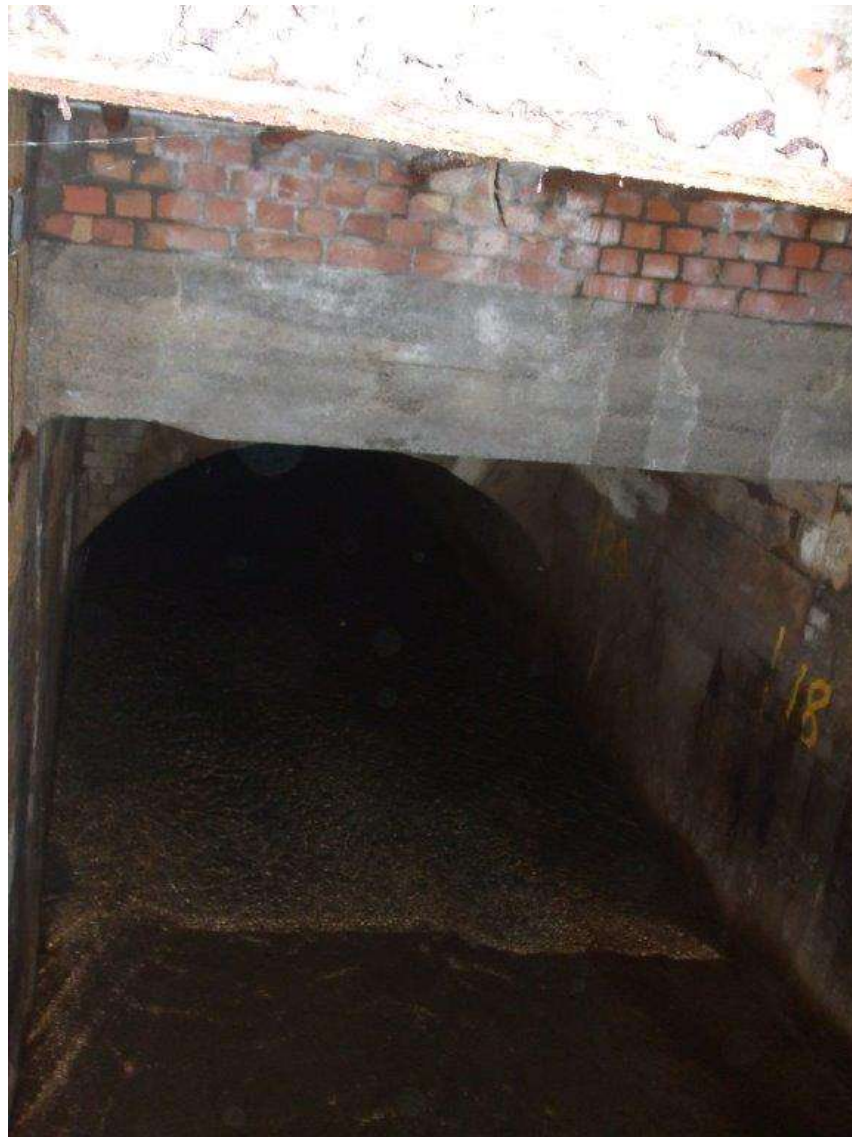
Remediation works in the Blocked River Race were undertaken between 10 June and 9 October 2014. As contamination was identified throughout the silt profile within the Blocked River Race, all deposited silt required removal down to the solid river bed.

Fig. 2. Sludge Deposits in the River Race

Initial silt retrieval works were undertaken by remote pumping using a 'Grindex Solid' pump to remove contaminated silt directly into 200L drums. The pump was supplemented by a hydrocyclone to reduce the water content within the drums. The returned water from the hydrocyclone was used to further agitate the silt with the Blocked River Race. Following removal of silt from the area immediately beneath the opening, man-entry was undertaken to move the pump to areas of silt starting with the area upstream towards the blocking wall and then heading downstream towards the manhole. All drums of silt were cleaned, stabilised with 'dry add' where required, sentenced and transferred to the waste storage compound. As silt removal works reached the area immediately beneath the courtyard manhole the measured dose levels became too high to continue man-entry. Works from the courtyard access were suspended pending dose assessments and a revision to the Ionising Radiation Risk Assessment (IRRA).

Following revision to the IRRA works were recommenced from the courtyard end running simultaneously with excavations from the downstream end. Man-entry was undertaken in to the Blocked River Race and contaminated silt was excavated by hand directly into 200 L drums. Filled drums were removed from the Blocked River Race on a hoist, cleaned, stabilised with 'dry add' where required, sentenced and transferred to the waste storage compound.

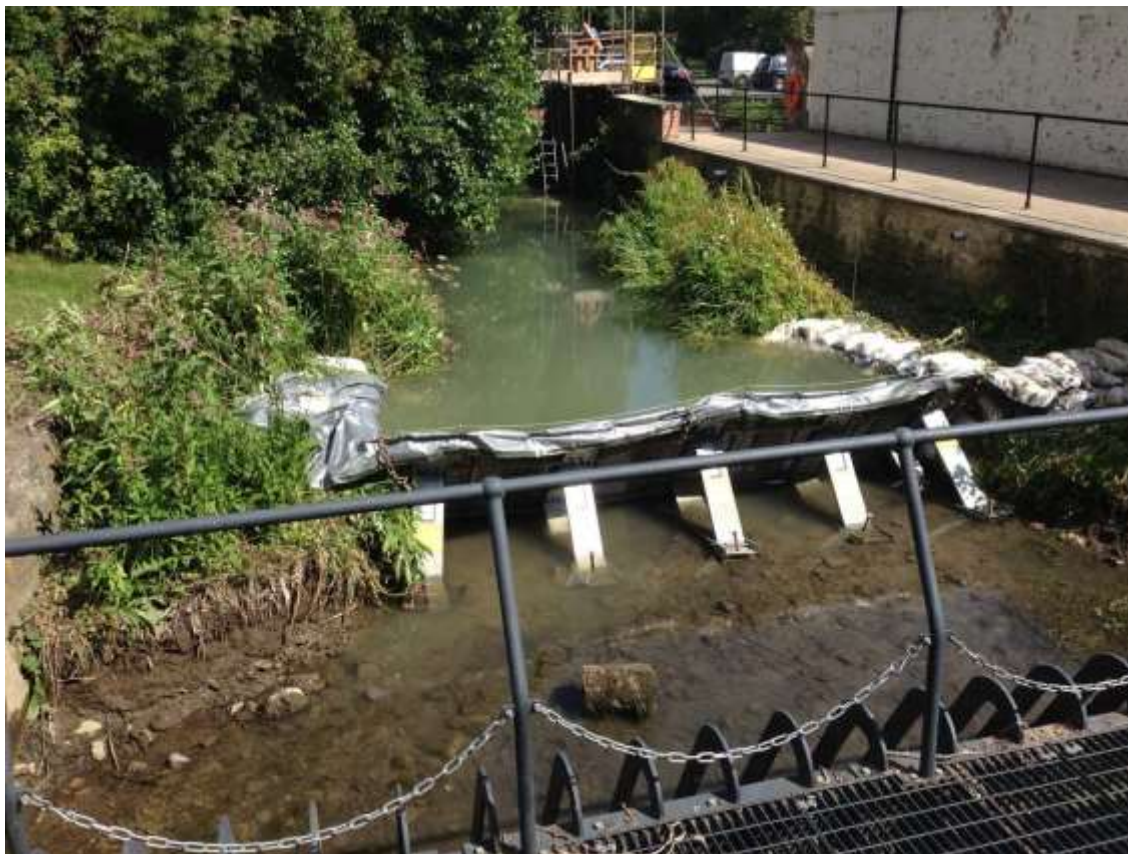
To limit water ingress from the adjacent river channels a dam was installed across the River Frome to divert the main flow of the river away from the work area to the south of the site. Initially the dam was constructed with sandbags, however following a period of heavy rain this dam failed on 16 June leading to a flooding of the works area. A replacement, flood defence type dam was installed on 23 June to replace the sandbag dam. The river diversion remained in place until 10 November.

Fig. 3. River Diversion

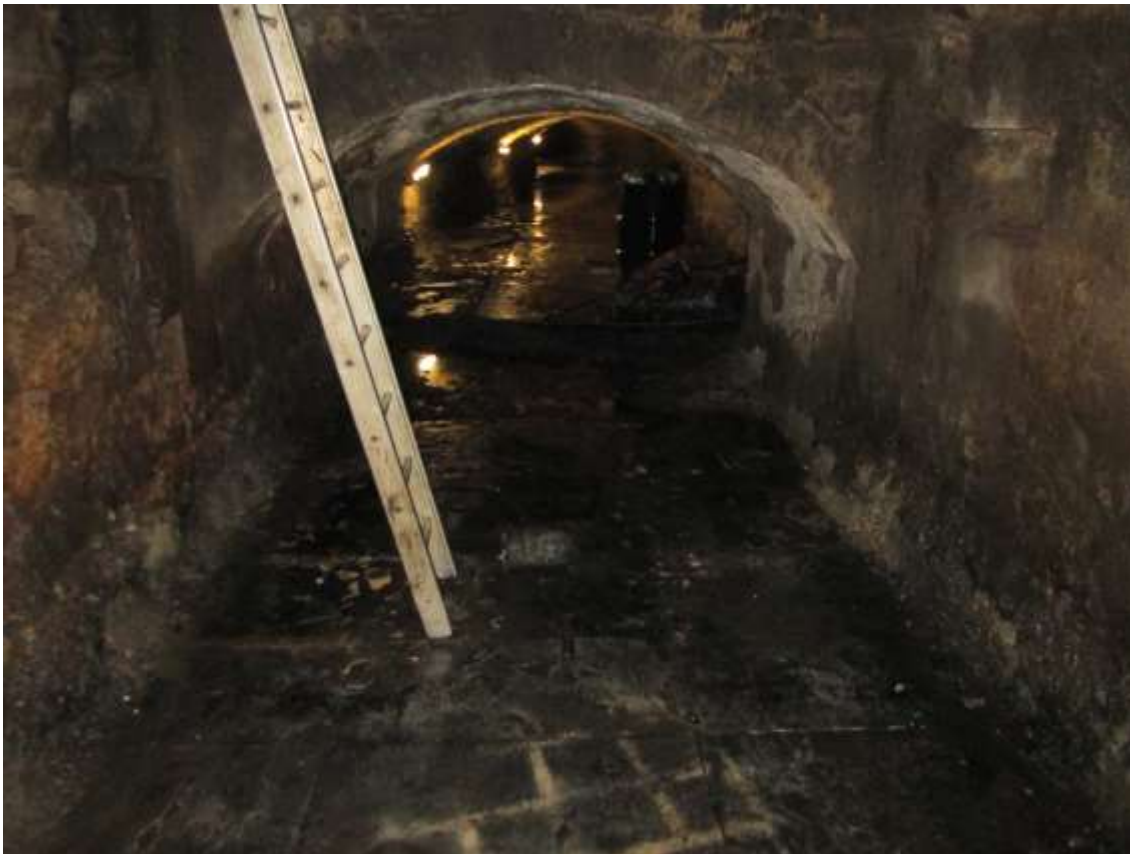
Following silt removal, a walk over survey identified significant residual contamination in the floor of the River Race immediately beneath the courtyard manhole. Further excavation work was undertaken to remove partially cemented material that had accumulated beneath the manhole down to the stone bed of the River Race. Concentrations of radioactivity were significantly reduced. Further excavation/breaking out of remnant contamination in the floor not undertaken to avoid structural damage to the building.

Fig. 4. River Race following Remediation

After all excavation works were concluded, a survey was completed. The base of the River Race was then encapsulated in concrete with the aim of preventing river water ingress mobilising residual contamination.

A poured concrete floor approximately 100 mm thick was laid from 34 m to 54 m at the courtyard end of the River Race. Due to the presence of standing water, concrete canvas consisting of approximately 3.5 m x 1.2 m strips was laid on the floor from the open end to 34 m. A retaining wall of approximately 0.7 m height was constructed of poured concrete across the open end of the River Race to reduce the turbulence of river ingress.
