## **Remote Decommissioning of the Plutonium Experimental Extraction Facility, Sellafield – 17031**

### **ABSTRACT**

### **INTRODUCTION**

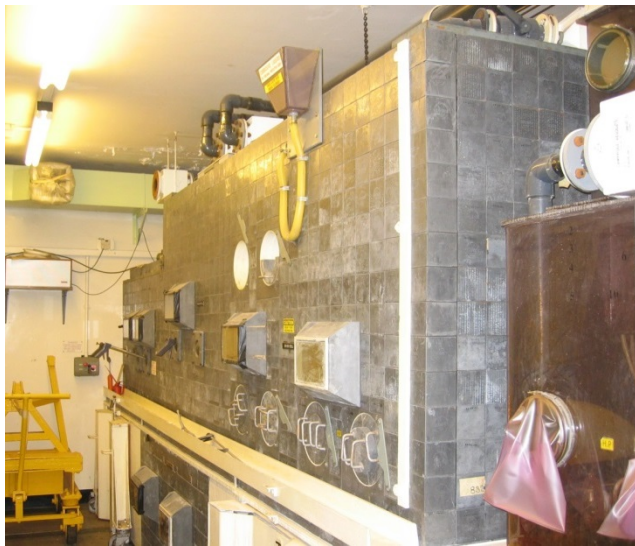
Figure 1 - Shielded section

All the gloveboxes were constructed of Darvic, a calendared polyvinyl chloride (PVC) material which is no longer manufactured. This material is known to embrittle and darken with age, and also to degrade with exposure to acids, ultraviolet rays and ionizing radiation. The shielded gloveboxes were Darvic underneath with a shield wall constructed of lead 'chevron' bricks surrounding the gloveboxes.

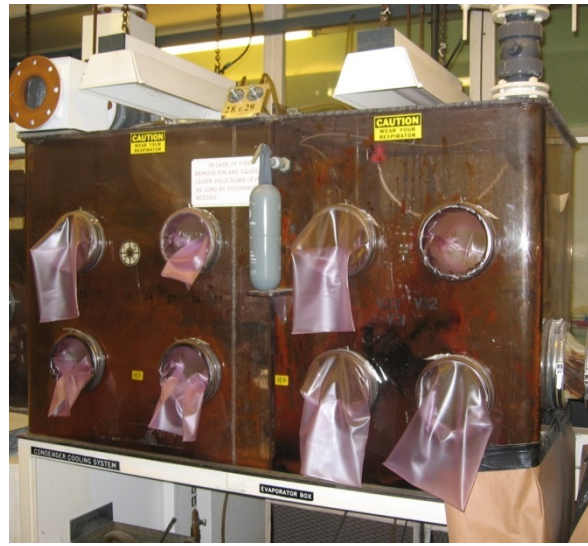
Figure 2 - Unshielded glovebox

As with many experimental processes on the site, once research was complete the facilities were left in extended care and maintenance. Over time equipment such as glovebox pressure gauges deteriorated and thus could no longer be relied upon. Additionally many records relating to the process and the equipment could not readily be located. Clouding of the Darvic material made inspection of the glovebox contents more difficult.

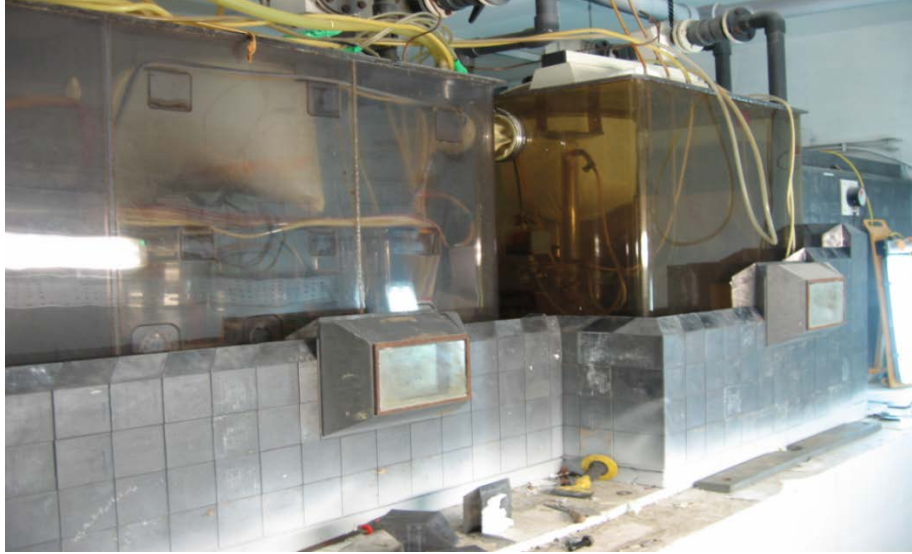
Figure 3 - Shielded section following partial lead removal

Bricks were removed manually by operators one-by-one with health physics in attendance to monitor radiation levels. When dose reached a certain level it was agreed that removal would cease (see Figure 3).

This approach allowed approximately 21 tonnes (approx. 23 tons) of lead bricks to be removed as exempt waste rather than becoming contaminated and requiring disposal as PCM, giving a substantial lifetime cost saving. The material has been retained by the site for future use.

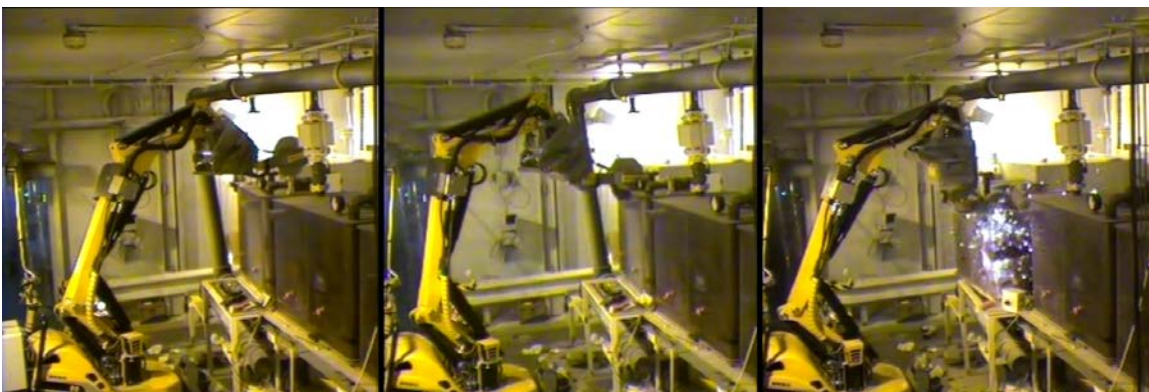
Figure 4 - Brokk® beginning size reduction of glovebox suite (CCTV stills)

A combination of circular saw and Darda shear was preferred by the operators for size reducing the Darvic. Operators first used the saw to create an opening in the glovebox, then changed to the shear and used the end paddles to break pieces of Darvic off until size reduction was complete (see Figures 4 & 5).

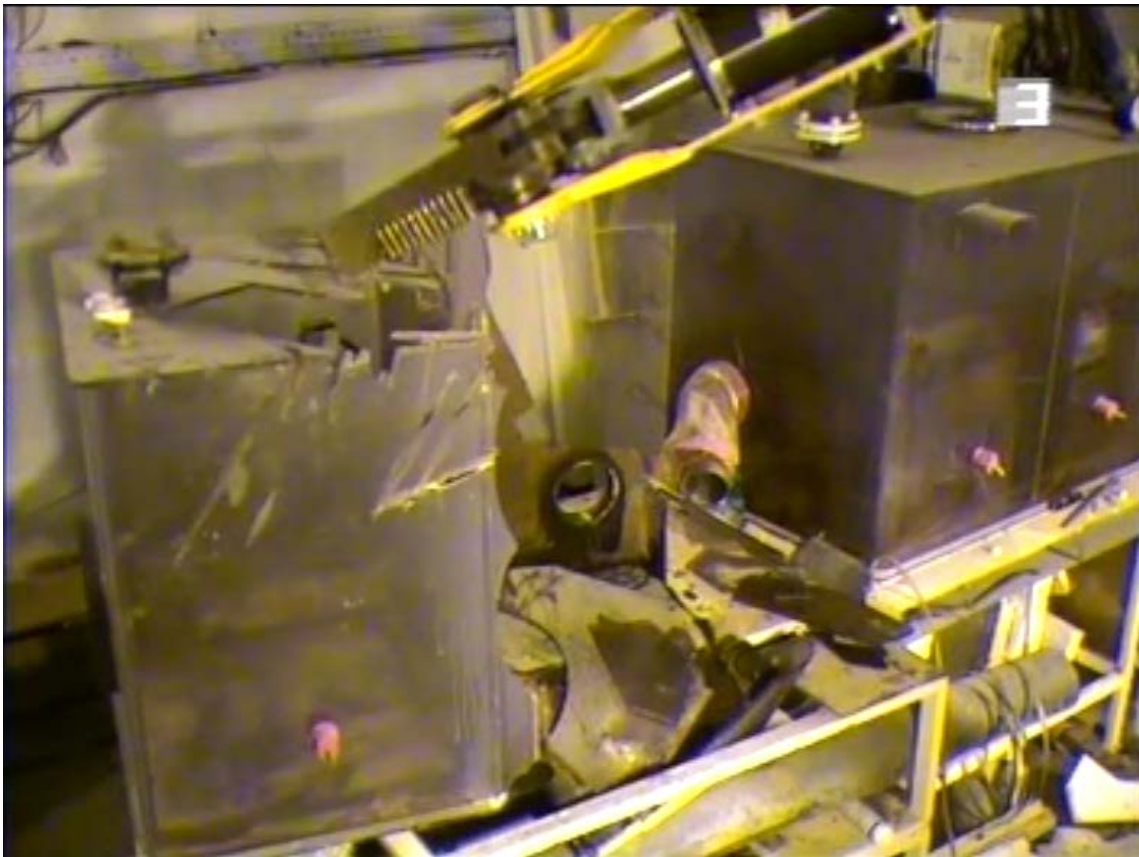
Figure 5 - Darda HCS7 shear being used to break up Darvic (CCTV still)

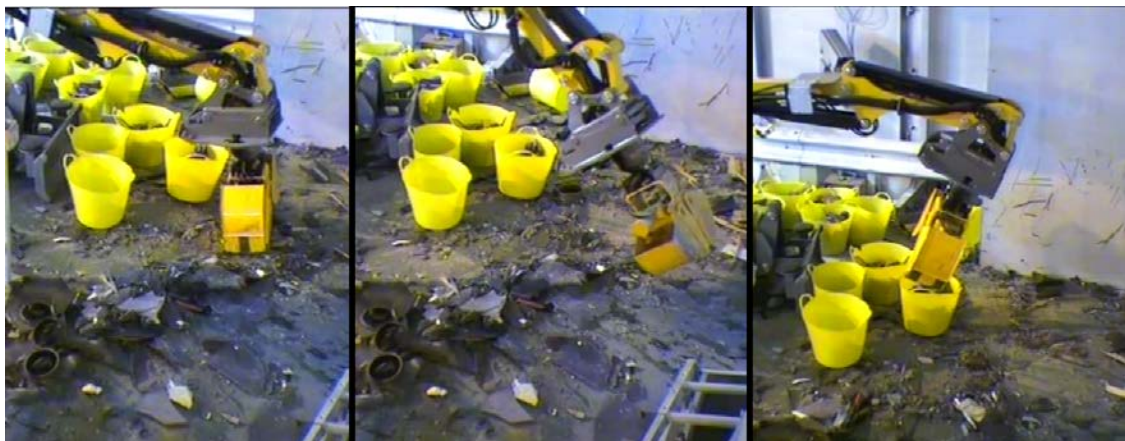
Figure 6 - Waste handling using C025H-25 clamshell bucket (CCTV stills)

Stands and other metal items were size reduced using the cropping function of the shear. Waste was sorted and handled using the clamshell bucket (Figure 6) and the shear paddles.

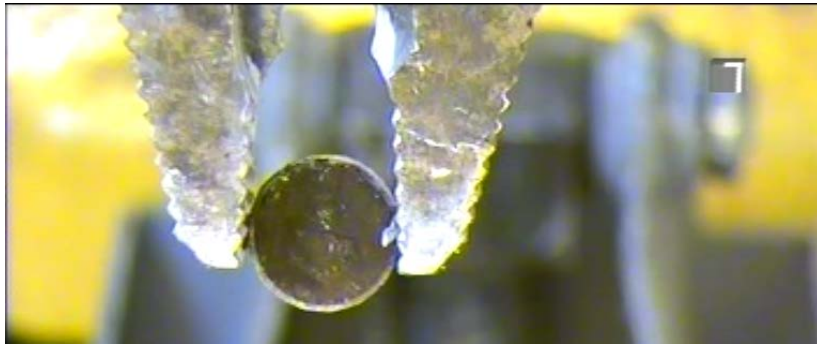
Figure 7 - Small item held in HCS7 shear paddles (CCTV still)

Relatively small objects could be handled by the paddles at the end of the shear, despite the lack of force feedback and the remoteness of the operator. During a previous project operators were able to turn a latch approximately 25mm (1") long using a combination of multiple camera angles and examination of the shadows around the object to build up a quasi-3D image. Similar techniques were used here to enable the handling of various small items of debris (see Figure 7).

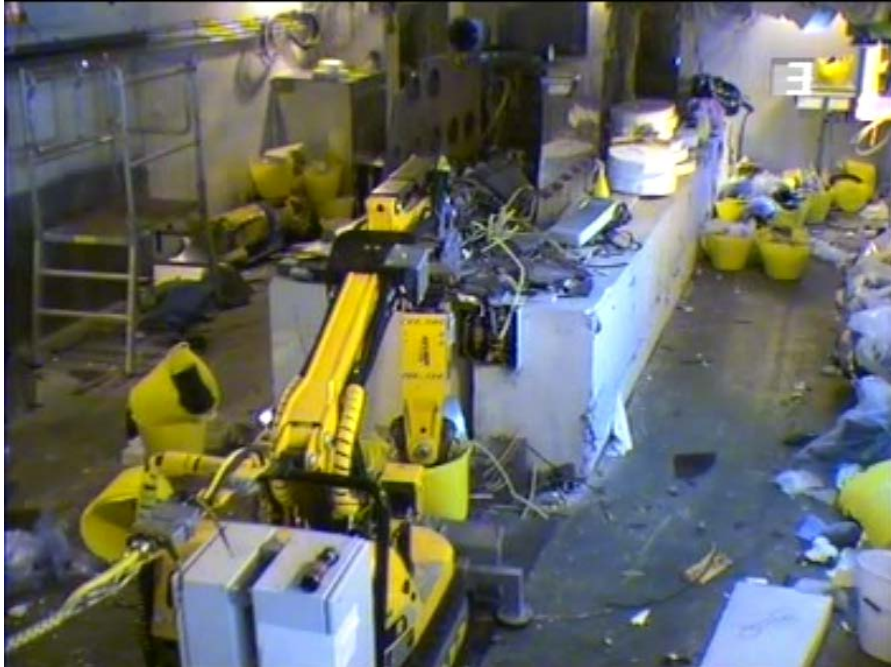
Figure 9 - General view of cell mid-decommissioning (CCTV still)

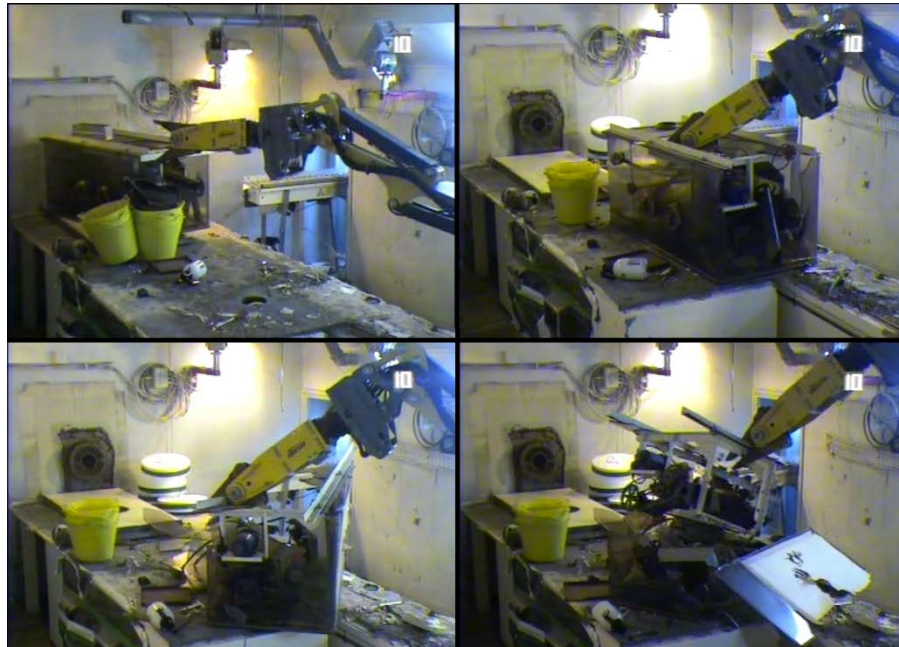
Figure 10 - Removal of internals from cutting cell glovebox (CCTV stills)

Decommissioning of the shielded section was conducted in largely the same manner as the unshielded section, since the gloveboxes were Darvic underneath the shielding. The last glovebox, the cutting cell, presented the greatest challenge to the equipment as it contained a lathe supported by a steel framework (Figure 10). The frame was removed from the Darvic glovebox shell, before the metalwork was cropped with the shear.

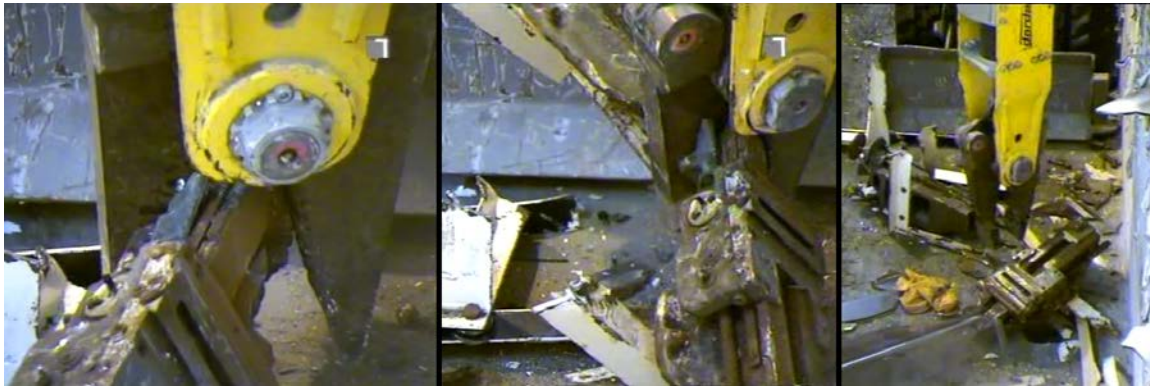
Figure 11 - Lathe being cropped by Darda HCS7 shear (CCTV stills)

The lathe bed was the largest item cropped by the shear (Figure 11).
