## **Characterization and Remediation of the Hanford 618-10 Burial Ground Vertical Pipe Units – 17121**

Gary M. MacFarlan, PMP  
Polestar Technical Services

### **ABSTRACT**

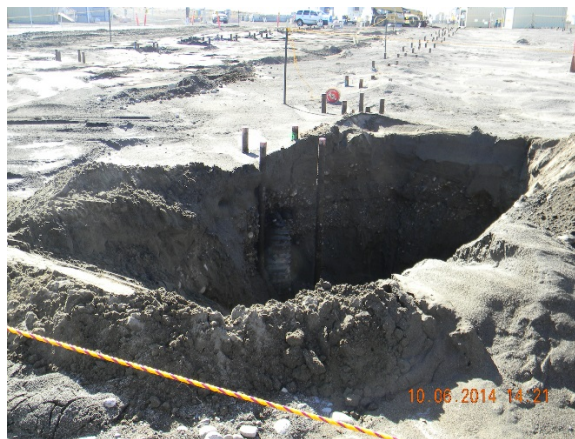
content and create maps (Fig. 2) showing the dose rate distribution throughout the VPU. This information was further refined once potholing around the VPUs was completed (Fig. 3) and the actual distance between the CPTs and VPUs could be validated. Potholing activities were also used to determine the construction (steel pipe, metal culvert or 208-L (55-gal) drums) used for each VPU.

Fig. 3. VPU Potholing.

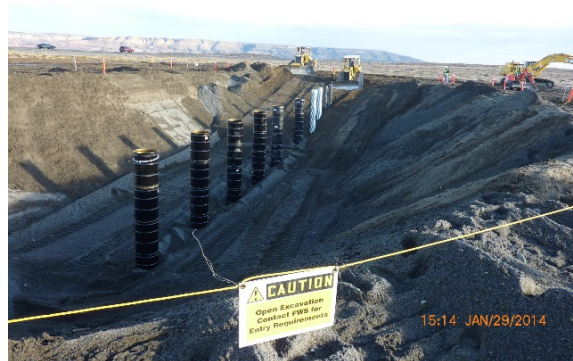
In order to ensure the success of the auguring process a full scale mock-up area was constructed (Fig. 4) and typical items that would be present in the actual VPUs was placed inside of the VPUs. As can be seen in Fig. 5, these included 113.6-L (30-gal) drums filled with smaller canes, 18.9-L (5-gal) buckets filled with various items such as metal washers, nails, PPE, scrap metal, tygon tubing. Concrete plugs were poured at various levels as the items were placed into the VPUs and a final concrete plug was placed and filled the VPU to the top.

Fig. 4. Mock-up Area.

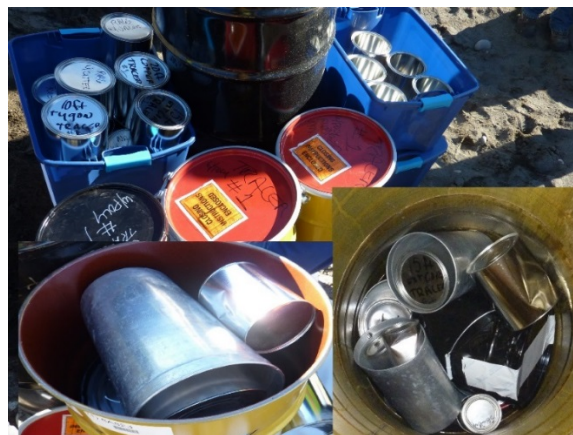
Fig. 5. Loaded Mock-up VPUs.

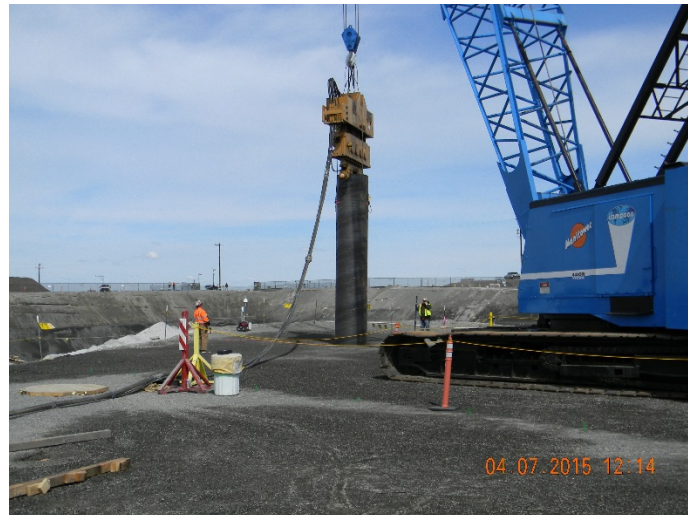
With the completion of characterization and the confirmed location of each VPU the CPTs were removed and a 122 cm (48-inch) diameter, 8.63 m (28-foot) long steel over-casing was driven around each VPU using a vibratory hammer hanging from a crane (Fig. 6). The over-casing was installed to control materials located in the VPU during the next stages of the process.

A carbon steel pipe with a 122 cm (48-in.) outer-diameter and a 1.3 cm (0.5-in.) wall thickness was selected for the over-casing. This over-casing is long enough to pass through the overburden, surround the entire length of the VPU, and extend beyond the bottom of the VPU.

Fig. 6. Installation of Over-Casing.

The depth (below grade) required for driving the over-casings was determined to be the sum of the maximum overburden, VPU height, and required clearance below the VPU. The below-grade length of 7.6 m (24.8 ft) results from the following values:

- Maximum overburden: 2.07 m (6.8 ft)
- Typical VPU height: 4.6 m (15.0 ft)
- Minimum bottom clearance: 0.9 m (3.0 ft)

The over-casing height above grade must be high enough to contain material swell from the augering operations. An estimate of this height was calculated by considering augering swell, addition of water for in situ moisture control, and freeboard.

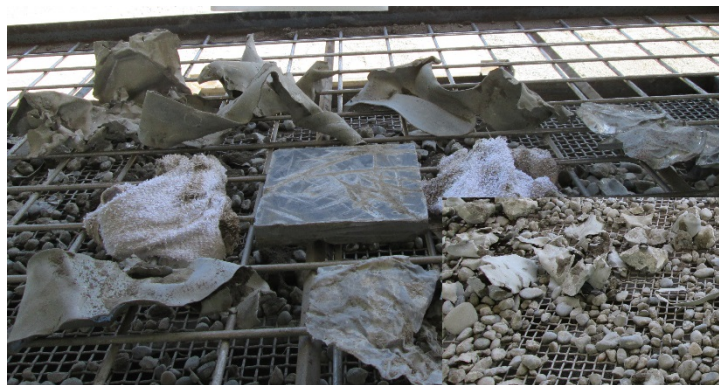
Size reduction and stabilization was performed using a Bauer BG-30 drilling machine and a specially designed auger in order to neutralize hazards contained in the VPUs in situ, thereby minimizing any potential for exposure of personnel or release to the environment. The process was designed to breach all containers in order to ensure that no free liquids and no voids are present, and to size reduce all material within the over-casing to facilitate removal. Fig. 8 shows the typical size of the retrieved materials after augering was completed. For reference the larger screening material is 7.6 cm x 7.6 cm (3-inch x 3-inch) and the smaller screening material used was 1.3 cm x 1.3 cm (½-inch x ½-inch) in size. As can be seen in Fig. 7 the augured material was greatly size reduced and no unopened containers or free liquids were present.

Fig. 7. Typical conditions of item after being augured.

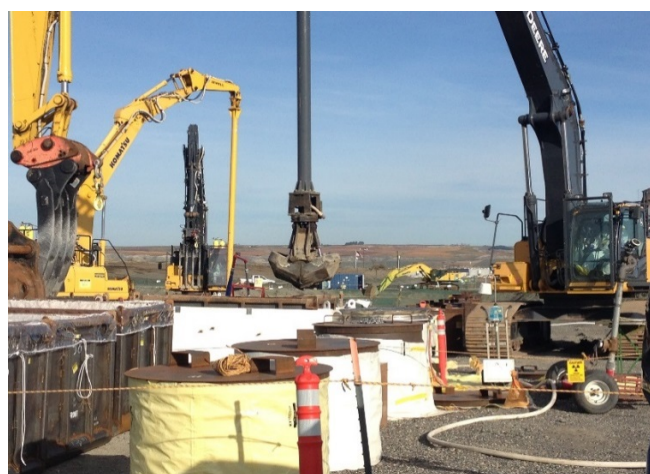
After the auguring was completed a modified excavator with an extension tube and specially designed clamshell was used to retrieve the material from the overcasing (Fig. 10). As the waste material was removed it was loaded into metal waste boxes that were filled to the appropriate level to allow for the addition of a stabilizing grout. A low strength grout was added to encapsulate any possible lead and to stabilize the waste in general. The waste material and grout were mixed using a specially designed mix rake attached to an excavator (Fig. 11). Once the waste/grout mixture solidified, the waste boxes were loaded into an additional waste container and shipped offsite for disposal.

Fig. 10. VPU Waste Retrieval Clamshell.

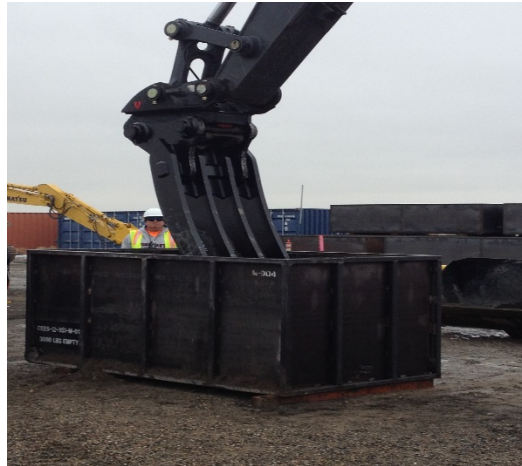
Fig. 11. Grout/Waste Mixing.

- After the waste was placed into the metal waste boxes a low strength grout was added and the grout and waste material was mixed using a large rake device attached to an excavator.
