## **Hanford's Double-Shell Tank AY-102 Recovery Project – 17416**

### **ABSTRACT**

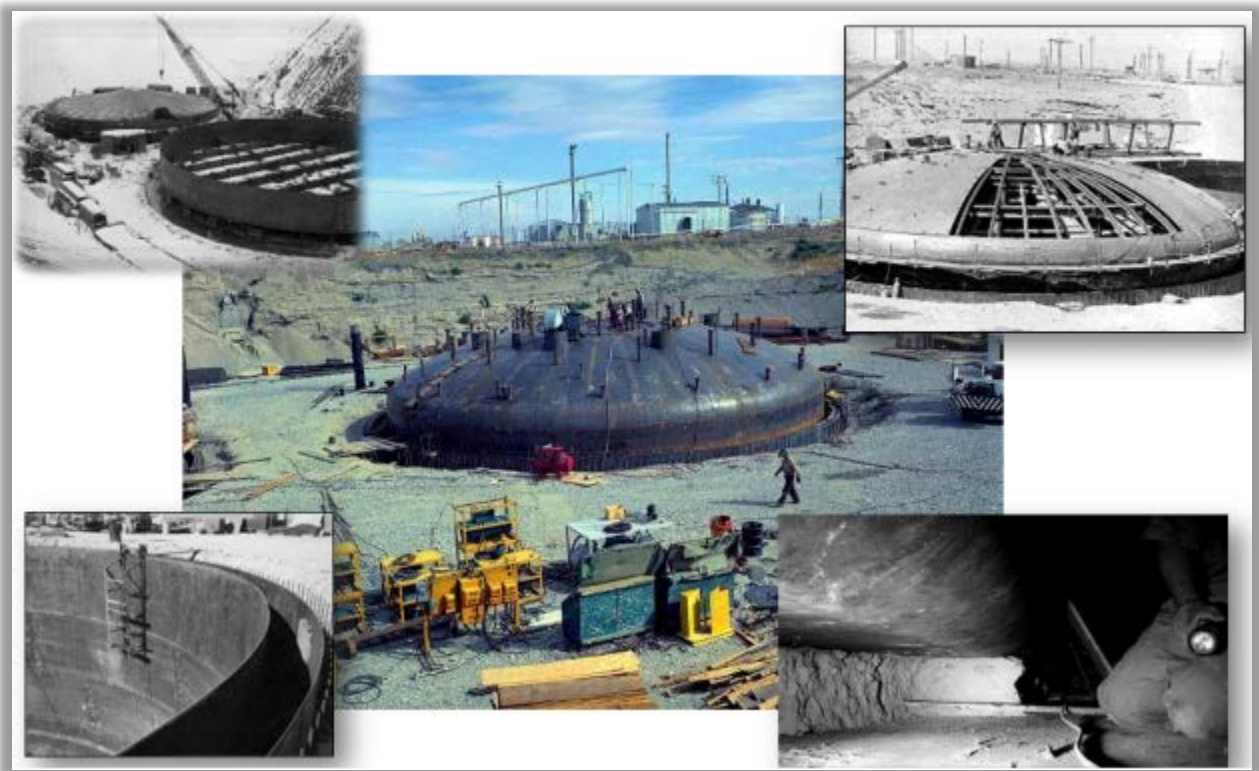
Tank 241-AY-102 (AY-102) was the first of what would ultimately be 28 high level waste storage Double-Shell Tanks (DSTs) constructed at the Hanford Site. Construction completed in 1970 and the tank was put into service in 1971 with a designed service life of 40 years. The tank consists of a 22.9-meter diameter carbon steel primary liner with a nominal storage capacity of 3,800,000 liters inside a 24.4-meter diameter carbon steel secondary liner, which is encased by a reinforced concrete shell. The primary tank is supported by refractory concrete on the floor of the secondary liner. An annular space of 0.8 meters is formed between the primary

tank and secondary liner. Figure 1 shows AY-102 at various stages during construction.

**Figure 1. AY-102 Tank Construction**

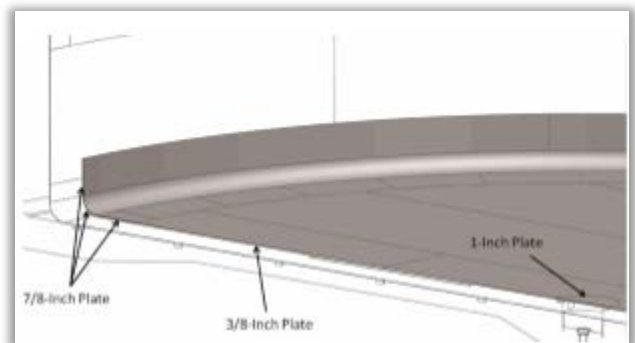
Tank AY-102 has a flat primary tank bottom, which differs from the dished bottom single-shell tanks that have been retrieved previously. The tank bottom is composed of primarily 9.5-millimeter thick steel plate, with the exception of a 1.2-meter diameter, 25.4-millimeter thick plate located at the center and 22.2-millimeter thick plate located along the perimeter of the tank bottom joined to the tank bottom knuckle. A small, vertical section of 22.2-millimeter thick steel plate, referred to as the bottom transition plate, is also joined to the bottom knuckle (Figure 2).

**Figure 2. Primary Tank Bottom and Knuckle**

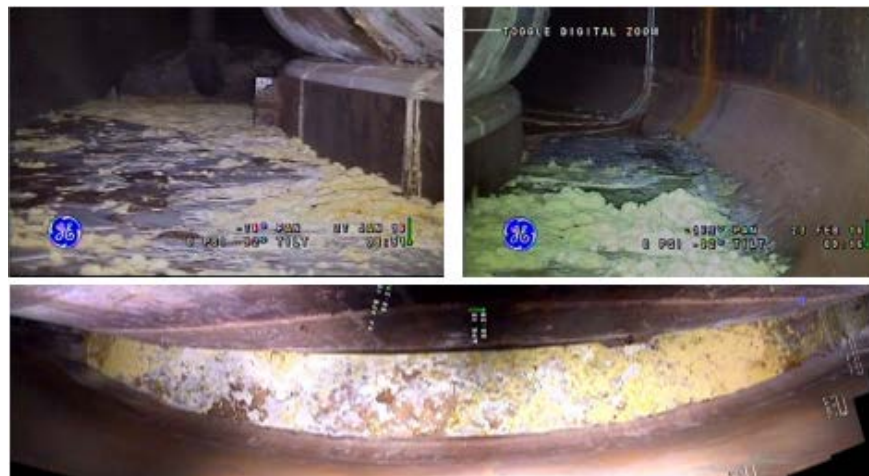
In August 2012, an accumulation of material was discovered at two locations on the floor of the annulus that separates the primary tank from the secondary liner, and at a third location on the primary tank dome above the waterline. A formal leak assessment team was established to review the construction and operating histories, and determine whether the material found on the annulus floor resulted from a primary tank leak. There was consensus agreement among the leak assessment team members that the radioactive material on the annulus floor of Tank AY-102 was the result of waste leaking from a breach in the bottom of the primary tank. The probable leak cause was identified as corrosion at high temperatures in a tank whose waste containment margins had been reduced by construction difficulties. The comprehensive review of construction history highlighted a number of issues that were encountered and may have played a role in the tank failure, including trial-and-error repairs that left the primary tank bottom with residual stresses [2]. Of particular note, the primary tank floor plate weld rejection rate was 36 percent and weld maps showed some area being reworked as many as four times before finally passing radiography examination. As a result, the AY-102 leak integrity classification was changed from "sound" to "assumed leaker." Figure 4 shows images inside the annulus of AY-102 from in-tank inspections performed in 2016 prior to the start of retrieval operations.

**Figure 4. AY-102 Annulus Waste Accumulation<sup>1</sup>**

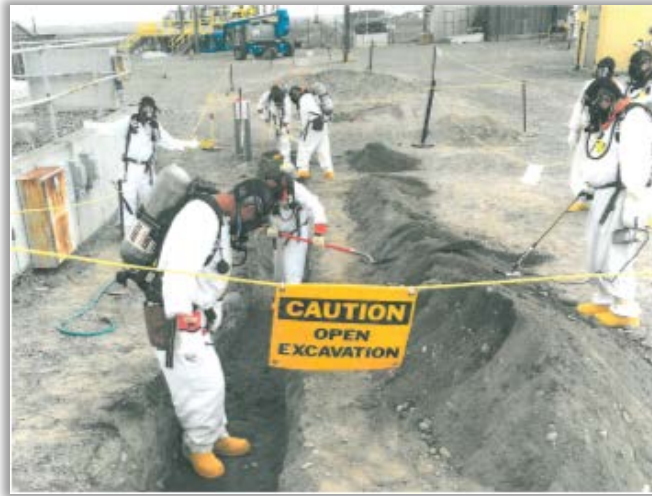
The selection of AP-102, located in the 241-AP tank farm, required installation of over 1,200 linear meters of above-ground transfer line piping. To traverse the distance between the two tanks, installation work was required near the 241-AX tank farm where heavy construction work was underway to prepare for the future retrieval of the 241-AX tanks, which required a significant integration effort to properly prioritize and safely conduct field work. Figure 6 shows a work crew digging a trench through the 241-AX tank farm for transfer line installation.

**Figure 6. Trench Digging through 241-AX Tank Farm**

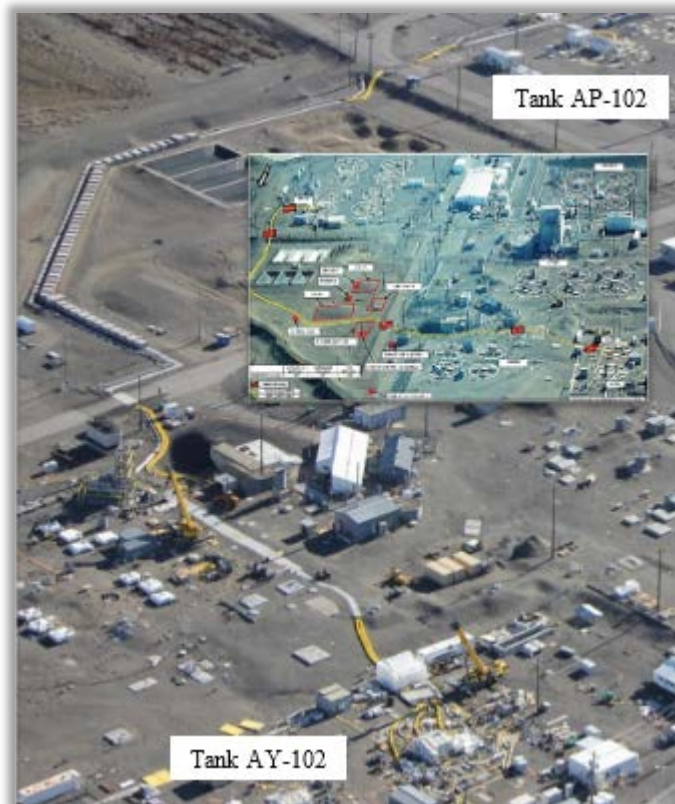
Figure 8 shows the original conceptual view the design team developed for transfer line routing, overlaid on an actual aerial photo of the completed installation.

Figure 8. Conceptual Sketch and Aerial Photo of the Waste Transfer Route

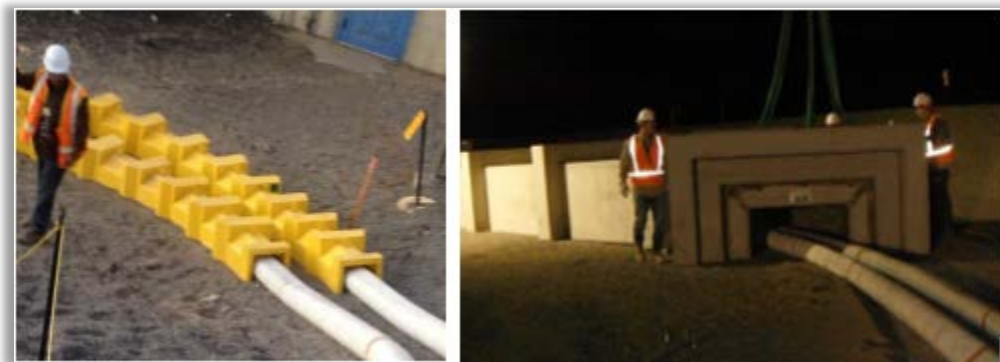
Where normal vehicle access would be required and digging was tolerable, the transfer line was buried to a depth of approximately 30 centimeters and covered with multiple 5-8-centimeter thick steel plates, resulting in a total steel thickness of 10-15 centimeters. Where crane access was required, the transfer lines were buried, but the steel plates were required to span the trench at a greater distance to allow for the higher loads imparted by cranes. In total, over 354,000 kilograms of steel plate were procured and installed along the transfer route.

Where excavation was not feasible, hose barns were used to shield the transfer line. Lead-Antimony hose barns have been used at the Hanford Site for many years, but the higher dose rate required 5-centimeter thick units in favor of the previous 2.5-centimeter units. To accommodate the new units, the specification required modification and the vendor had to make changes in their fabrication, packing, and shipping processes. Approximately 600 5-centimeter Lead-Antimony hose barns were used to shield the transfer line. The inter-farm area between 241-AY and 241-AP farms utilized concrete hose barns as a less expensive alternative to excavation or Lead-Antimony shielding. Approximately 53 concrete hose barns measuring 0.6-meters thick and 3-meters long and weighing roughly 20,000 kilograms each were procured and installed. The logistics of contract placement, fabrication, shipping, receipt/inspection, and off-loading of these components proved challenging, but in the end, were an effective alternative. Figure 9 shows installation of the hose barns along the slurry and supernate transfer lines.

**Figure 9. Lead-Antimony (left) and Concrete (right) Transfer Line Shielding Installation**

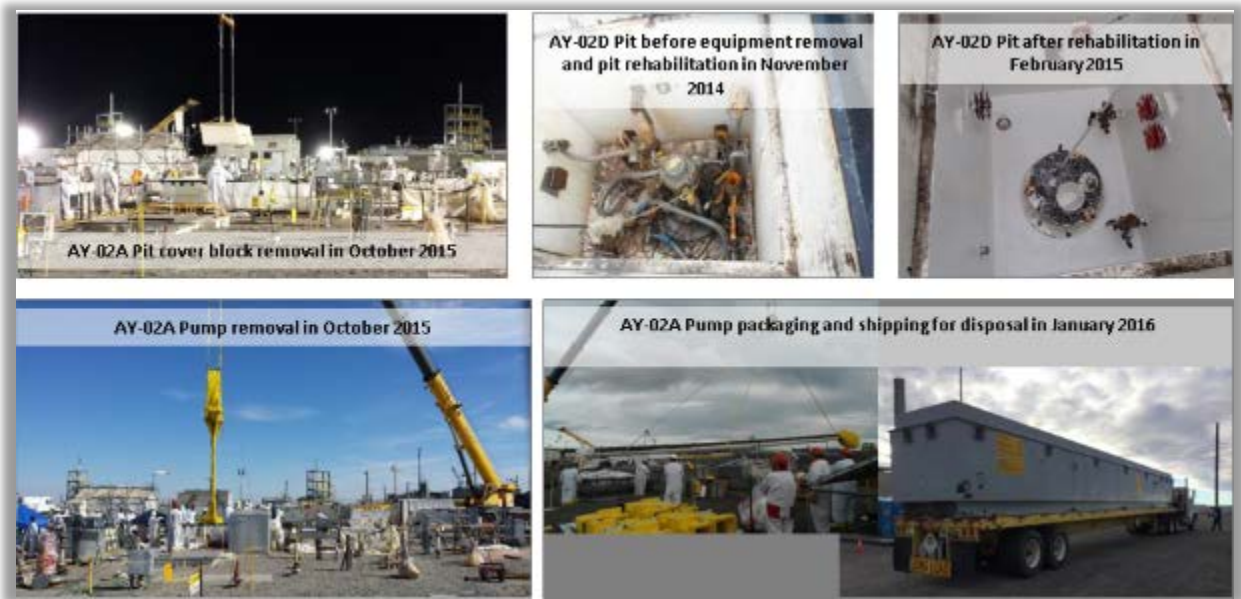
A large amount of tank preparation and infrastructure upgrade work was required on both tanks AY-102 and AP-102. The construction team had to perform numerous high-risk work evolutions, including 7 pit entries and refurbishment of 5 of those pits and removal of long-length equipment, which included 5 obsolete pumps in contact with tank waste. This work was necessary prior to installing new retrieval and transfer equipment. Some of the work performed is shown in Figure 10.

**Figure 10. Tanks AY-102 and AP-102 Equipment Removal and Pit Refurbishment**

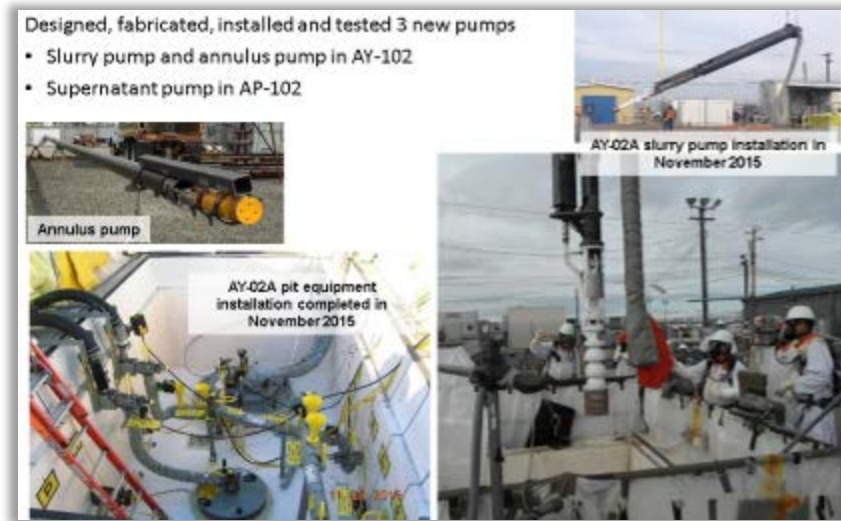
After the preparation work was completed, installation of the long-length equipment in the refurbished pits also proved challenging. In total, two pump assemblies were installed in the AY-102 and AP-102 primary tank pits, one pump assembly was installed in the annulus of AY-102, and six sluicers were installed, including the original two Sluice Cannons for the first phase of operations and the four Extended Reach Sluicer replacements, which required subsequent removal of the Sluice Cannons. In addition, the pump pits required installation of transfer line piping and valves to direct the flow of waste. Figure 11 highlights some of the installation work performed.

**Figure 11. Equipment Installation**

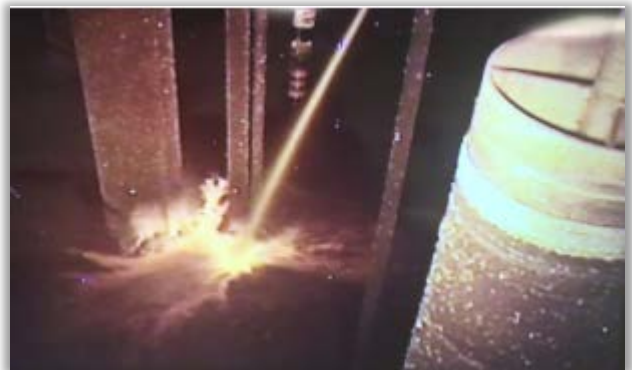
Through all of the challenges encountered, the project persevered and retrieval operations were initiated on March 3, 2016. Retrieval operations began removal of the AY-102 supernate waste. Approximately 2,086,000 liters of supernate waste were transferred from AY-102 to Tank 241-AW-105. The transfer was completed on March 7 through the Double-Shell Tank piping system using the newly installed retrieval slurry pump in AY-102.

**Figure 14. AY-102 Sluicing Operations**

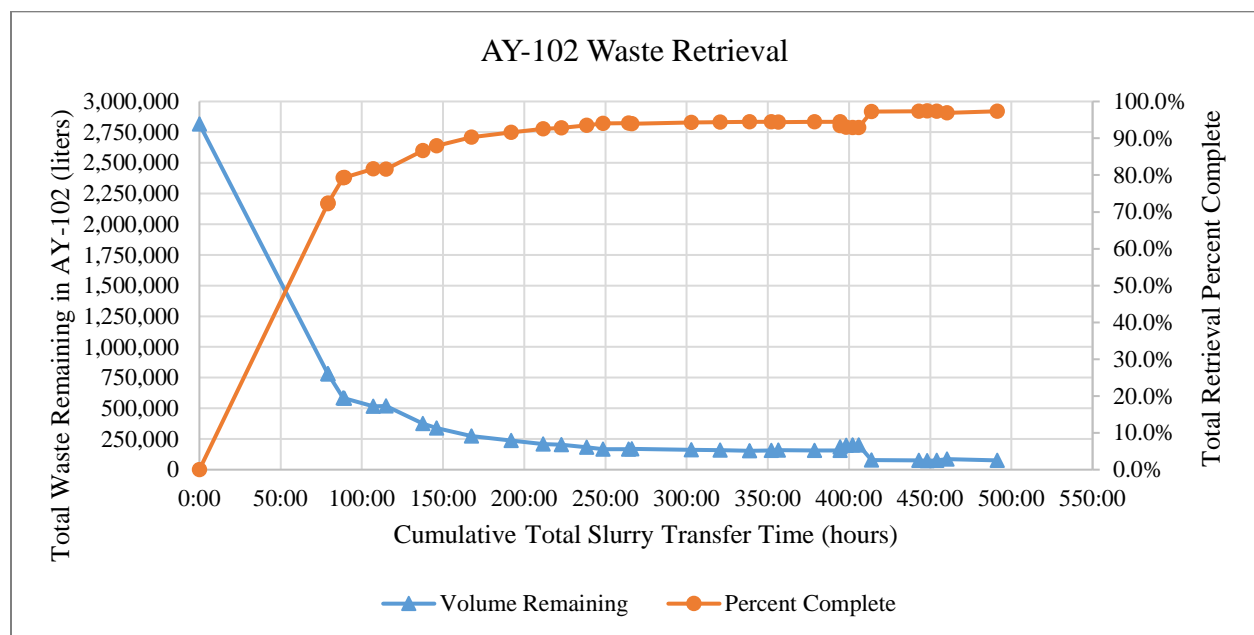
The Sluice Cannons removed an estimated 428,000 liters of sludge and interstitial liquid waste, which represents removal of 75% of the original sludge and interstitial liquid volume. In total, approximately 2,661,000 liters of waste were removed from AY-102 during the initial retrieval phase, representing removal of 95% of the original waste volume, as shown graphically in Figure 15. At the completion of operations with the Sluice Cannons the total remaining waste in AY-102 was estimated at approximately 155,000 liters, which included waste accumulation in the annulus [7].

The field work to install and test the Extended Reach Sluicers completed in October 2016 and retrieval operations resumed December 8, 2016. As of December 31, 2016 the Extended Reach Sluicers had operated for over 100 hours and updated residual waste volume measurements indicated an estimated 75,000 liters of waste remained in the primary tank and annulus. Based on the flat-bottom design of the tank and the suction-break elevation for the slurry pump, it is anticipated that at least 30,000 liters of total waste will remain in the tank at the conclusion of operations.

**Figure 15. AY-102 Waste Retrieval Progress**

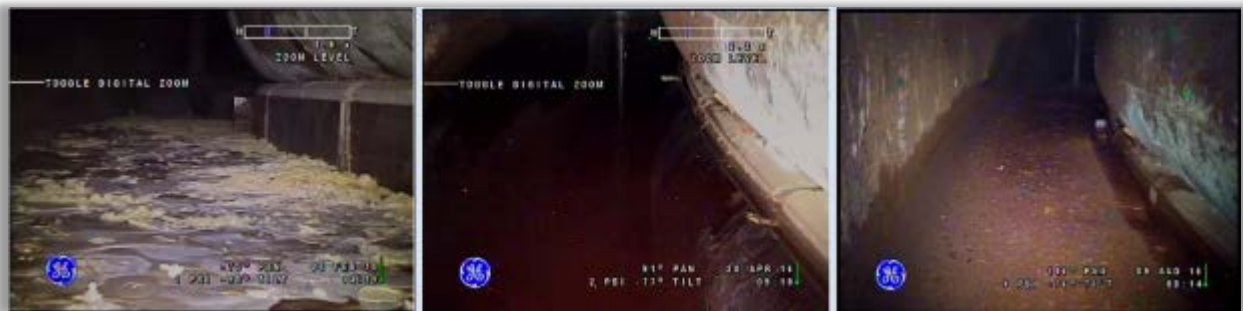
During the operational shutdown to support installation of the Extended Reach Sluicer equipment, the remaining visible liquid waste heel in the annulus evaporated, exposing a layer of solid material. The solid material was sampled and is believed to consist of a mixture of sludge waste and refractory, but the sample analysis has not been completed. Figure 16 shows the progression of the annulus waste condition as observed during annulus video inspections through Riser 87. The left image shows the pre-retrieval condition on February 3, 2016, the middle image shows the condition following the initial liquid leak to the annulus as of April 20, 2016, and the right image shows the recent condition with solid material exposed as of August 9, 2016.

**Figure 16. Annulus Waste Condition**

Following suspension of operations, the annulus waste reached a maximum level above the refractory air slots to approximately 21.6 centimeters before gradually decreasing. The gradual decrease was attributed to absorption of liquid waste into the refractory and evaporation [8]. The annulus pumping system became operational on April 21, 2016 and was used periodically to remove liquid accumulation in the annulus during retrieval operations. In total, the annulus liquid level was pumped down 15 times during the first sluicing campaign.
