Challenges to Collection of High Quality Samples of Saltstone -17468

F. Malcolm Smith
Savannah River Remediation, LLC
Building 705-1C, Aiken, SC 29808

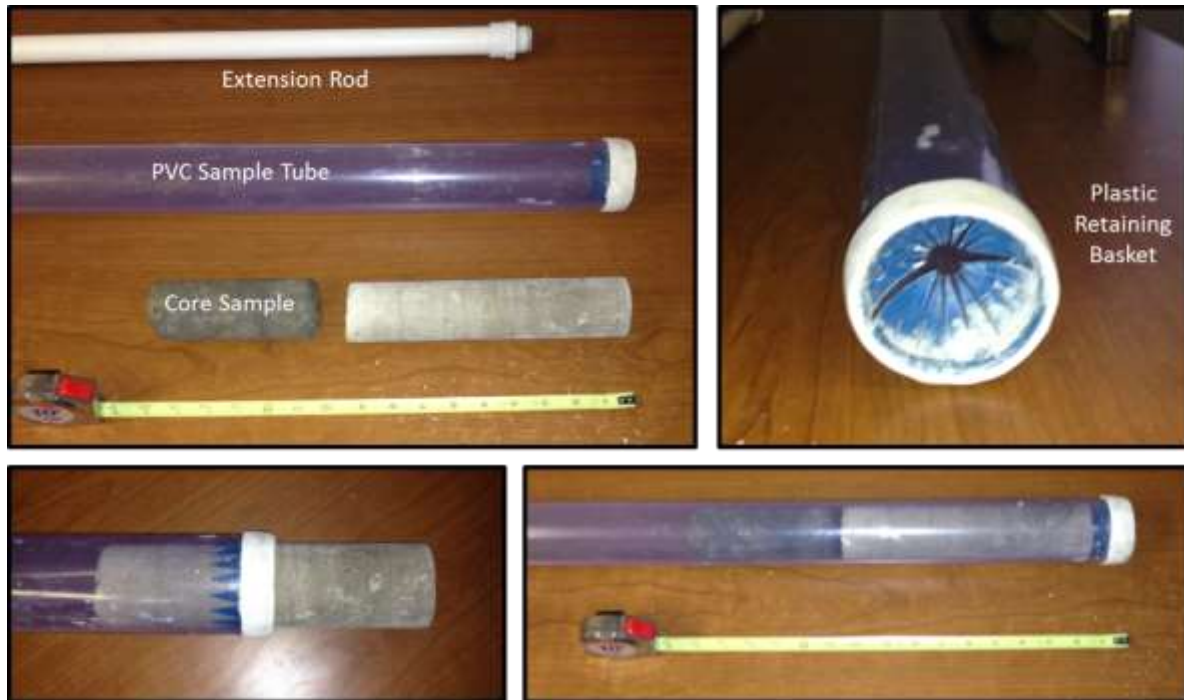
Fig. 2. Clear PVC Extraction Tube

Two additional steel plates were fabricated with 10 cm slots to install around over the second camera port where the drill string was inserted. Extraction tubes (Figure 2) consisting of clear PVC tubes and a toothed basket were fabricated to insert into the grout and extract the intact cores after they had been drilled.

Special core extraction tools were fabricated to extract core material remaining in the holes after drilling. Core extraction tools were developed and refined through mock-up activities conducted prior to field execution. Each tube was made of clear polyvinyl chloride (PVC). A glued coupling was fitted on the top of the tube so that threaded extension rods could be installed to insert and remove the tube from the hole. Another thinned-glued coupling and a "toothed" basket was installed on the bottom end of the tube to capture sample material. During mock-up the misalignment of drilled core material in the drill hole was encountered. To increase the probability of successfully retrieving core material, a glued coupling with a hand crafted "scoop" was fitted at the bottom end of the tube. The "scoop" was used to assist in centering cores relative to the extraction tube. Each extraction tube contained drilled drain holes so water from the drilling did not remain in the tube after extraction. Rotating the extraction tube with the "scoop" design would enhance the ability to align core material and provide a greater probability of successful core extraction.

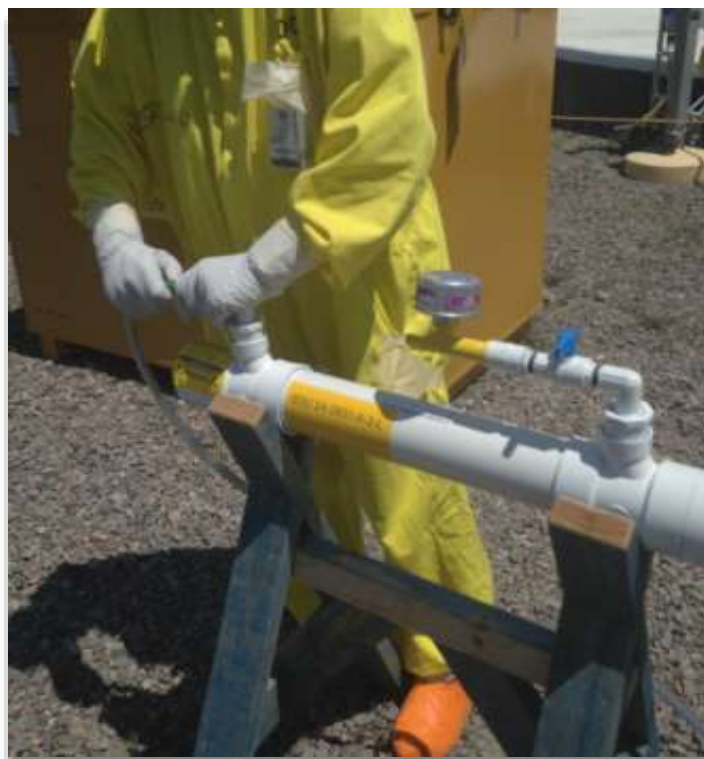
Fig. 3. Inert Transport Tube.

Special inerting tubes (Figure 3) were fabricated to ensure that the samples were maintained in an oxygen- free environment after extraction and throughout transportation to Savannah River National Laboratory (SRNL) for eventual storage in an anaerobic chamber. Inerting tubes were approximately 96.5 cm length with the main tube body being 7.6 cm diameter PVC. A quick disconnect was added to one tube end to connect the nitrogen gas supply. A purge valve fitted with a high-efficiency particulate air (HEPA) filter was added at the opposite end of the tube.

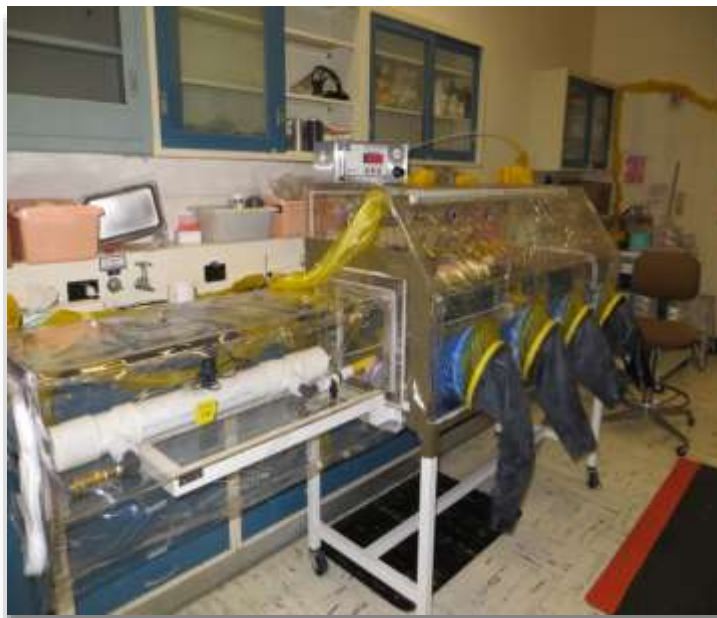
Fig. 4. Anaerobic Chamber.

A special anaerobic chamber (Figure 4) was fabricated to receive, store, and prepare the samples for analysis in an inert environment at SRNL. The chamber contained a transfer chamber to introduce samples to the main anaerobic chamber, a main anaerobic chamber equipped with gloves, and an integrated oxygen monitoring/nitrogen purge system.

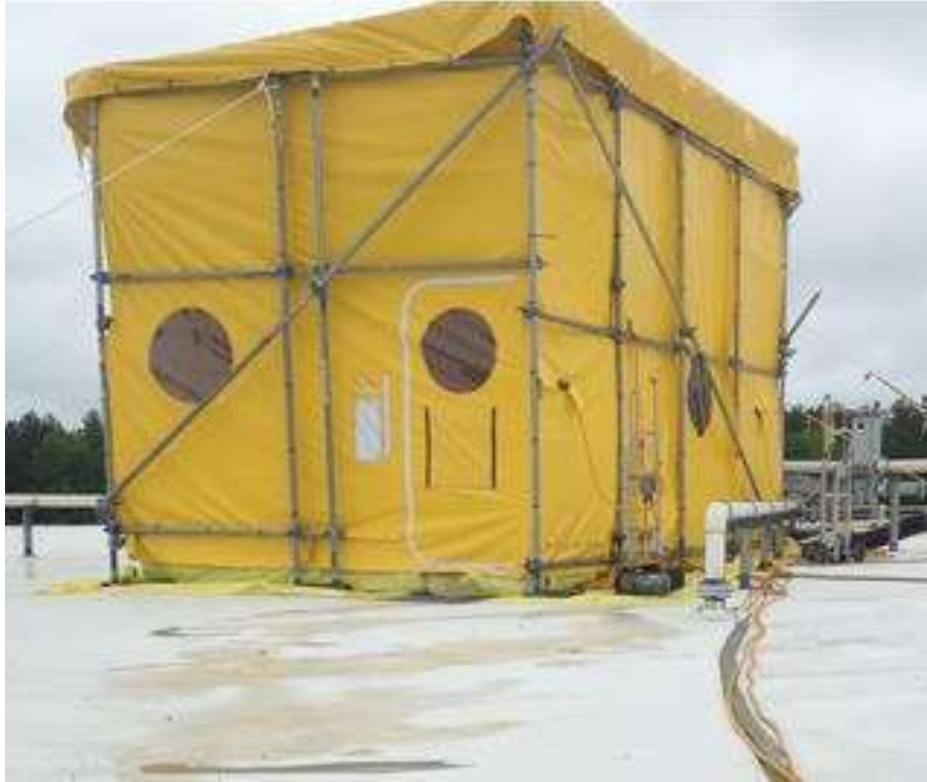
Fig. 5. Contamination Control Hut on SDU cell 2A.

To conduct core drill activities in a contaminated environment, containment huts were shop fabricated and installed over each camera port (Figure 5). Each hut was approximately 4.57 meter by 4.57 meter by 3.66 meter high with an adjacent air lock. Temporary ventilation was added to each hut while in use as a precaution in case airborne concentrations exceeded radiological work permit (RWP) and IH levels.

SDUs normally have only passive ventilation. Supplemental active ventilation was installed to ventilate the cell vapor space, induce negative pressure in the containment huts, and reduce or eliminate both airborne radiological contamination as well as chemical contaminants of concern.

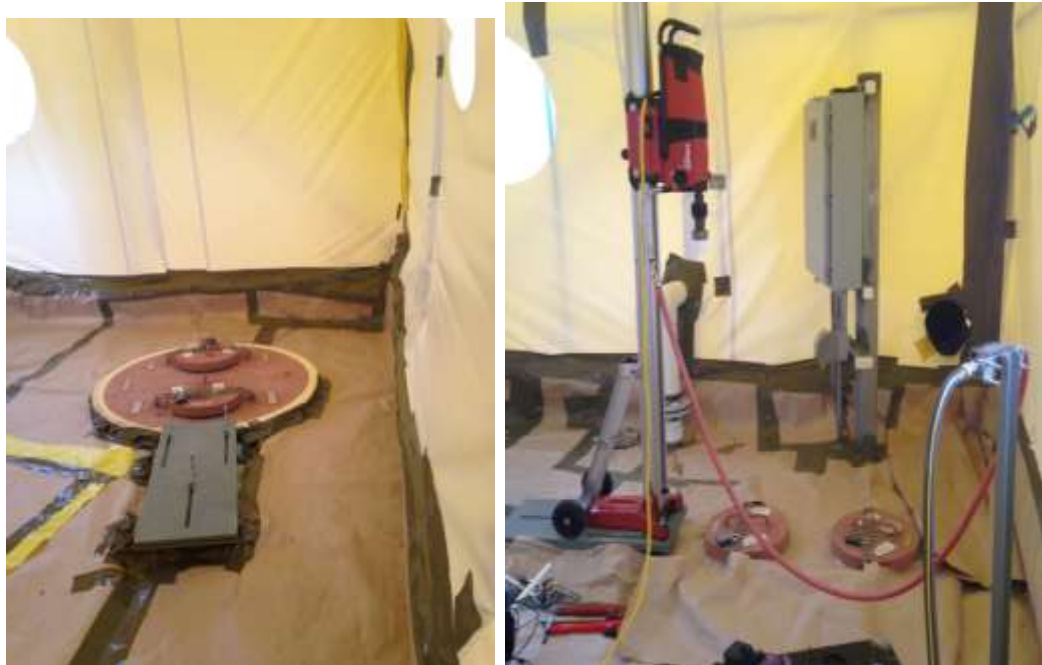
Fig. 6. Slotted mounting plate at an SDU 2A camera port (left) with drill rig installed (right).

To anchor the drill equipment to the concrete cell roof, anchor bolts were installed in the roof at the three camera ports. A shop-fabricated drill mounting platform (Figure 6) was installed over the anchor bolts, securing the drill rig to a stable foundation. Shims were also used to enhance the ability to lock the movable drill mounting plate in place during drilling operation.

To mitigate drill string vibration and allow repositioning of the drill equipment anchor, the drill equipment to the concrete cell roof, anchor bolts were installed in the roof at the three camera ports. A shop-fabricated drill mounting platform was installed over the anchor bolts, securing the drill rig to a stable foundation. Commercially available collapsible dryer vent was used as a drip shield around the drill string. This was critical in preventing water from saturating personnel protective clothing that would compromise its protective ability.
