# The Legacy of Taiwan Lanyu LLW Interim Storage Site- 17491

Hongnian Jow, PhD Jow International, Kirkland, WA, USA

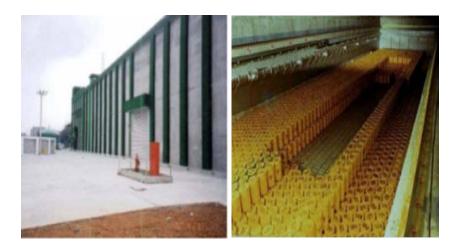
Fig. 2: Left, Building of a Taipower Indoor LLW Storage Facility; Right, Inside of a Taipower Indoor LLW Storage Facility

After the shipment of LLW waste to the Lanyu LLW storage facility began in May 1982, the local aboriginal tribe realized that the facility was not a fish cannery, rather a LLW storage facility, and began the protest against the LLW storage facility. The LLW shipment was ended in June 1995 after a strong protest from the local aboriginal people. Since June 1995, Taiwan LLW has been temporarily stored at the indoor storage facilities at the three Taipower NPPs and the INER. Figure 2 below shows a LLW indoor storage facility at a Taipower NPP.

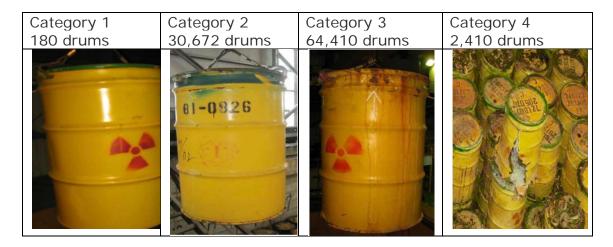
Taipower began the inspection and repackaging of the Lanyu LLW drums in December 2007 and this activity was completed in November 2011. During the inspection and repackaging, there were four categories of drum corrosion status identified depending on the corrosion situations of the waste drums. Figure 5 below shows the photos of four different categories of corrosion status found during the inspection.

Fig. 5: Four Different Categories of 97,672 Lanyu LLW Drums Before Rectification [1]

The following rectifications were taken for the four different categories of drum corrosion status:

<u>Category 1</u>: No sign of corrosion and paint in good condition: no rectification was needed and drums were to the trenches.

<u>Category 2</u>: LLW drum containers show some peeling paint and minor rust, but no sign of corrosion. After repainting, drums were returned to the trenches.

<u>Category 3</u>: LLW drums show severe corrosion; however, the solidified waste inside remained intact. Placed those drums in the new 0.914 m by 1.219 m (3 feet by 4 feet) galvanized steel containers and the containers were returned to the trenches.

<u>Category 4</u>: LLW drums were broken and the solidified waste inside also broken loose. The LLW loose pieces were re-solidified on site at the Lanyu LLW Storage Facility and placed in new 55-gallon galvanized steel drums and the new drums were returned to the trenches.

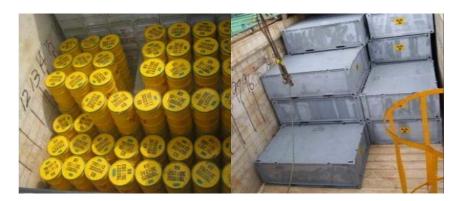
Fig. 6: Left, 55-gallon drums In a Storage Trench; Right, 0.914 m by 1.219 m (3 feet by 4 feet) Galvanized Steel Containers in a Storage Trench, as of November 2011

Figure 6 shows typical LLW drums in a trench at the Lanyu LLW storage facility after the completion of rectification in November 2011 [4].
