Legacy Sludge Removal and Treatment From Y-12 Storage Tank -17585

Pat Hopper, PMP*, Joseph Hawk, PE*, Mark Kent**

*Atkins Nuclear Secured, LLC

ABSTRACT

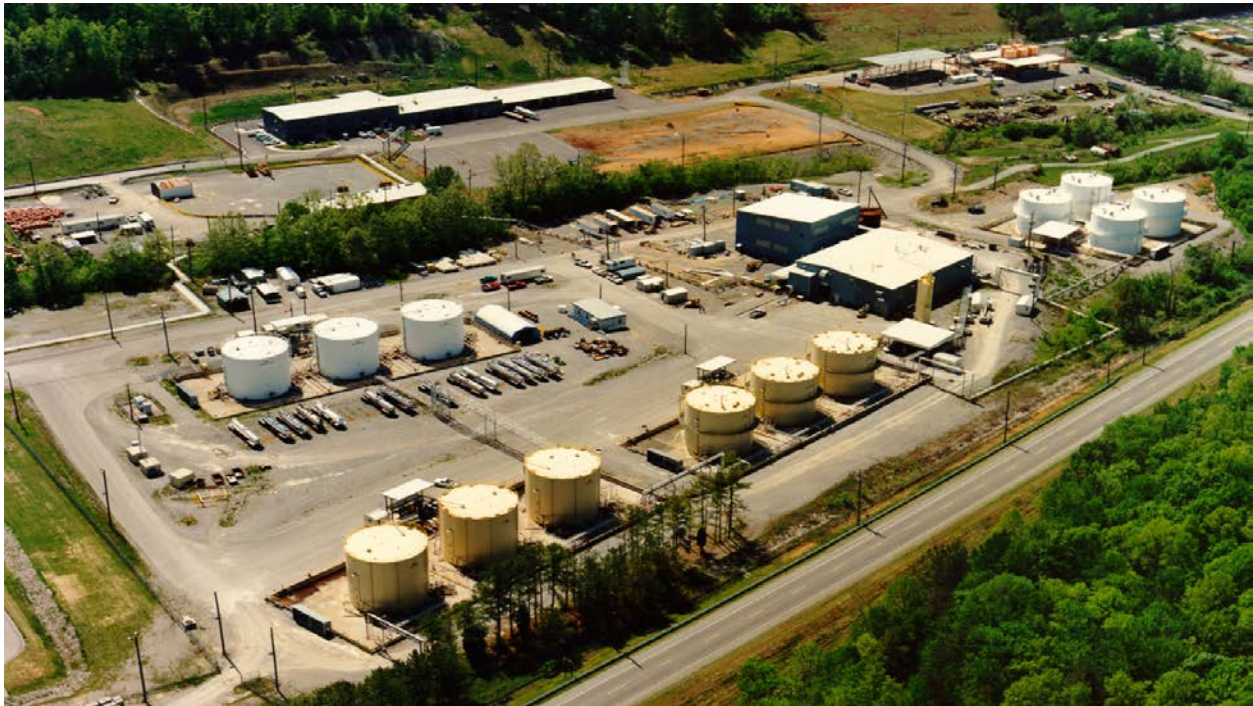
Figure 1. West End Treatment Facility (WETF) and West Tank Farm (WTF).

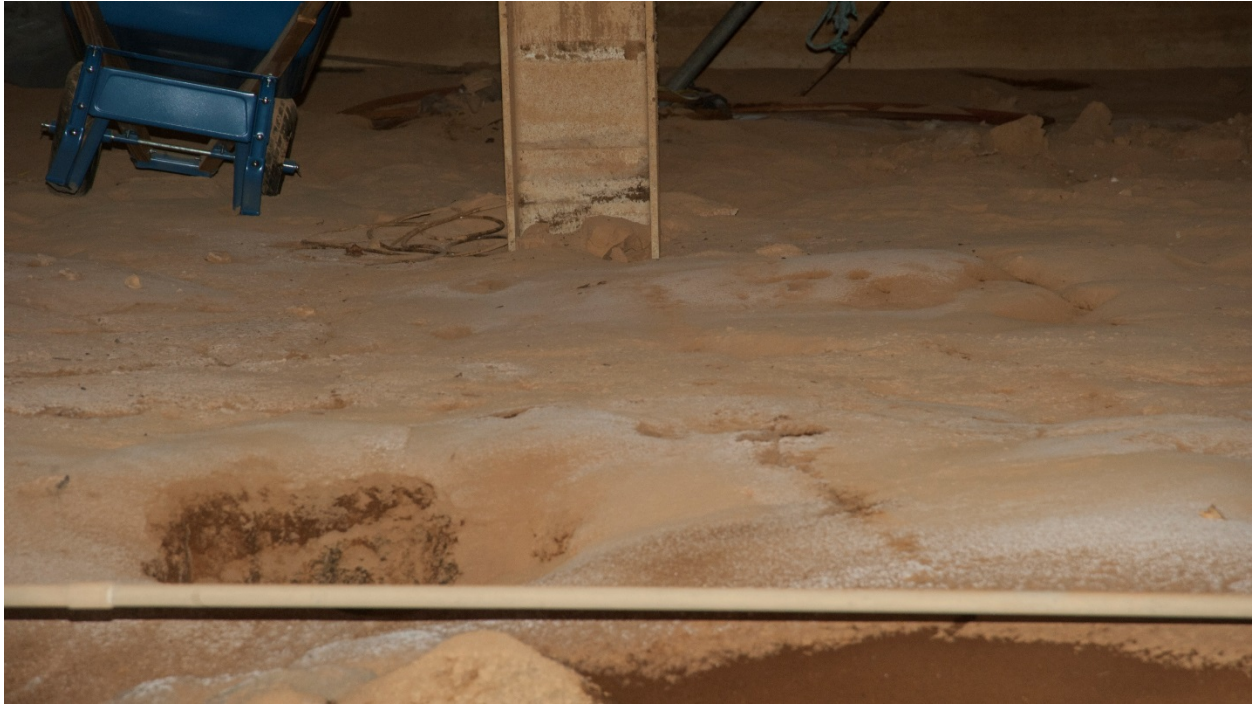
- Work completed by Atkins Nuclear Secured, LLC Liquid Waste Management Services subcontract with Consolidated Nuclear Security LLC
- Legacy sludge from past wastewater treatment operations
- Last transfer into F10 tank was in April 2003
- Approximately 3,000ft³ of sludge in F10 tank
- Sludge concentrated in uranium and heavy metals and designated mixed waste (LLW and RCRA toxicity characteristic)
- F10 Tank has 500,000 gallon capacity, and is approximately 48ft diameter x 40ft height.

Figure 2. Inside View of Tank Prior to Removal of Sludge.

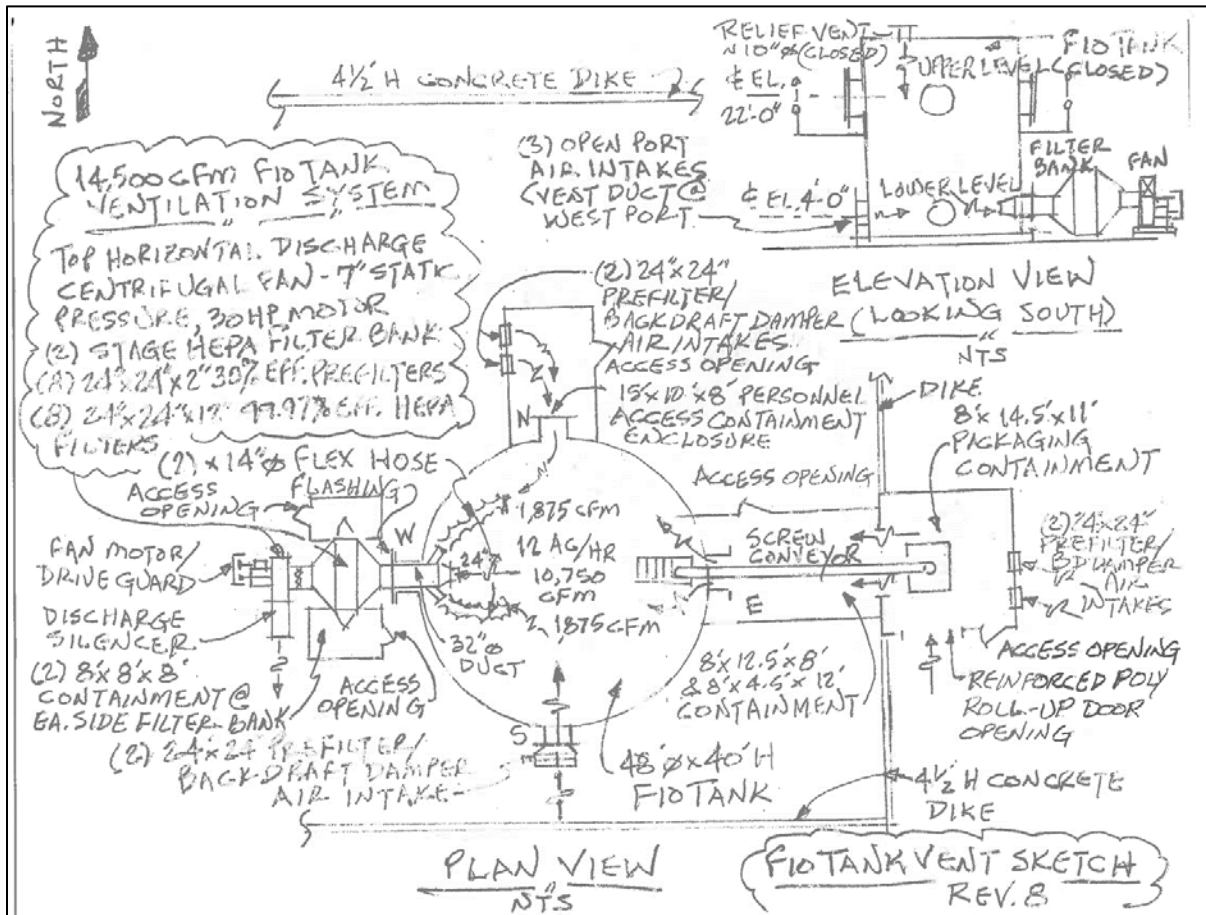
Plan View of Ventilation System and Containment Structures

- Conveyor system minimum feed rate = 100ft³/hour
- Ventilation system minimum air change requirement = 12 air changes/hour in tank and each of the containment structures
- Bidders list included local vendors with extensive material handling and ventilation experience
- Vendor technical representatives provided input for equipment specifications
- Fully assembled conveyor system was successfully pre-tested at fabricator facility before being delivered to project site
- Single ventilation system design with strategically placed air intake structures – Air intake structures included volume control damper, backflow damper, and filter material
- Ventilation system was successfully air flow tested, balanced, and DOP tested after installation

Figure 3. Plan View of Ventilation System and Containment Structures.

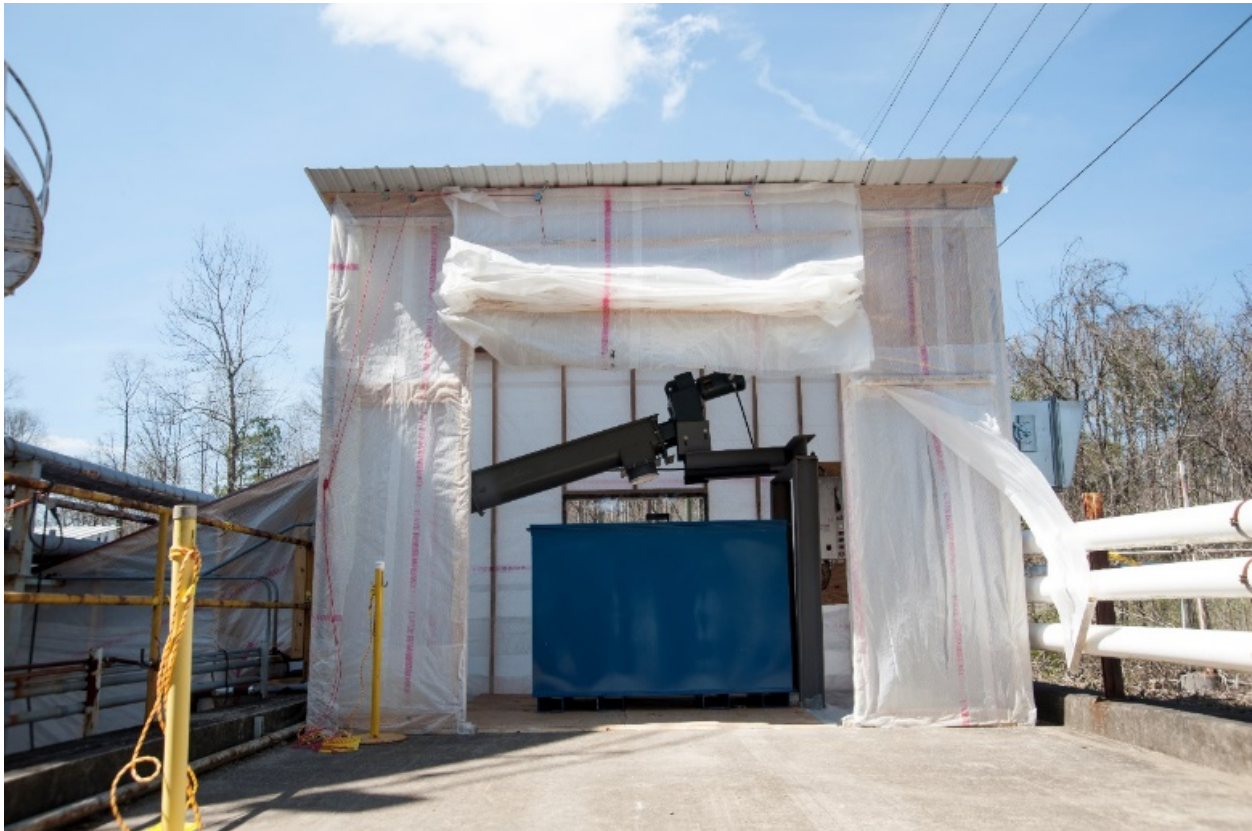
Figure 4. Box Containment Structure Showing Auger Discharge Shoot.

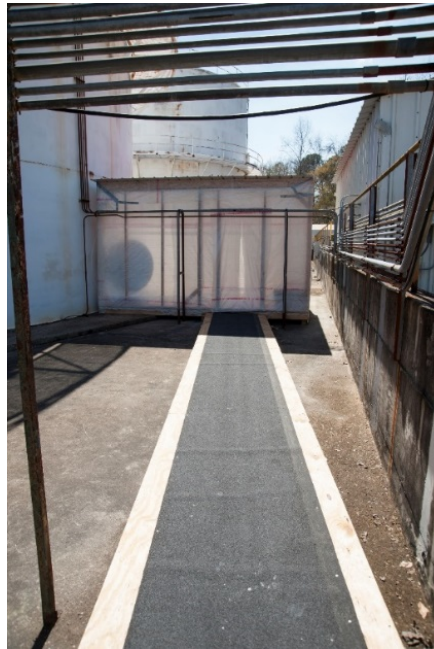
Figure 5. Elevated Walkway to Boundary Control Station to Allow Work When Dike Contained Water.

- The fully assembled conveyor system was lifted, at its designed incline, under existing process piping and utilities, into a 3ft diameter tank manway
- Power outage required due to close proximity of crane and load to overhead high voltage line
- Major ventilation system components, including the fan and HEPA filter bank structure, were lifted into the tank dike
- Containment structures were built to enclose the packaging area, conveyor system, ingress/egress location, and ventilation system HEPA filter bank
- Containment structures constructed using fire retardant poly sheeting and wood to meet fire protection requirements
- Elevated walkways and platforms were constructed to keep working surfaces above water after major precipitation events

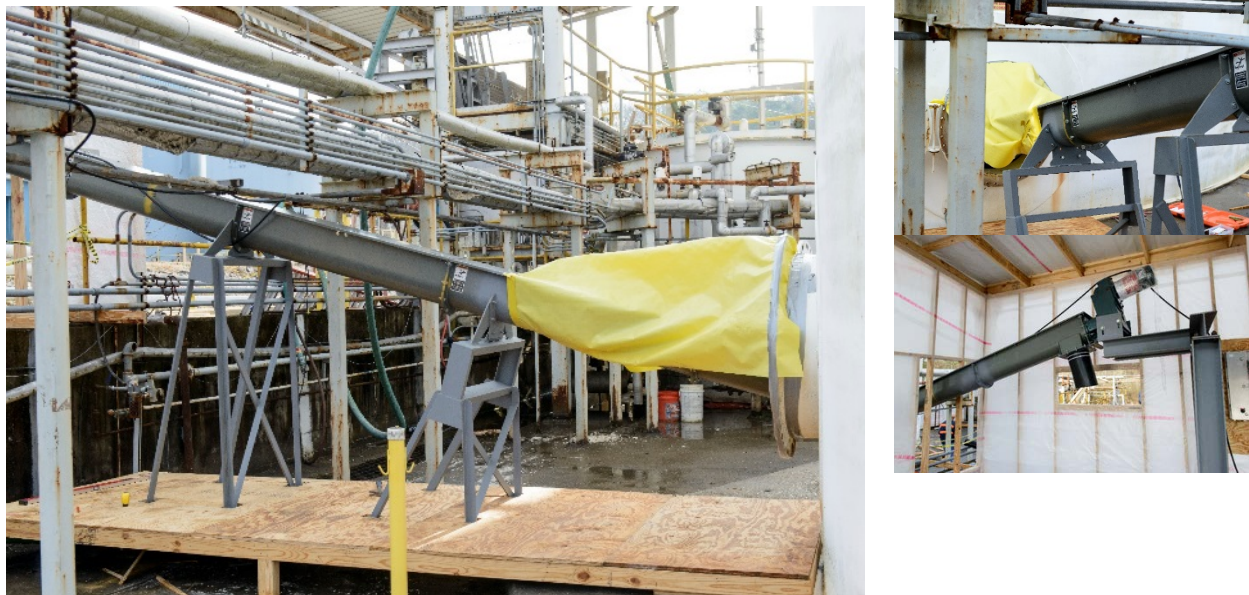
Auger Conveyor System Construction

Figure 6. Construction of Sludge Auger Conveyor System.

- Manual removal of sludge, with conveyance to packaging area using a 35ft long screw conveyor system with 5hp motor, was selected due to its simplicity and support of the ATLC operators
- Magnesium oxide was added to the sludge inside the tank prior to placement into screw auger to stabilize cadmium and eliminate toxicity characteristic
- A 14,500cfm top horizontal discharge centrifugal fan with 7in static pressure and 30Hp motor used to control airborne contamination

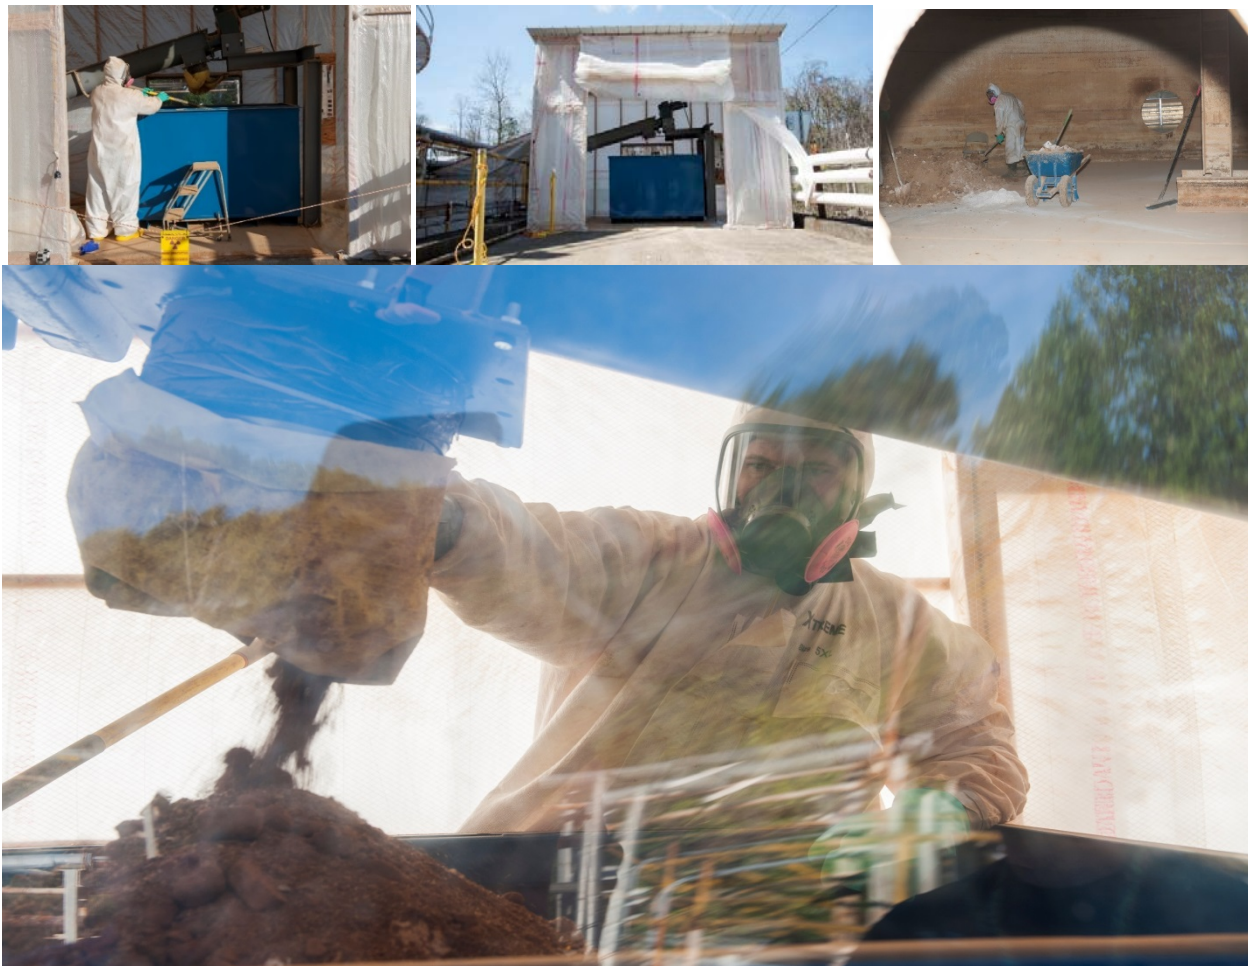
Figure 7. Sludge Removal Inside Tank and Box Filling Operations.

- Conservative production rates were built into the baseline schedule to account for worker safety considerations inside tank such as confined space, heat stress, ergonomics, respirator use, limited lighting, and shorter stay times.
- After implementation of process improvements during 1st 5 boxes, production rate increased from 0.63 boxes per day to 1.4 boxes per day.
- During initial removal activities, the sludge was clogging the screw conveyor near the center hanger bearing, causing the system to be periodically shut down for cleaning.
- Process improvements included further size reduction and stockpiling of sludge inside tank, amending the sludge with polymer, and controlling the rate of feed material into the conveyor system to reduce clogging of the screw conveyor.

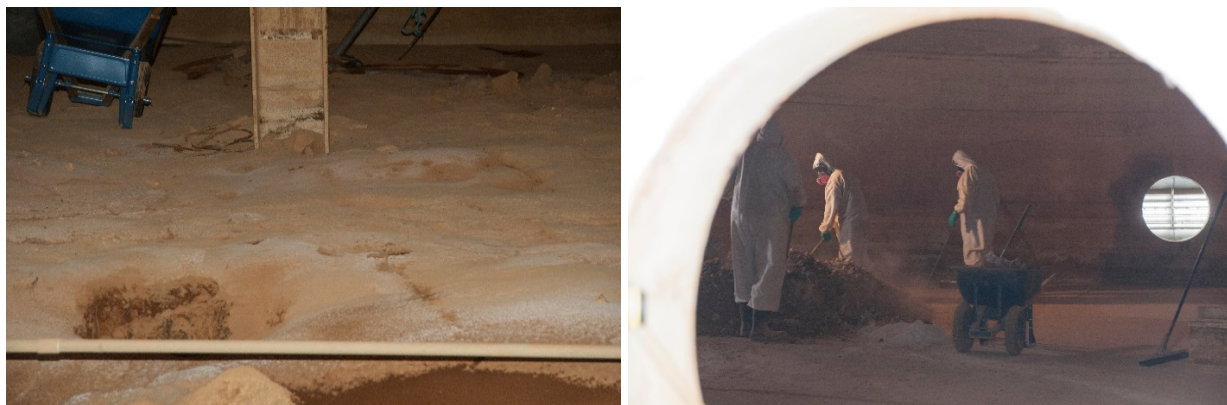
Figure 8. Before and After Sludge Removal Inside Tank.

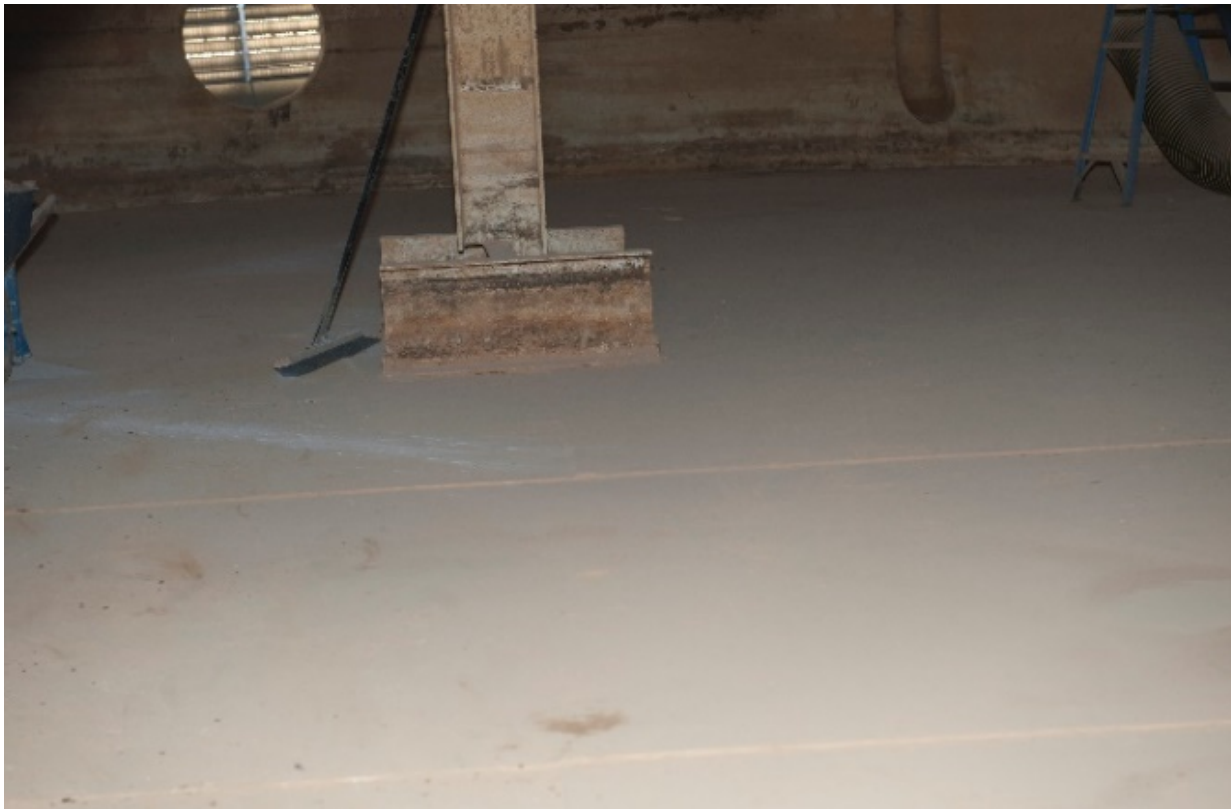
Figure 9. Tank Inside Surface After Sludge Removal and Ready for Structural Integrity Inspection.
