Waste Management Symposia 2017

# Current Status and Challenges at Fukushima Daiichi Decontamination and Decommissioning

Naohiro MASUDA

President of Fukushima Daiichi Decontamination and  
Decommissioning Engineering Company,  
Tokyo Electric Power Company Holdings, Inc.

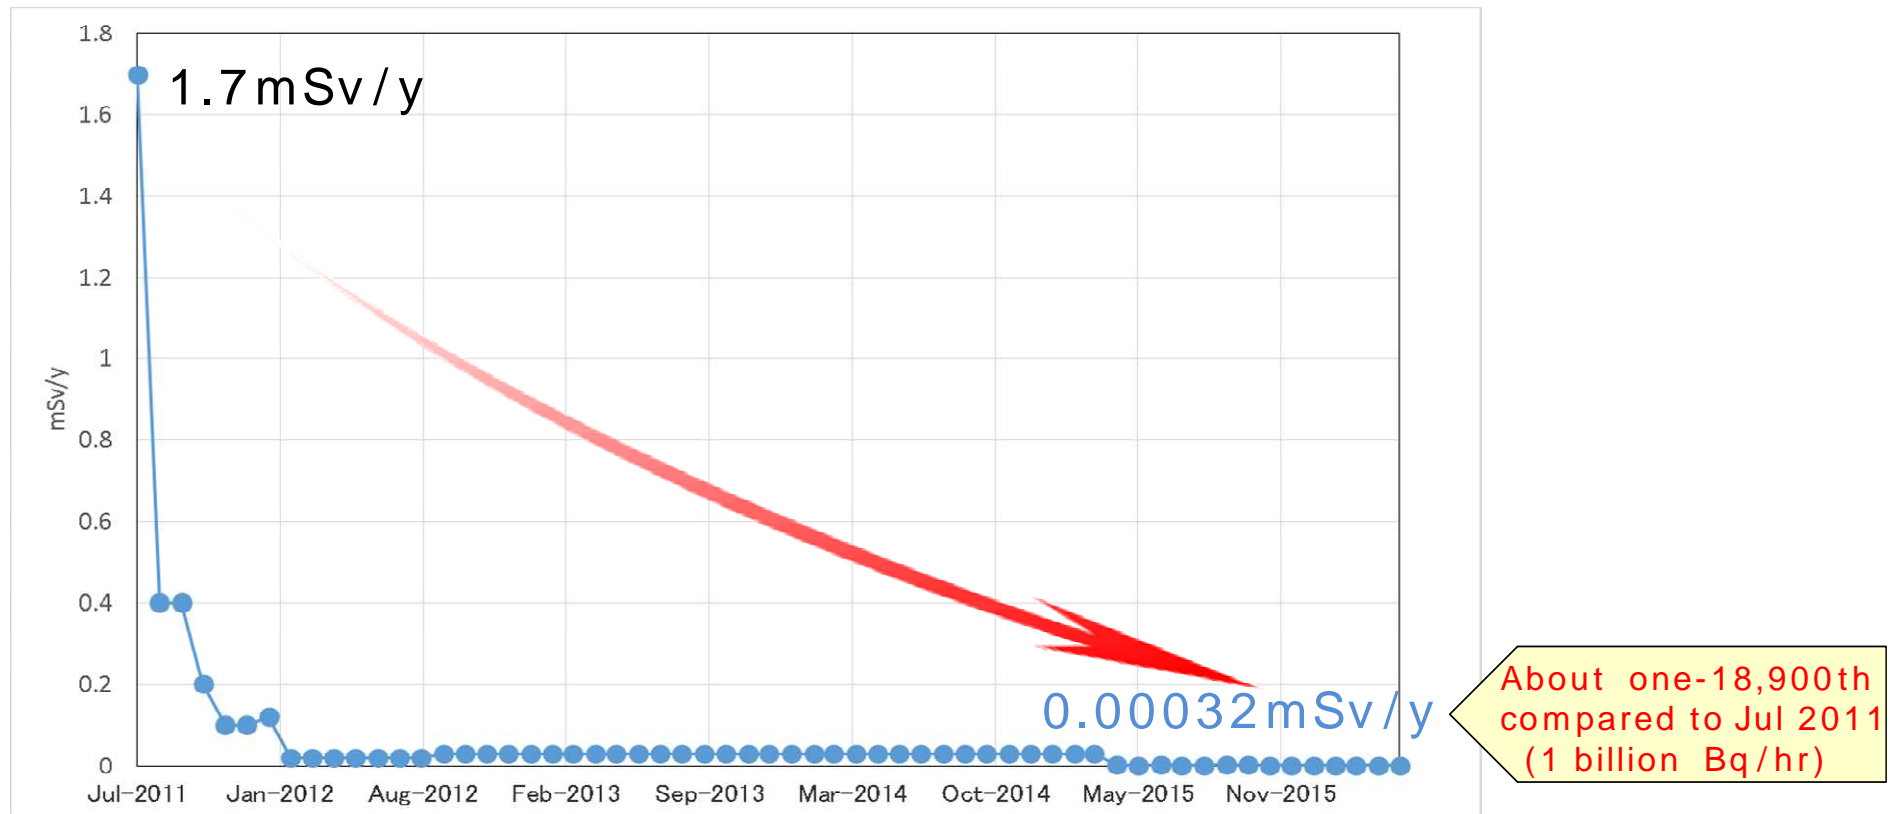
Exposure dose by radioactive materials (cesium) from Units 1 to 4

Amount of radioactive materials (cesium) released from Unit 1-4 PCVs is assessed based on airborne radioactive material concentrations at top of reactor buildings

Estimated value of total release amount (as of August 2016) about 53 thousand Bq/hr

- Accordingly, assessed the exposure dose at site boundary as maximum 0.00032 mSv/yr (Excluding effect of already released radioactive materials)

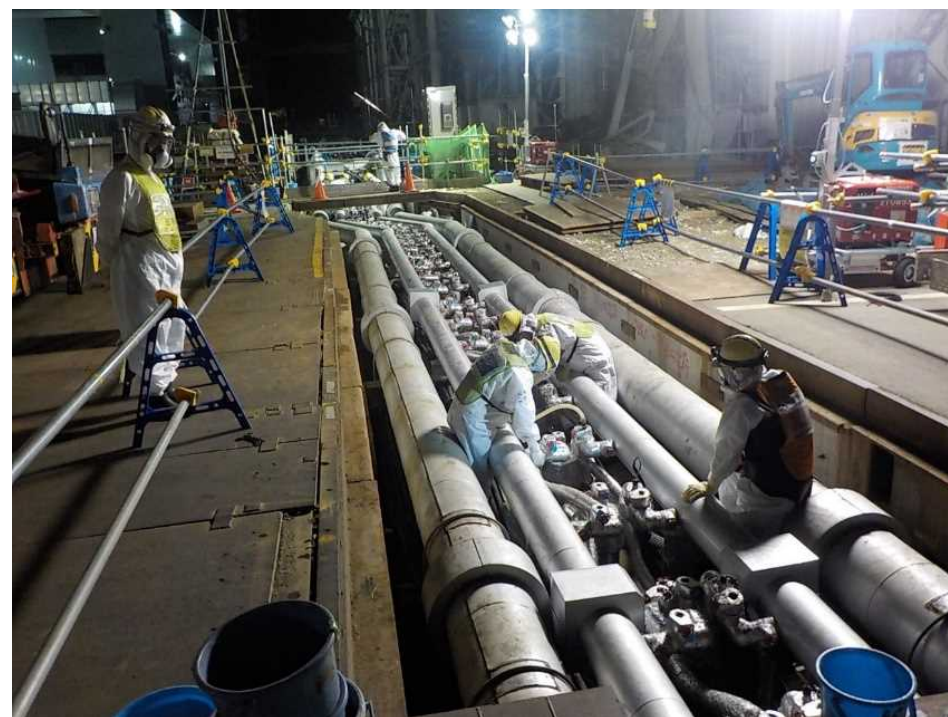
Pipe arrangement for coolant

Blocking the groundwater penetration into the buildings (Image)

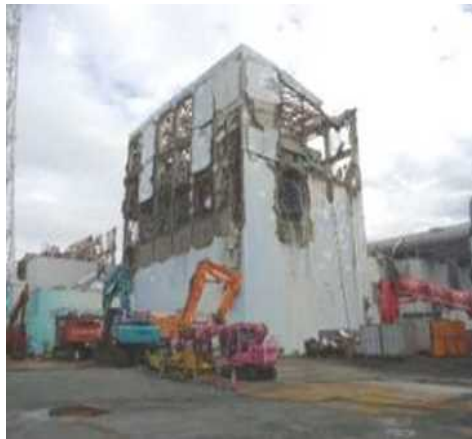
September 22, 2011

- Fuel removal started on November 18, 2013.
- Removal of 1535 fuel bundles completed on December 22, 2014 as scheduled
- No risk from fuel remains at unit 4. This gives confidence to proceed to fuel removal at units 1, 2 and 3

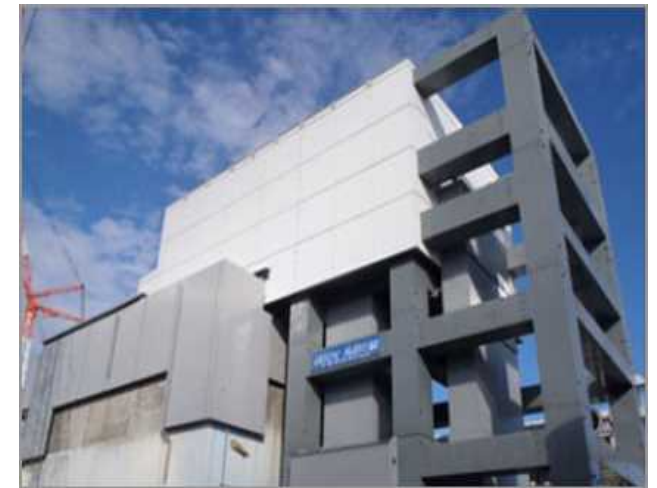
November 12, 2013:  
Completion of building steel framework (The volume of steel used is equivalent to those of Tokyo Tower.)

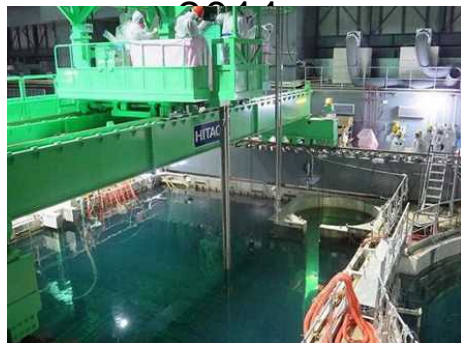
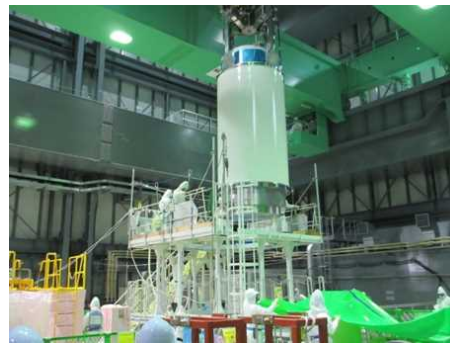
Process of removing fuel rods at SFP Unit 4

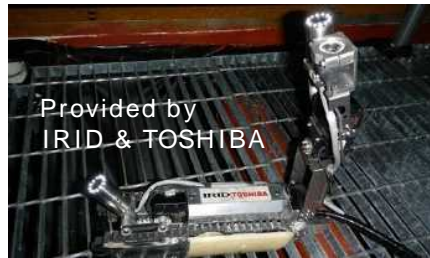
Robot for Survey

The head camera with a lamp had a tilting and panning function. The robot also has a dosimeter and a thermometer.

- Exploration inside the PCV and at the bottom of the RPV was conducted in order to investigate conditions such as the location of fuel debris inside the PCV.
- X-6 opening was used as a path for devices shown below to proceed inside the pedestal.
