AN APPROACH TOWARDS THE FINAL DECOMMISSIONING & DEMOLITION OF A MAJOR NUCLEAR FACILITY AT UKAEA WINFRITH

K. D. Miller, S. J. Parkinson, R. M. Cornell
RWE NUKEM Limited
Winfrith Technology Centre, Dorchester, Dorset, United Kingdom

D. I. Smith
United Kingdom Atomic Energy Authority (UKAEA)
Winfrith Technology Centre, Dorchester, Dorset, United Kingdom

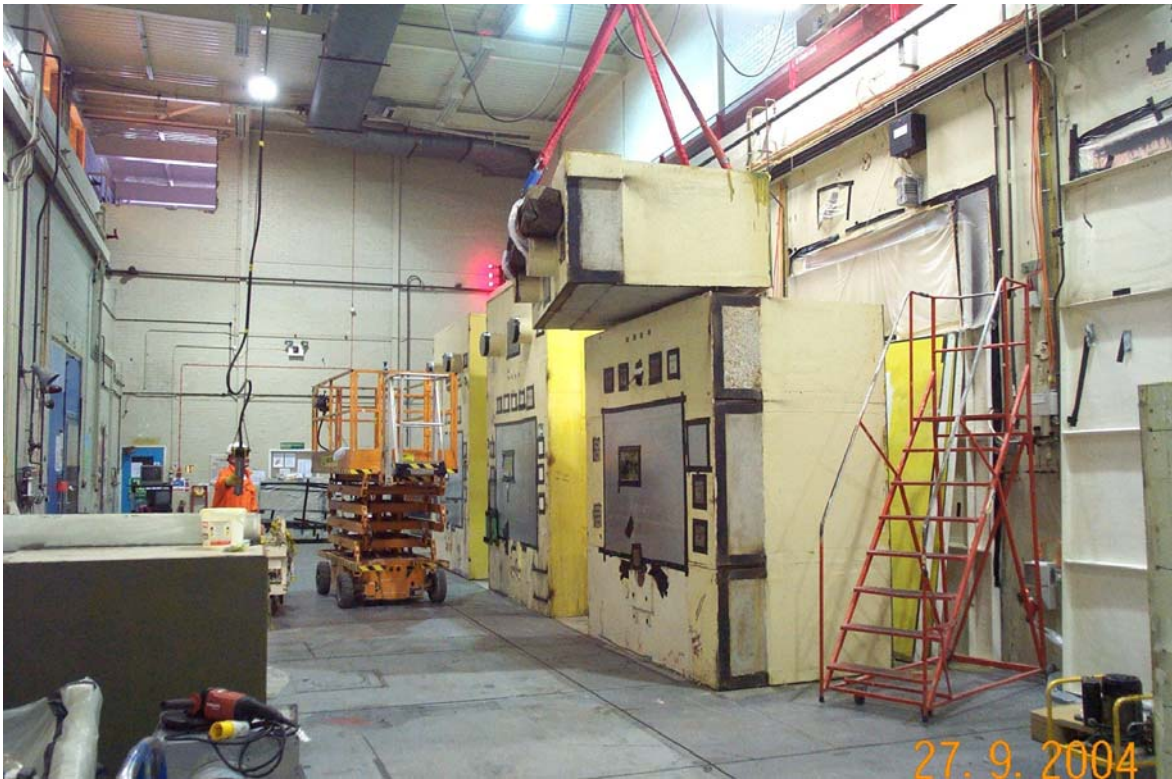
During the modifications made to both cave lines in the 1970s, the original non-operational faces were provided with mobile window plug units weighing ~40Te. Each plug contained a zinc bromide window, two manipulators and central light unit and was constructed in a modular fashion using five individual concrete and steel blocks assembled together, (Figure 1).

Fig. 1. Withdrawal and dismantling of the NCL window plug units

This modification was carried out to double the operational capabilities of the caves so that more equipment could be introduced. The NCL was provided with five of these blocks and the SCL with three. The design provided a capability for these units to be hydraulically raised at the outer face and then moved on guidance rails into and out of cave wall recesses using a mechanical actuator. The NCL decommissioning has reached a sufficiently advanced stage to permit all five units to be withdrawn from the south cave wall, allowing them to be decontaminated and dismantled into their component parts. Modular containment panels were installed in-cave over the inner plug unit faces to prevent the spread of loose contamination onto the decontaminated cave inner surfaces during the plug withdrawals. A doorway built into the panels allowed operators to enter from inside the cave and decontaminate the newly exposed surfaces to low levels. Residual contamination was then 'fixed' with paint to allow the modular panels to be cleaned and removed to another position. Later, the painted walls were fully decontaminated as for the rest of the cave line using hand-held Trelawney scabbling units and needle guns/chisels, (2). At the end of these operations, all five plug units had been withdrawn and decontaminated to

low levels ready for dismantling. This was a major advance since it removed a significant section of the cave wall ahead of the main demolition. For reasons explained later, this was an important step in the approach to the full demolition of the two separate cavelines inside A59.

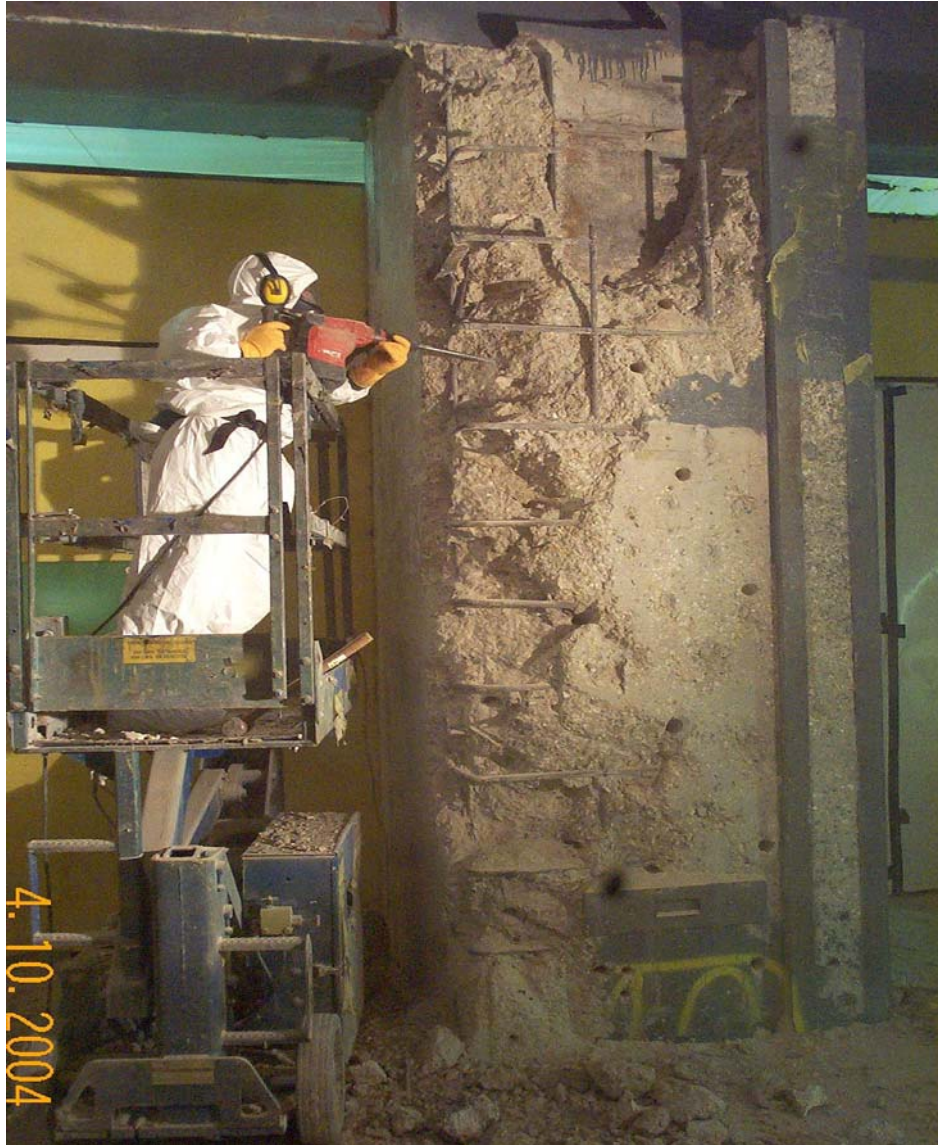
Fig. 2. Breaking away concrete from the encast ventilation ducts

Finally, a hydraulically powered concrete burster was used with the drilled holes, having the merit of being very flexible and relative simplicity of operation. The unit cracked the concrete very successfully despite the amount of steel reinforcing that was present. As a result, the outer surface and one side of each of the five ducts were fully exposed within a period of about 5 weeks using a team of 3-4 operators, (Figure 2).

Initially teams of operators attempted to remove the concrete using electrically operated 'jack hammers' but progress was slow and tiring for the operators. Another method employed involved the drilling of 30mm diameter holes at 10cm intervals into the concrete and filling these holes with expanding grout. Over a period of one to two days the grout expands during solidification to crack the surrounding concrete. This worked tolerably well but the process involved considerable down time whilst the grout became effective and so this process, which initially appeared promising, was abandoned.

The radiation levels inside the ducts had already been reduced by pressure washing, working from the top end of the horizontal section, (2). Subsequently, the front face of the ducting was progressively cut away in sections to allow the whole of the vertical section down to ground level to be sealed internally with 'Spraylat' water-based adhesive to control residual contamination. The stripping of the adhesive from these surfaces and subsequent re-application allowed local dose rates to be reduced by more than a factor of two whilst always maintaining a

close control of contamination. This approach demonstrated the benefit of using strippable paints rather than the normal variety in situations of this type. Once opened and sealed internally, the rest of the ducting was removed from the cave wall by local sectioning at ground level and at the upper end. The duct sections were subsequently size reduced and disposed of as LLW. The residue of the horizontal sections of ducting, cleaned at an earlier stage, were also recovered and disposed of in a similar manner. Significant amounts of concrete debris were generated throughout these operations and after monitoring about 10% were disposed of via a free release route along with most of the steel reinforcing. Activity levels on the remainder of the debris were low but it was judged not to be cost effective to carry out detailed sorting and monitoring of these materials to reduce the quantity of LLW generated in this case.

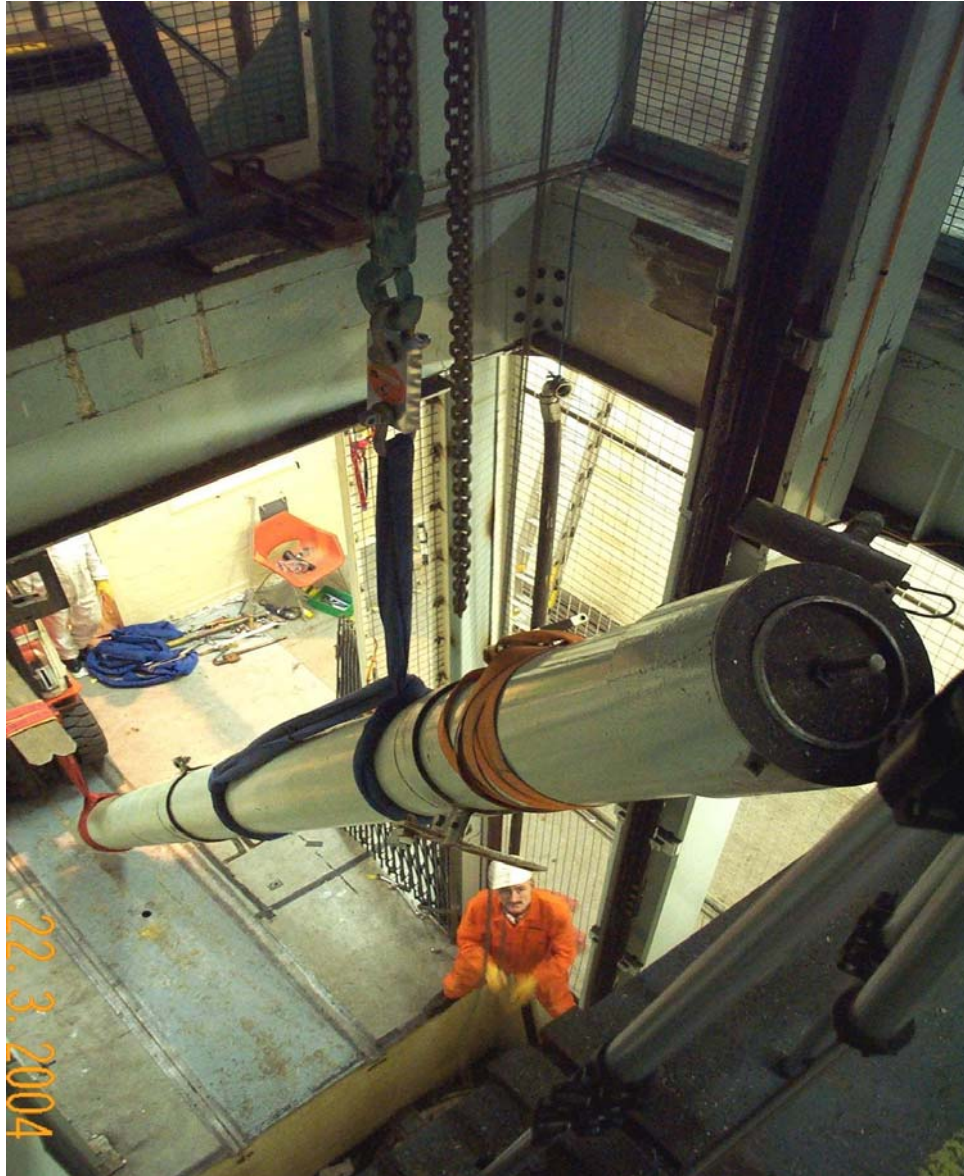
The Pickering Hoist, Figure 3, is essentially a lift operated by two powerful hydraulic rams mounted on either side of a rigid base structure. The lift is about a 3m cube in size enclosed by an open framework with an access through an interlocked folding door. There are rails across the ground floor and cave roof enabling the flask, mounted on a low wheeled trolley, to be located where required to charge and discharge ILW cans and other items. The wheeled trolley was dismantled and disposed of first and then the main lift and cage structure was cut away leaving the solid base plate, steel support structure and the two large vertical hydraulic rams.

Fig. 3. Dismantling of the Pickering hoist

The rams were secured to the steel support structure so their removal became the first major task. The hydraulic system was isolated electrically and drained, the oil being recovered into polythene lined drums for sampling and subsequent disposal as clean material. The exact weight of each hydraulic cylinder was not recorded and could not be obtained from the original manufacturer. Their masses were thus calculated conservatively and shown to be $\sim 0.5T_e$, allowing the local steel support structure to be used to attach a ratchet operated chain hoist for lowering the two rams to the ground. A radiation survey showed that these were clean and this allowed their subsequent disposal for scrap. The steel structure was then cut away using a standard gas cutting technique to finally clear the access to the east end of the cave line. All the steel structural materials were confirmed to be clean and this again allowed for their subsequent recycling.

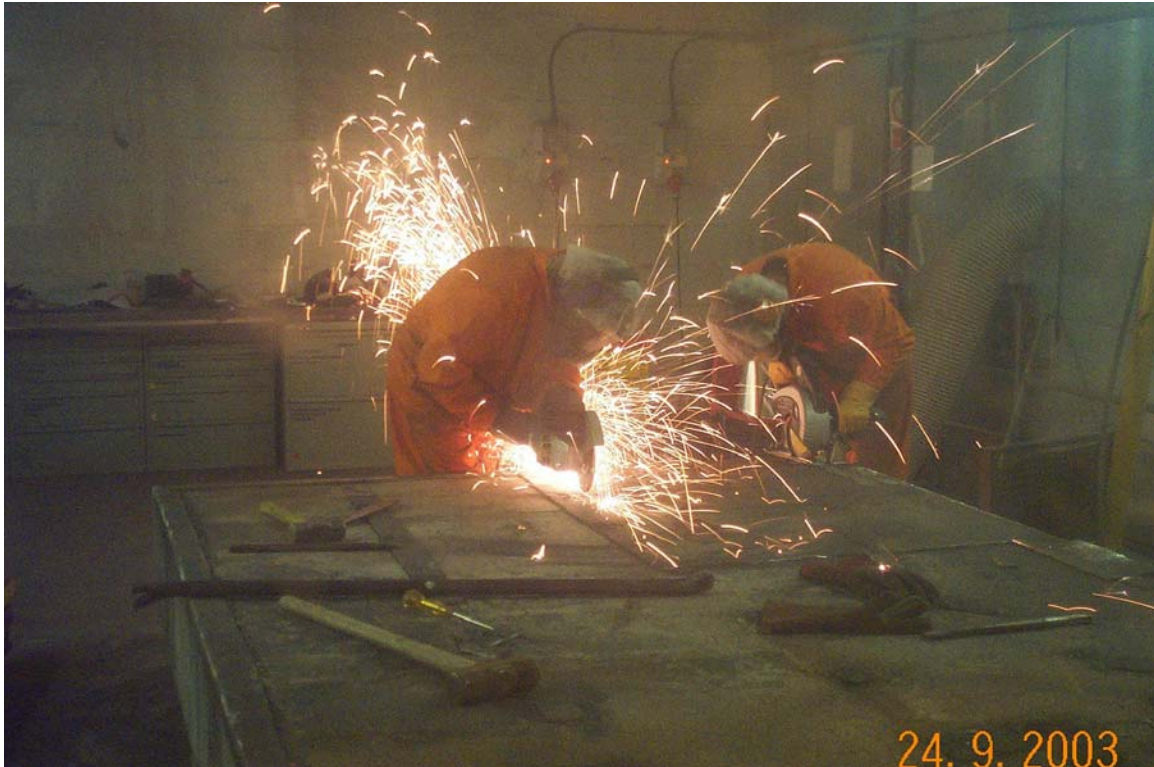
An area, known colloquially as the 'squash court', was set up inside the building to receive heavy concrete blocks and the wing walls to enable the external steel skin to be cut away using electrically powered angle grinders, Figure 4. The location was chosen adjacent to the east end of the NCL with local 40Te Craneage available to handle the loads. There are steel rails set in the floor leading into this area for use with a low wheeled trolley upon which blocks or wing walls up to 40Te in weight could be supported. This trolley had originally been used to handle CAGR fuel transport flasks of similar mass and was a good example of the re-use of apparently redundant equipment. The working area is surrounded by clear plastic sheeting secured to steel uprights and sealed at base and ceiling. The area can be entered through a pair of vertical doors made of similar material with wheeled ends to facilitate opening/closing. The area is ventilated by a powerful air mover which draws air from the facility at about $1.8\text{m}^3/\text{sec}$ through a long steel tube directed across the ceiling and down into one corner of the facility.

The work is always carried out in a similar manner with operators cutting away the steel from all surfaces, turning the block when required to expose the lower face. Care is taken with the radioactive monitoring to ensure that any contamination on the items is controlled before movements are undertaken. The blocks are then moved to a low background area for monitoring of all surfaces. Any residual activity is marked with black spray paint for further attention.

Fig. 4. Removal of steel plates from concrete blocks in the ‘Squash Court’

One further cleaning operation using mechanical chisels to remove the spots of fixed contamination is usually sufficient to fully decontaminate the blocks. The recovered steel is collected up and disposed of as LLW in ISO containers. The vast bulk of the blocks/wing walls is then be disposed of via a free release route with substantial savings in disposal costs. Analysis of core samples taken from some of these blocks has confirmed the absence of radioactive contamination or activation products in these materials, supporting their disposal by these means.
