## UNDERWATER COATINGS FOR CONTAMINATION CONTROL

J. Tripp, K. Archibald, A. M. Phillips, J. Campbell  
Idaho National Laboratory

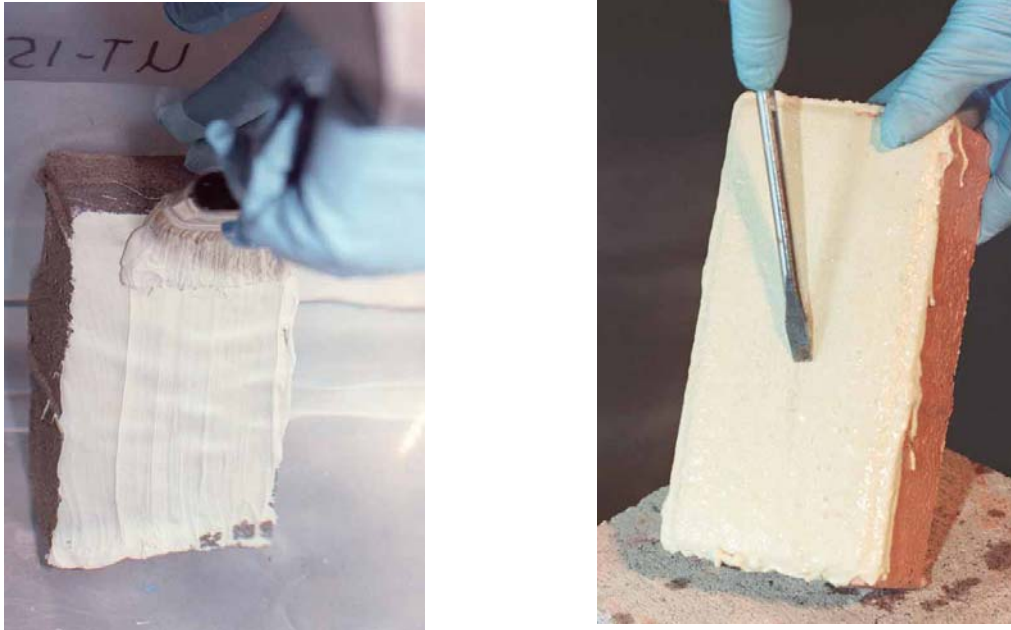
**Fig. 1. UT-15 adhered well to all surfaces when applying and after drying.**

The three coatings that were the easiest to apply and adhered well were the NMP 1710, Corro-Coat FC 2100 Epoxy, and the UT-15 Underwater Epoxy. However, there is some concern on the Corro-Coat FC 2100 since after several weeks it broke off the stainless steel surface. Many of these coatings require a roughened surface to adhere well according to manufacturer's instructions and this may be why this coating came off. The surfaces were not roughened prior to application to more closely simulate field application conditions. In several cases, applied coatings bonded well to the epoxy painted surfaces but caused the bond of the epoxy paint to the surface of the coupon to weaken.

Based on these results, use of the UT-15 (Figure 1) and the NMP 1710 coatings were recommended for use in the actual fuel basins.

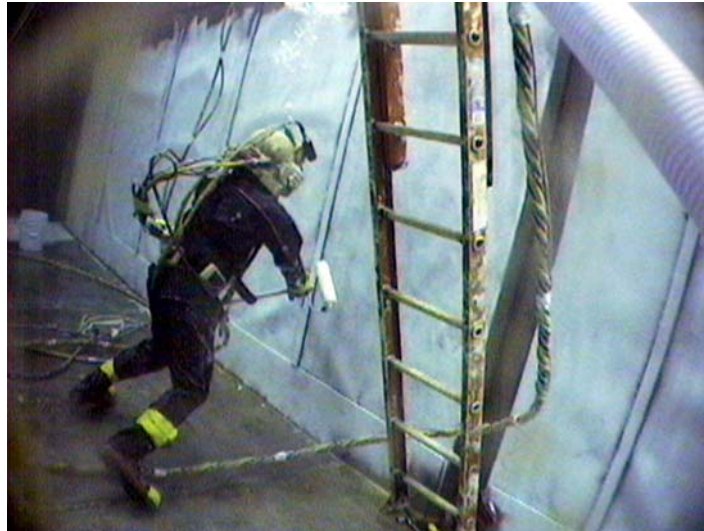
**Fig. 3. Applying fixative to the wall of the MTR canal.**

S. G. Pinney commercial divers were chosen to complete this work. Before beginning dive activities, all areas to be worked on were surveyed by the divers themselves. The potential for finding unexpected debris items during cleanup of the basins was anticipated. The dive master was in constant voice and video contact with the divers during dive operations. Divers were instructed not to pick up anything before scanning it. There were no instances in which a diver entered an unsurveyed area or picked up objects that had not been surveyed. They first scrubbed the loose contamination off the basin walls and floors using a ship hull scrubber and vacuumed up the sludge. They then applied the UT-15 coating using a two-hose power roller system, which mixed the epoxy at the roller head, and eliminated the pot life concerns.

The epoxy coating is much more difficult to apply under water than house paint in air. It took considerable effort to get a complete coating that passed the dive master's inspection. The divers also had to deal with the bubbled and loose paint layer on the TAN basin walls and the rough, bare concrete surface on the 603 Overflow Pit walls. The condition of the existing surfaces directly affected the time needed to apply the fixative.
