DEVELOPMENT OF VISUAL CRITERIA FOR EVALUATION OF CORRODED TRU-WASTE DRUMS AT THE DOE HANFORD SITE

G. R. Cannell, L. Dayley
Fluor Hanford, Inc.

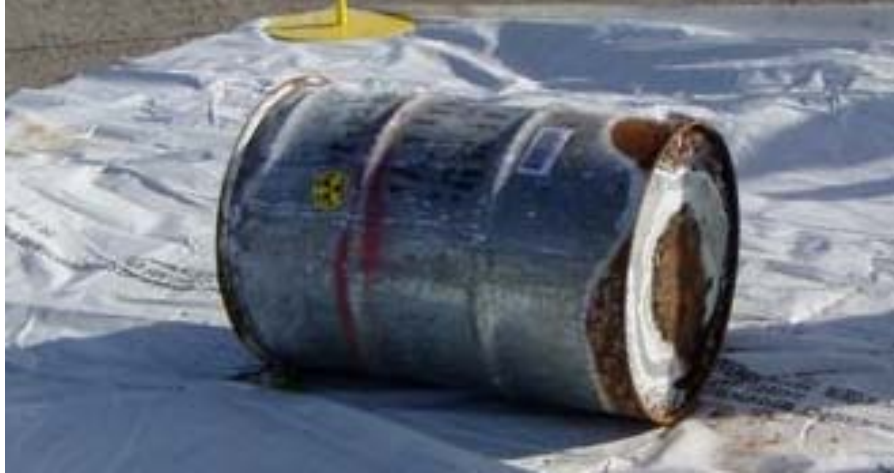
Fig. 1. Typical Drum

The eleven drums investigated are a subset of a group of retrieved and segregated CH-TRU waste drums from the Hanford Sites LLBG not meeting the then-current corrosion criteria for on-site transfer. Selection was subjective with the intent to include a variety of corroded conditions, from “light” to “heavy” attack. The drum shown in Figure 1 is typical of the drums evaluated.

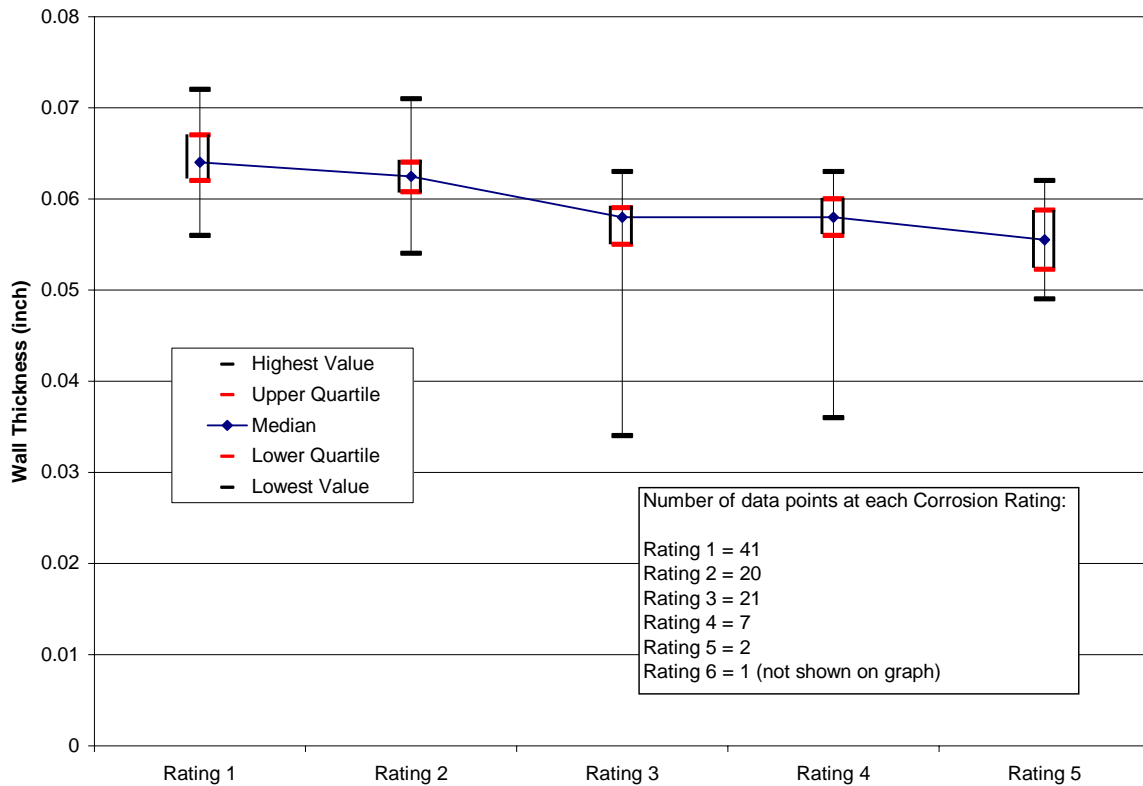
Fig. 3. Wall Thickness vs. Corrosion Rating

Ninety-two separate corrosion areas from the 11 drums were evaluated for which both photographs and wall thickness measurements were obtained. The nominal wall thickness (at time of manufacture) of all drums evaluated was 1.524 mm (0.060 inch). The maximum wall thickness measured, of the 92 areas, was 1.829 mm (0.072 inch) and the minimum wall thickness, 0.864 mm (0.034 inch).

Figure 3 plots corrosion rating (X axis) against measured wall thickness (Y axis) for 91 areas (The single area rated with a 6 is not plotted.). The data is presented in a “box and whisker” format to help visualize data distribution and identify trends. The data indicates that as the corrosion rating increases, wall thickness decreases. It is acknowledged that additional data points at the higher ratings would provide a greater understanding of specific behavior and trending at those conditions – see box in lower right hand corner of Figure 2 for data point totals. All thickness values for corrosion surfaces characterized with a rating of 5 and less exceeded the Hanford-specified threshold for structural integrity of 0.762 mm (0.030 inch).

- The structural integrity of Hanford CH-TRU waste retrieval drums is maintained when wall thickness values are greater than or equal to 0.762 mm (0.030 inch).

- The data reported herein suggests that drum surfaces characterized by a rating of 1-4 can be expected to have wall thickness values greater than or equal to 0.762 mm (0.030 inch) and expected to provide original drum design containment properties.

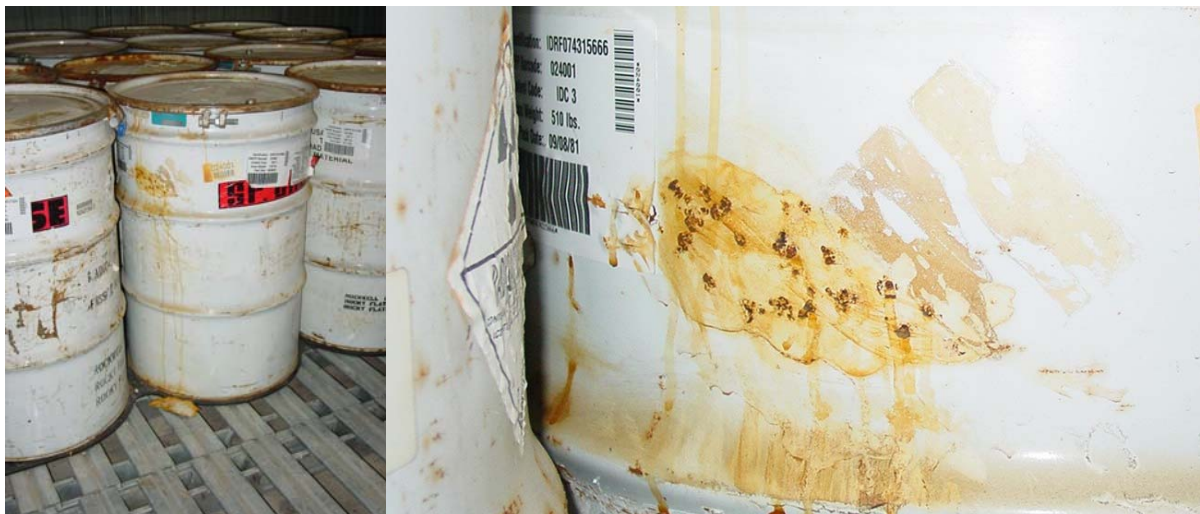
Fig. 4. Internal, Through-Wall Pitting

Evaluation and characterization of corroded surfaces are from the drum exterior surface only. There is the potential for Hanford CH-TRU waste drums to experience wall thinning as a result of attack at the drum internal surface. Other DOE sites have reported internal corrosion in some of their CH-TRU waste drums that had become filled with water; due to unique storage and

weather conditions, reference [3]. It was observed that pitting was the predominant form of attack and was most likely to occur in the lid. Internal, through-wall pitting, when observed from the drum exterior surface, is evidenced by staining or discoloration (typically dark brown) and a small hole(s) which may or may not be visible to the unaided eye. The surrounding surface appears largely unaffected, see Figure 4. None of the Hanford drums retrieved to date have shown signs of internal pitting corrosion.
