**USING THE ISMS PROCESS TO QUALITATIVELY EVALUATE RISKS AND CONSEQUENCES FROM RELOCATING MONOLITH CASKS AND VAULTS TO A DESIGNATED STORAGE FACILITY**

**ABSTRACT**

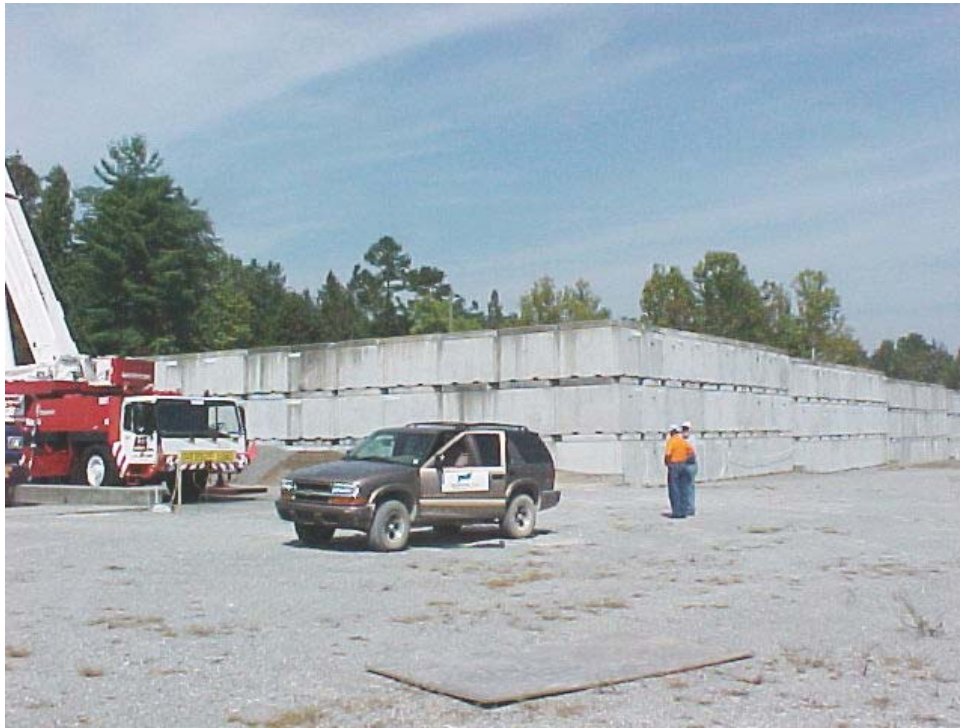
**Fig. 1. Overview of the IWMF illustrating full pads containing regular vaults and a nearby empty pad with a crane readied for adding more casks and vaults.**

The WR required the strategic placement of these casks and vaults with other existing IWMF casks and vaults in preparation for final disposal (Figure 1), ultimately resulting in burial under an engineered earthen cap.

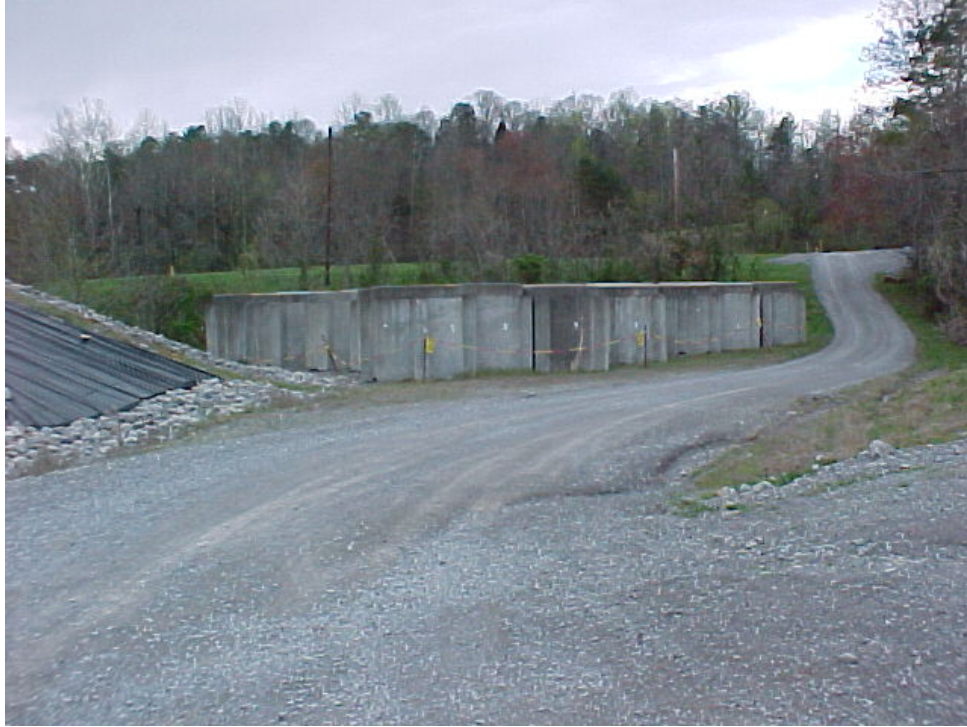
**Fig. 2. Monolith casks with lids before relocation to the IWMF pad in SWSA 6.**

On April 1, 2004, a work-planning ISMS session was conducted with stakeholders involved in executing the WR. The location of the monolith casks (Figure 2) and size of the double vaults (Figure 3) presented several challenges.

Recalling that a typical monolith cask with lid weighed 21.7 tonnes (24.1 tons) empty, executing this WR would require a minimum 22.5-tonne (25-ton) capacity forklift. Even though a properly rated forklift could eventually be procured, the ISMS evaluation provided numerous justifications that using a forklift of this capacity was still not the preferred option for this relocation activity:

- A forklift operator's forward view was restricted due to the height of the monolith cask and side view was restricted due to the width of the double vault container.

- The initial positioning of the casks presented problems in accessing the lifting-strap pockets (i.e., the pockets faced opposite and away from the roadway).

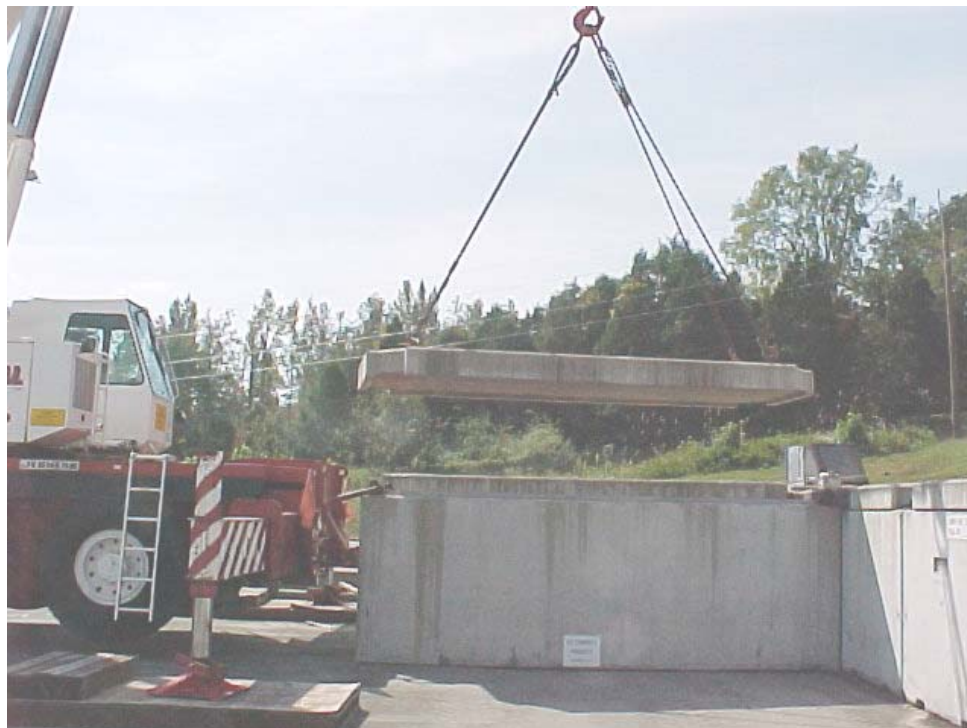
**Fig. 3. A double regular vault after relocation to IWMF pad. The lid is being removed to facilitate rock-filling operations.**

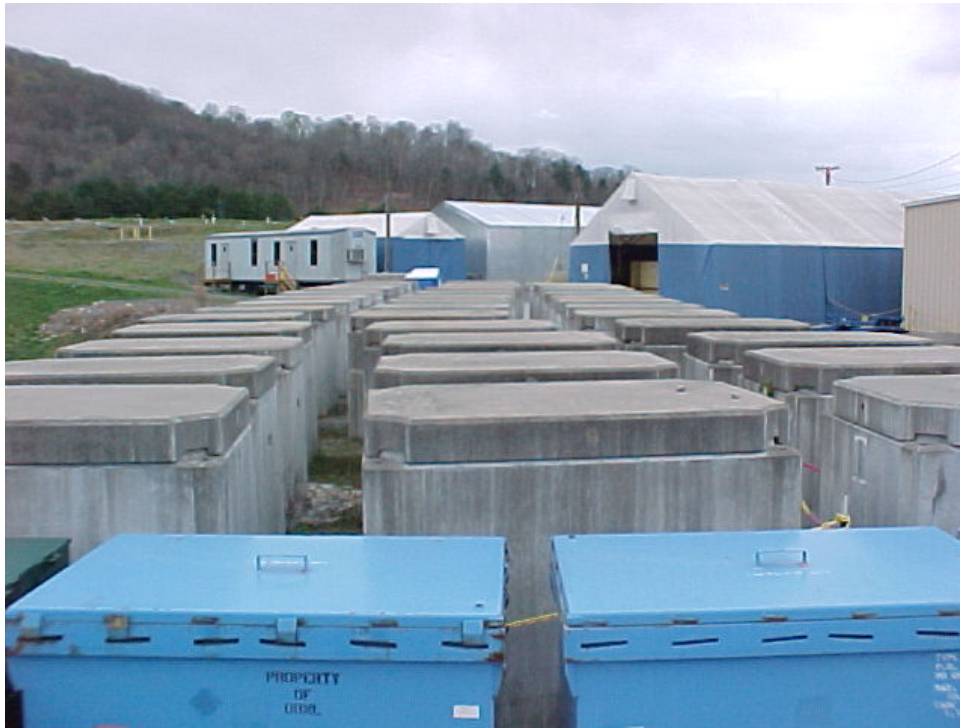
**Fig. 4. Regular concrete vaults.**

Another set of 49 empty regular concrete vaults, weighing <9.0 tonnes (<10 tons) empty, were located in SWSA 6 on a solid-packed gravel lot (Figure 4).

Although it was anticipated that the 22.5-tonne (25-ton) rated forklift would cause damage to the ground surface, these vaults could be lifted with a lighter [e.g., 9.0-tonne (10-ton) capacity] forklift and placed on a flatbed truck for transport to the IWMF. They could then be unloaded with a forklift and positioned for rock-filling operations.

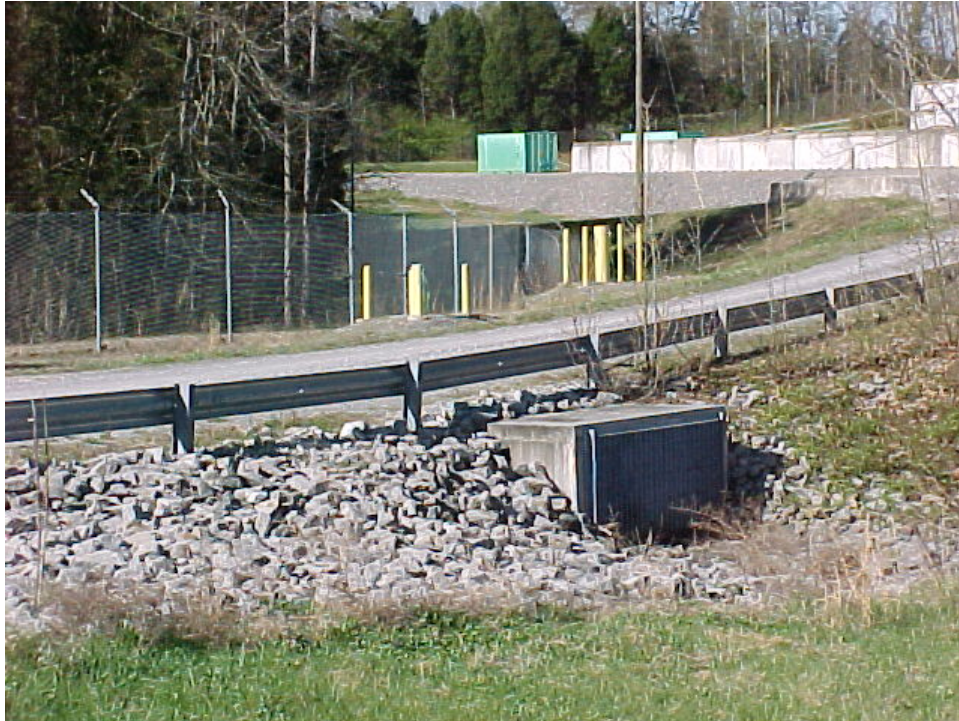
**Fig. 5. Rectangular concrete culvert under IWMF Drive.**

Another concern along this route was a concrete box culvert that traverses underneath the roadway (Figure 5).

The short wheelbase of a loaded forklift would have distributed a concentrated load on the culvert compared to a tractor-trailer that spreads the load. Despite the fact that other contractors had used this route in the past to construct and place vaults on the IWMF pad, the load-bearing capacity of the culvert had not been rated. Historic engineering drawings could not be located on this culvert so it was difficult to properly evaluate the exact rating capacity for this structure. Since the shortened wheelbase of the forklift could concentrate the gross load directly over the culvert, it was determined that the loads needed to be transferred using a flatbed trailer where only a fraction of the load was ever directly over the box culvert during transport. Such practices reduced the chances of harmful failure, which could have resulted in personnel injury and/or costly project delays if corrective measures were necessary.
