ROBOTIC SYSTEM USED FOR HOT CELL DISMANTLEMENT

K. Kasper, C. Higgins, K. Roberts
SCIENTECH, LLC

WM'05 Conference, February 27 – March 3, 2005, Tucson, AZ

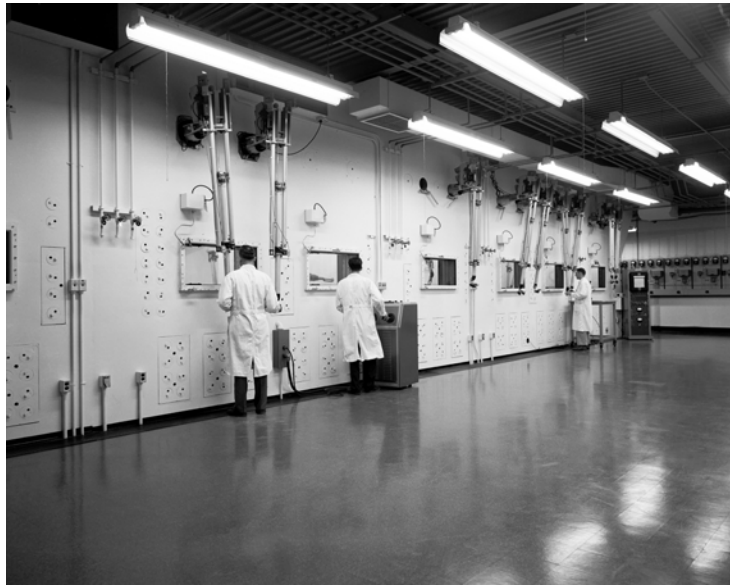
Although the Quehanna Hot Cell Complex (Figure 1) contained six hot cells that were used for a variety of radiological operations, Cell 4 was the most hazardous. In Cell 4 during operations, the soluble strontium carbonate was converted to the insoluble strontium titanate in the Cell 4 process system. The process system included two stainless steel working “boxes” that were accessed with manipulator arms from the cell face area. The space behind the process boxes was filled with a nest of tubing, ventilation system, a heavy shield wall, and two tanks. Initial manned entries into the process boxes indicated unsealed residual Sr-90 with radiation levels of up to 400 gray/hr (40,000 rad/hr). These extremely high radiation levels and very high airborne contamination levels precluded the use of standard dismantling techniques.

Fig. 1. Cell Operations Area at Quehanna (circa 1965)

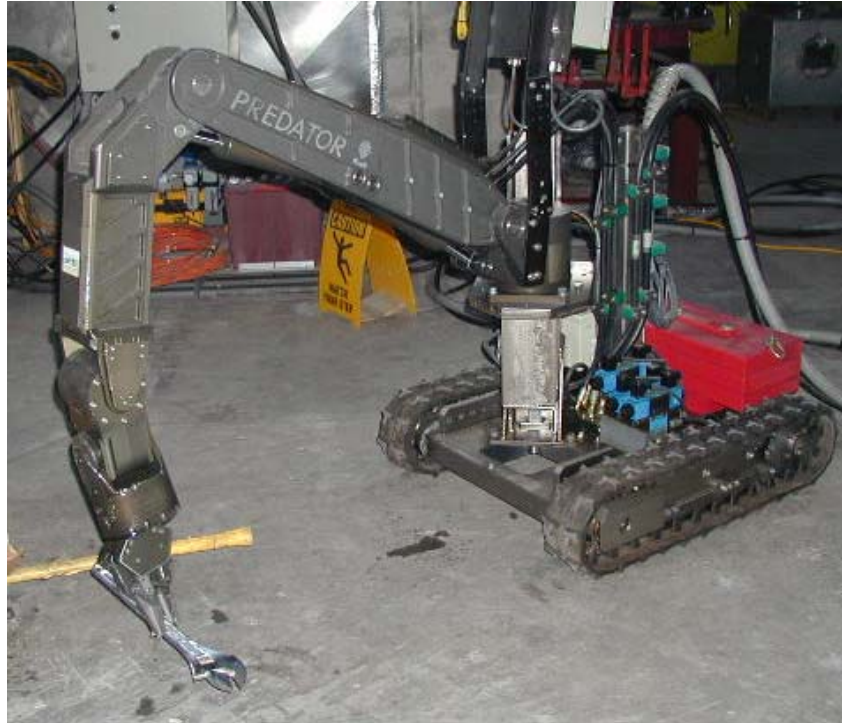
Several alternatives to process system dismantlement were considered. These included wire-cutting the entire hot cell and removing it as a single unit. In addition, consideration was given to using long-handled tools to dismantle the system underwater after the hot cell was sealed and flooded. Ultimately, robotic dismantlement was chosen as the most viable approach. The robot system used was a combination of commercially available components and custom made end-effectors (Figure 2). The base of the selected robot configuration was a Houdini, hydraulically operated, parallel track system with a footprint of 81 cm by 97 cm. The parallel track base was outfitted with an off-the-shelf Kraft robotic arm called Predator. The arm, which had 6-degrees of freedom, was capable of lifting 90 kg and could apply 136 Nm of torque. The gripping device on the end of the arm also had a force-feedback system that would allow the movement of objects without damaging them or causing undue strain on the gripper system. The robotic system was controlled and operated from a control room established in the Hot Cell Service Area approximately 30 m from Cell #4.

Fig. 2. The Quehanna Robot

Custom end-effectors were developed for the Kraft arm for the process system dismantlement. They included four types of grinders, a tube crimper, a tube cutter, a radiation probe housing, a tank-grabbing device, a nibbler, and a sheet metal cutter. During the dismantlement process, some of the tools worked very well while others were problematic. The grinders worked well but the robot arm could not negotiate non-linear travel with the nibbler. The entire robotic system and its support tools were field tested in a mock-up of Cell 4 prior to its deployment. This mock-up testing proved to be invaluable for testing and refining the robot and its tooling and for training robot operators.

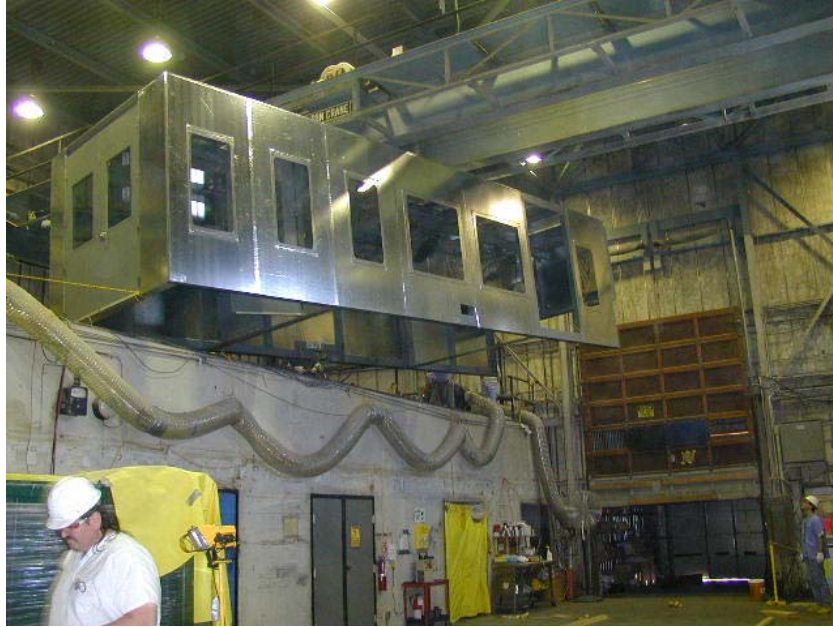
The robot was capable of conducting the necessary tasks in Hot Cell #4. During operation and maintenance procedures, however, incredible amounts of radioactive airborne material and surface contamination were generated. This material had to be contained. This was done primarily through the design and installation of a triple-chamber, double wall containment system (See Figure 3). The containment allowed for access and egress of personnel and the robot; however, by design, the robot only made a single trip into the containment.

Fig. 3. Installation of the Primary Containment

The containment was an effective contamination barrier and was assisted by the air handling system. The air handling system was joined to the original Hot Cell #4 ventilation ducting. This allowed clean air to be pulled away from the opening of the Hot Cell, which was a ceiling access opening. Air was subjected to two high-efficiency, particulate air (HEPA) units in series, stage 1 and stage 2. Stage 1 also had a redundant HEPA unit. Electrical power to the HEPA units was also redundant.

The containment system also included four air-monitoring stations that would provide a near-immediate indication of contamination migration. Besides housing the two openings to Hot Cell #4, the containment system also included the opening to Hot Cell #3. This hot cell, which was previously remediated, provided an effective station to accept highly radioactive components that were segmented by the robot for monitoring and packaging. Hot Cell #4 was also equipped with a remote- or locally-activated fire suppression system.
