**PHASE 2 DESIGN IMPROVEMENTS FROM PHASE 1
CONSTRUCTION/OPERATIONS OF EMWMF
AT THE OAK RIDGE RESERVATION**

M. J. Williams, J. R. Manning
Bechtel Jacobs Company LLC

ABSTRACT

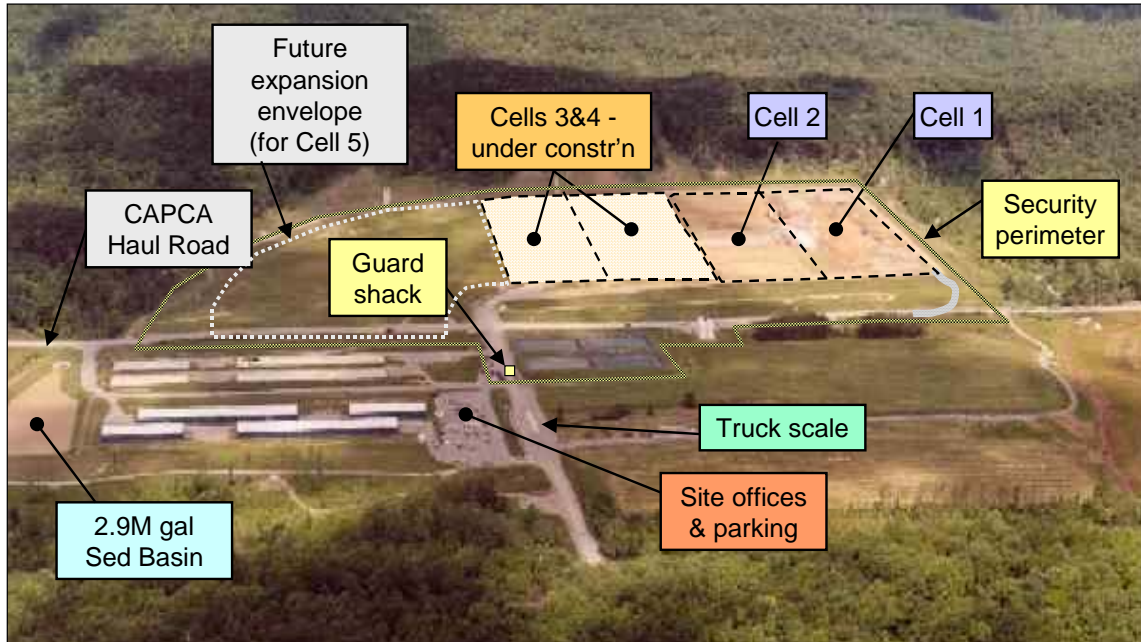
Fig. 1. EMWMF Site Plan.

The EMWMF is located on the side of Pine Ridge just west of the Y-12 National Security Complex (Figure 1). The project holds the distinction of being the first Department of Energy (DOE) privatization project to come to fruition. Construction of Phase 1 (Cells 1 and 2) of the facility started in February 2001 and concluded in April 2002, providing 300,000 m^3 (400,000 yd^3) of airspace for CERCLA waste disposal to jumpstart the cleanup of the Oak Ridge Reservation (ORR). Disposal operations then commenced in May 2002. At the end of calendar year 2004, waste disposal at the EMWMF had consumed half of the 300,000 m^3 (400,000 yd^3) of Phase 1 airspace. During construction and this initial operating period, lessons learned were assimilated for application in subsequent phases of the EMWMF project. The Phase 2 subcontract to add Cells 3 and 4 with an additional 600,000 m^3 (800,000- yd^3) of airspace was the first opportunity to apply the lessons learned to improve the design, construction, and

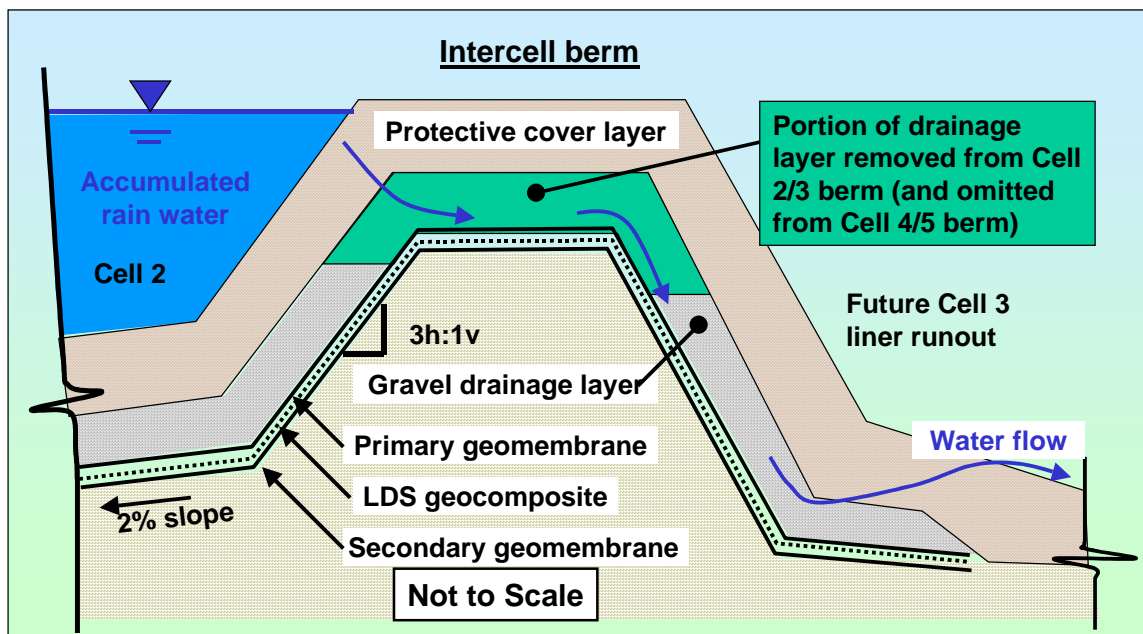
Fig. 2. Cross section of EMWMF Intercell Berm.

At the liner runout for future Cell 5, however, a more conventional intercell berm was constructed, though only 1.5m (5 feet) high, half the height of the Phase 1 berms. This was necessary to ensure adequate in-cell retention volume for contact water. The Cell 4/5 intercell berm incorporates an additional lesson learned regarding the in-cell retention of water. Experience in Cell 2 demonstrated the need to discontinue the drainage media in the LCS across the top of the berms to preclude migration of water over the berm into the uncontrolled future construction area (Figure 2). Prior to the start of waste disposal operations in Cell 2, its LCS was valved off to reduce the quantity of water entering the leachate system for treatment.

Consequently, accumulated water had to be pumped from the cell. After significant rains large quantities of water ponded at the south end of Cell 2 before it could be pumped out. The top 0.3 m (1 foot) of the berm was constructed of protective cover material. Beneath that was 0.3 m (1 foot) of drainage stone, and beneath that was the primary geomembrane. When the water level rose above the elevation of the drainage stone in the LCS at the top of the berm, it appeared that the protective cover material still contained the water. However, once the protective cover was saturated, the ponded water provided sufficient head to drive water through the drainage stone across the top of the berm creating a seep on the downgradient side. To remedy this, the protective cover soil and drainage stone were stripped from the top of the Cell 2/3 berm, a geosynthetic clay liner mat was inserted on top of the primary geomembrane, and the protective cover soil was backfilled. In Phase 2, the drainage stone in the LCS was discontinued 0.6 m (2 feet) from the top of the Cell 4/5 intercell berm to preclude seepage. The drainage stone was also discontinued across the Cell 3/4 intercell berm – 0.6 m (2 feet) from the top on the Cell 4 side and 7.6 m (25 feet) horizontally from the edge on the Cell 3 side.

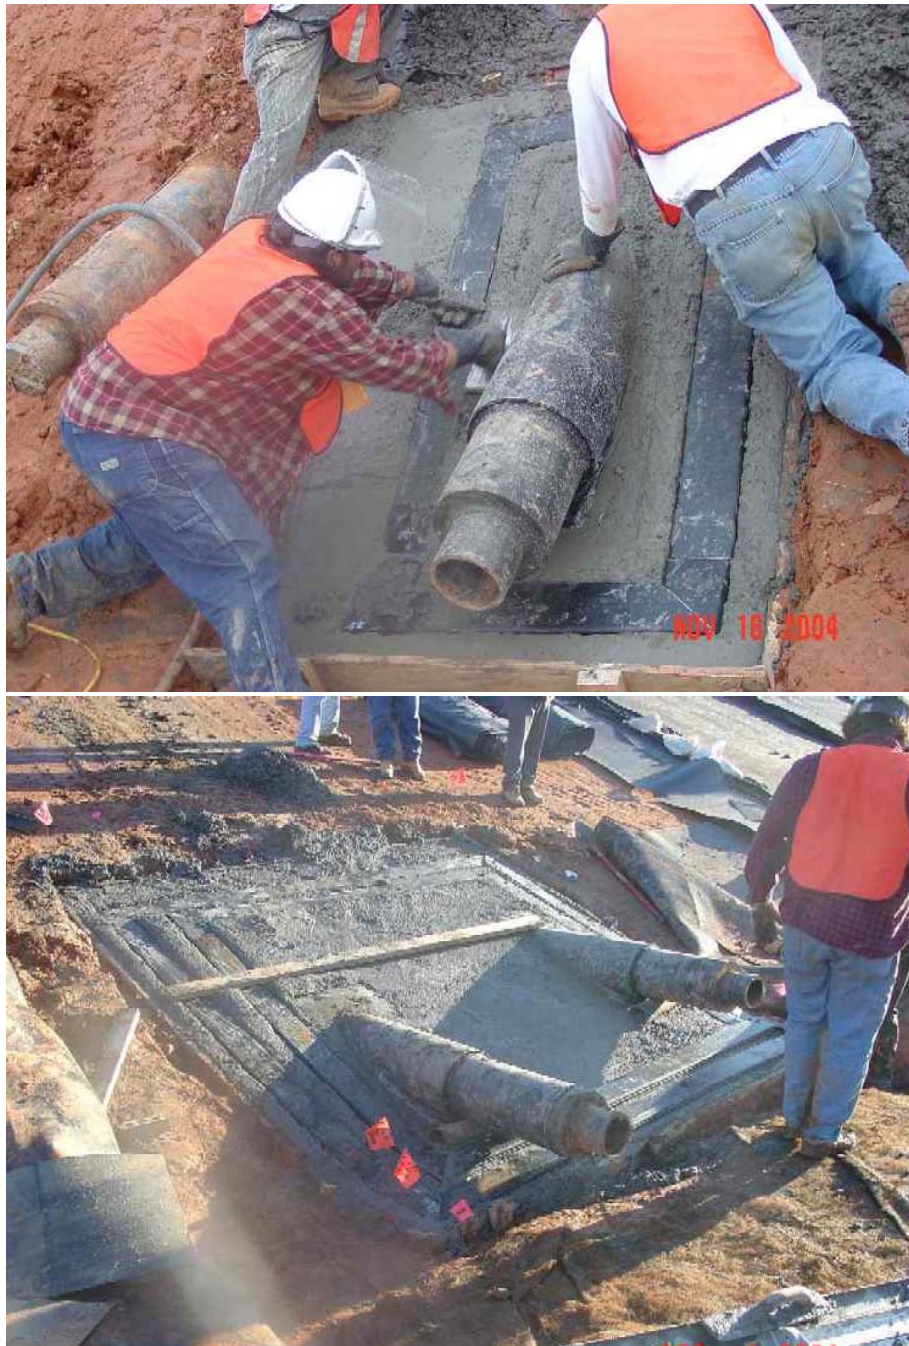
Fig. 3. Leak detection system (LDS) penetration block (top) and leachate collection system (LCS) penetration block (bottom). Details typical for both blocks.

The Phase 2 design opted for a cast-in-place concrete block at each pipe penetration to ensure stability of the pipes (Figure 3). Each dual-walled pipe (one LDS, one LCS, and one redundant LCS in each cell) was fitted with a pipe sleeve/collar constructed of 2.5-cm (1-inch) HDPE

flatstock and 30-cm (12-inch) HDPE pipe. The flatstock was shop-welded to the 30-cm (12-inch) pipe to ensure that the face of the sleeve appurtenance matched the design 3:1 slope of the face of the berm. Then the 30-cm (12-inch) pipe was field welded to the 25-cm (10-inch) HDPE outer containment leachate pipe. The penetration block was then placed and the concrete finished flush with the HDPE flatstock face and the surrounding clay liner. Fifteen-centimeter (six-inch) wide HDPE channel embeds were set in the face of each concrete block as it was being finished. The LDS penetration blocks had one ring of embeds; the LCS penetration blocks had two rings.

On the LDS blocks, the HDPE secondary geomembrane was extrusion welded to the outer edge of the channel embeds to maintain the integrity of each of the liner systems. A “picture frame” of HDPE geomembrane was welded between the inner edge of the embeds and the flatstock to provide complete coverage across the face of the penetration blocks.

On the LCS blocks, the secondary geomembrane was welded to the outer edge of the outer ring of embeds. The primary HDPE geomembrane then covered the outer embed ring and was welded to the outer edge of the inner embed ring. Another “picture frame” of geomembrane was welded between the inner edge of the inner embed ring and the flatstock around each of the two LCS pipes.

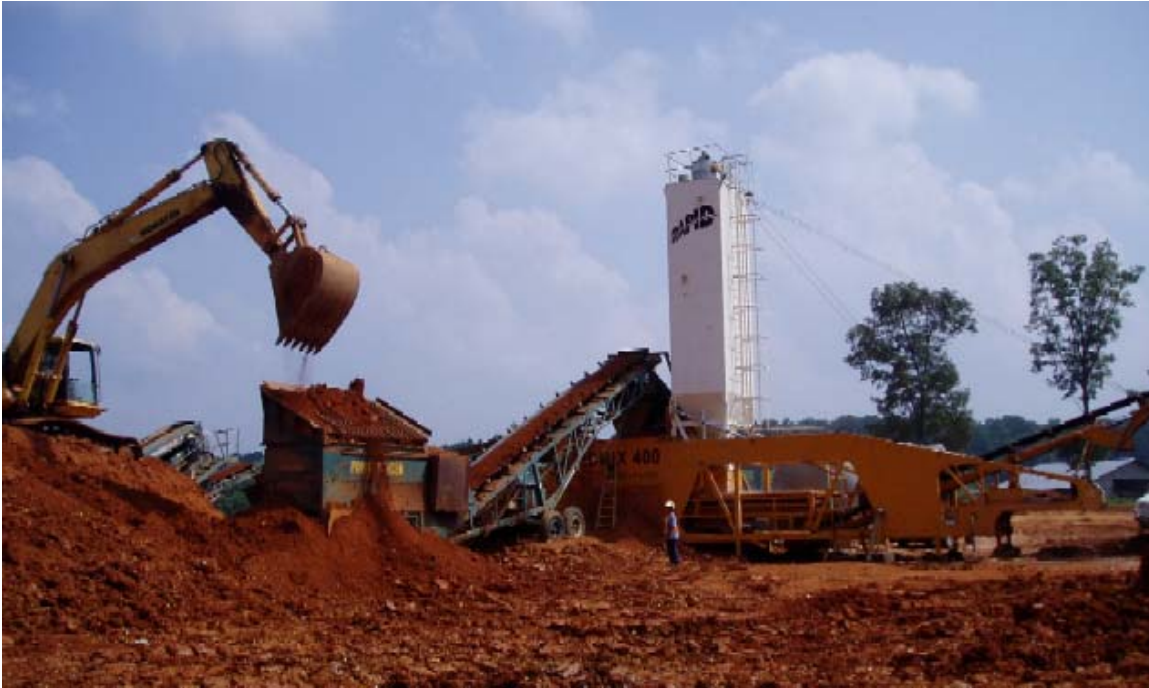
Fig. 4. Bentonite Pugmill at EMWFM Borrow Source.

A pugmill was set up at the borrow site to blend the bentonite with the native clay (Figure 4). The clay was screened through a 10-cm (4-inch) vibrating bar screen and a 2.5-cm x 2.5-cm (1-inch x 1-inch) grate prior to entering the mixing chamber where the bentonite was added. Finished product was stockpiled at the borrow site for transport to EMWMF in dump trucks. This operation produced its own set of lessons learned.

Initially, the raw clay was pushed to the input stockpile by a bulldozer then dropped onto the vibrating bar grate by an excavator. Even though the pugmill operation started in May, the clay didn't dry enough between rain events to preclude large clods, which produced a high reject rate from the bar grate. Then, water was added to condition the clay to the target moisture content of 4% wet of optimum as the clay entered the mixing chamber. The mixture of wet clay and bentonite powder plugged the mixing chamber at an intolerable frequency.

The fix was two part: add a piece of equipment and relocate the moisture conditioning of the product. A tractor with a harrow was brought in to continuously disc the clay. The reduction in clod size from this pulverizing action not only improved productivity of the bar grate, it facilitated drying of the clay, which was part of the solution to the other problem. The moisture conditioning process was moved to the belt at the output of the mixing chamber because the drier input clay more readily mixed with the powdered bentonite and did not stick in the mixing chamber. The pugmill produced pellets of amended clay that ranged from pea-sized to nickel-sized. Regular testing of the moisture content of the raw clay and a little trial and error in adjusting the flow rate of the spray heads on the output belt produced a product that was reliably within a percentage or two of the target moisture content.
