DOE BROOKHAVEN NATIONAL LABORATORY TRU AND LEGACY WASTE DISPOSAL

M. E. Pizzulli, F. P. Castellano
P.W. Grosser Consulting, Inc.

M. F. Clancy, Jr., P. T. Sullivan
Brookhaven National Laboratory

WM'05 Conference, February 27-March 3, 2005, Tucson, AZ

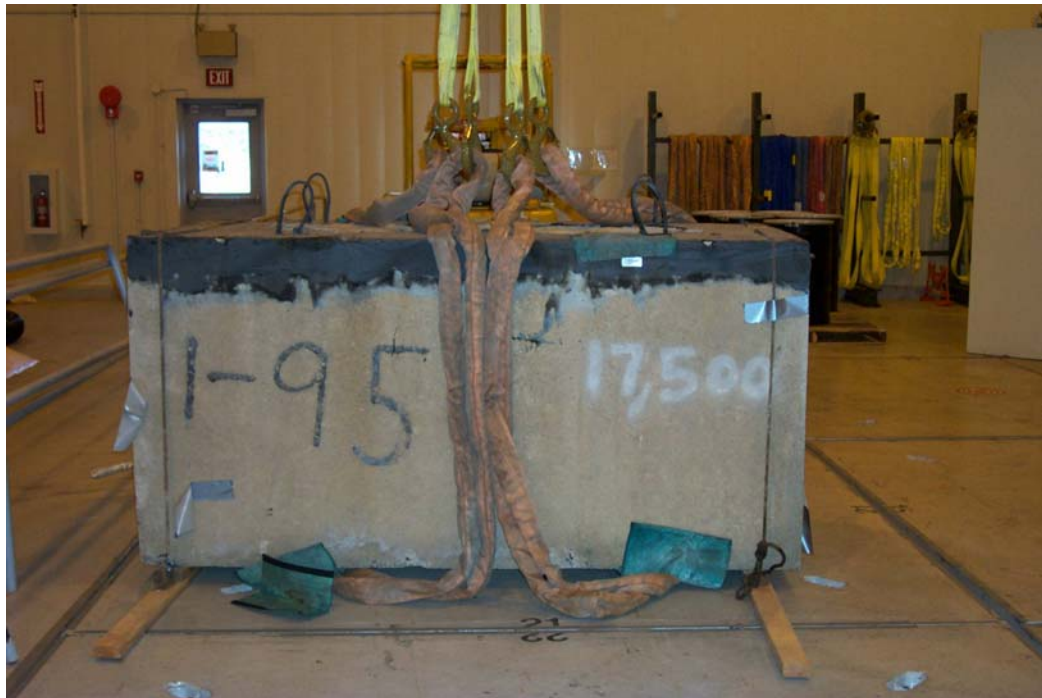
The 1-95 concrete vault was a steel reinforced seventeen-inch concrete disposal vault that was filled with radioactive waste for disposal from 1975 to 1977 (Figure 1). The vault was sealed with high density concrete in 1977 with the intent of sending it to a disposal facility. However, after sealing the vault, the initial pathway for disposal was no longer available due in part to the quantity of plutonium contained within the vault. Once in 1990, an attempt was made to open the vault using an electric jackhammer, but operations quickly ceased as the dose rates increased beyond the facility limits when several inches of concrete were removed. The vault was again concreted over and placed back into storage [15].

Fig. 1. The 1-95 concrete vault located in the Waste Management Facility (WMF).

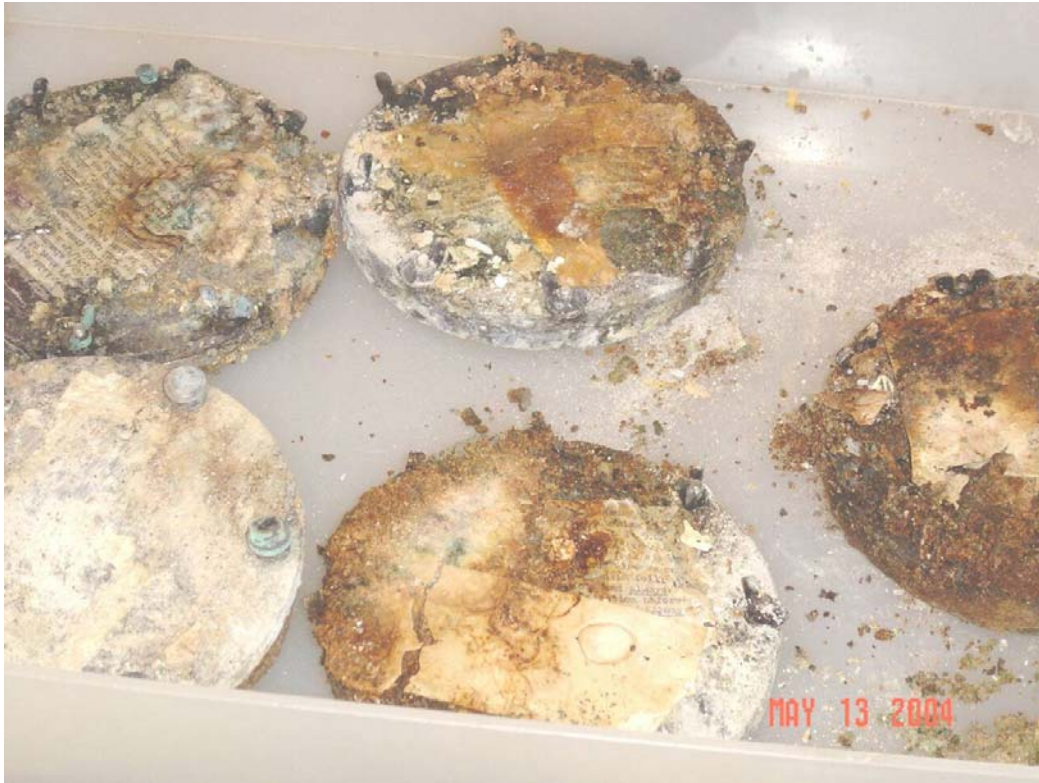
Prior to starting work on the third day, the project manager and a RCT began discussing the size and shape of a BLIP Target as compared to the plutonium foil aluminum holders. As it turns out, a BLIP Target measures 4.5-inch diameter by 1.0 inch high and the plutonium foil holders measure 6.0-inch diameter by 5/8 inches high, slightly larger than a BLIP Target. The RCT remembered a bag of what he thought were oversized BLIP Targets. The bag was retrieved and opened inside the ventilated enclosure and the 5 disks inside were laid out in a tray. Much of the original labels were still intact on the disks and it was confirmed that these were the five plutonium foil holders (Figure 2) [3,14,15].

Fig. 2. Plutonium foils inside of aluminum holders.

The foil holders were surveyed and bagged individually. There was no loose surface contamination on the outside of the holders and the one that was opened was also surveyed on the inside with no contamination detected. The foil holders measured 40-60 mR/hr at contact and up to 5 mR/hr at one foot. A gamma spectrum was collected and analyzed for the foils. The predominant radionuclide identified was americium-241, indicative of plutonium-240/241 decay. The foils were then removed from their holders and placed into small Ziploc storage bags (Figure 3). This work is done inside of a glovebag inside of a fume hood. The foils and the inside of the glovebag were surveyed and contamination was found. The activity measured inside of the glovebag was 300,000 dpm/100 cm² alpha. The foils in Ziploc bags are decontaminated and bagged one more time before placing them into a Type B container, where they are currently stored at the WMF [3,4].

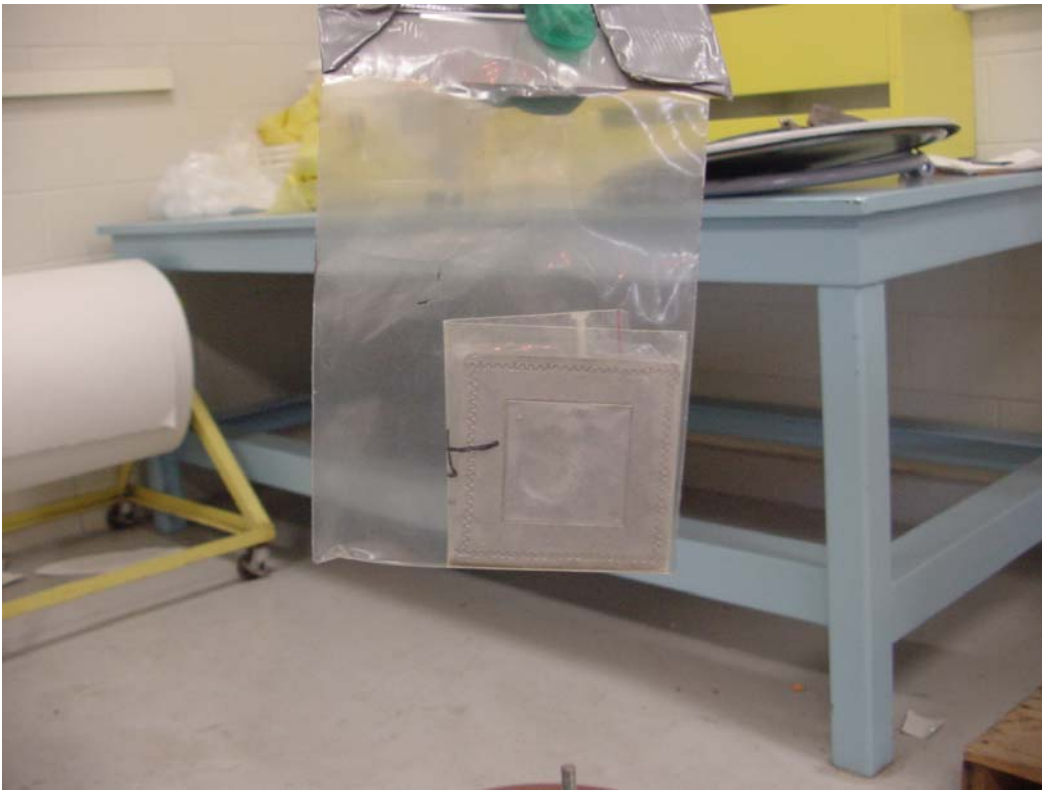
Fig. 3. Plutonium-239 foil removed from the steel holders and individually wrapped in a plastic bag.

Currently, the five Pu-239 foils are stored in individually wrapped Ziploc bags in a Type B container. A verbal agreement has been made with the Off-Site Source Recovery Project (OSRP) to accept these foils from BNL for eventual disposal at the WIPP facility. The foils were scheduled to be transferred to the OSRP's ownership in the fall of 2004, however due to the shutdown of LANL in the summer of 2004, the OSRP was not able to receive the foils. Since LANL is back in full-operation mode it is anticipated that the foils will be transferred in January 2005 [15].

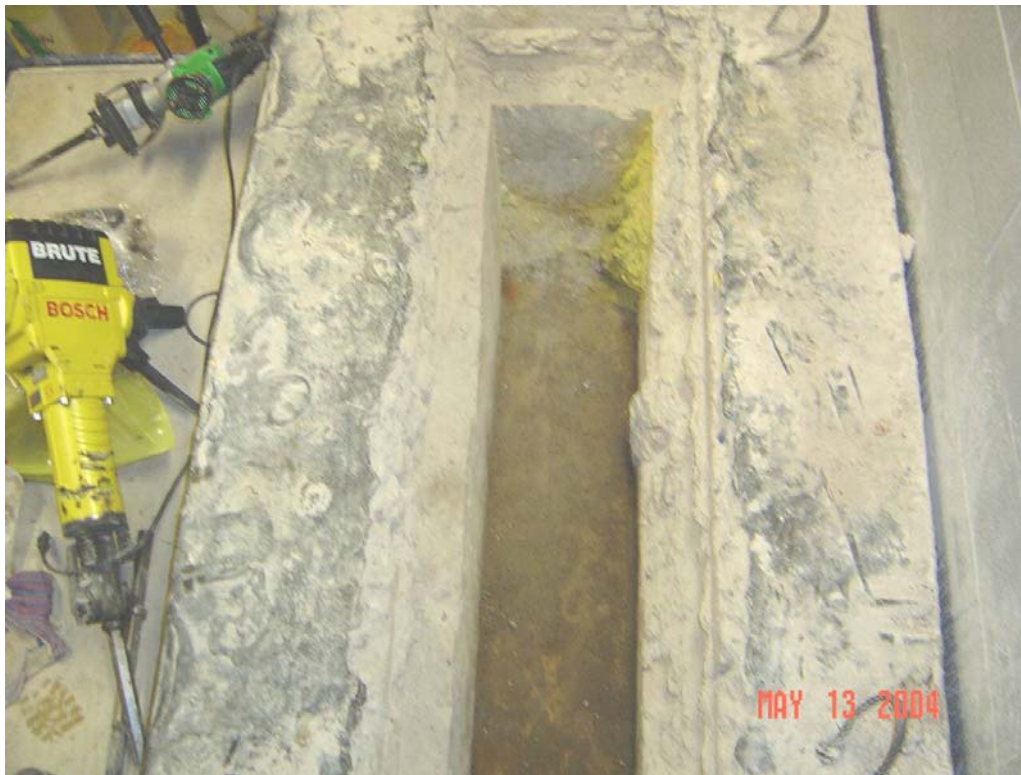
The remaining waste was removed from the inner cavity of the vault. The empty vault is shown in Figure 4. All concrete debris and miscellaneous non-source items removed from the vault were placed into a B-12 Industrial Package for disposal. All tools and equipment were decontaminated and removed from the ventilated enclosure for future re-use. The empty vault was wrapped in plastic, removed from the ventilated enclosure and placed into an Intermodal container for disposal [3,12].

Fig. 4. All waste items excavated and removed from the vault.

The remainder of the waste removed from the vault, including the empty vault itself, was disposed of as low-level radioactive waste and/or mixed waste (i.e., lead bricks) at Envirocare of Utah. Since the 1-95 vault and its contents fall under the Environmental Management Directorate's (EMD) legacy waste project, and BNL's EMD is scheduled for completion at the end of fiscal year 2005, it is crucial that the Pu-239 foils that currently remain at BNL are disposed of within the next seven months.
