**THE USE OF BENTONITE AMENDED CLAY
IN LOW LEVEL LANDFILL LINERS**

P. J. Flood, P.E.
Earth Tech, Inc.
10 Patewood Drive, Building 6, Suite 500, Greenville, SC 29615

D. Hoffman, Ph.D.
Washington Group International
105 Mitchell Road, Suite 200, Oak Ridge, TN

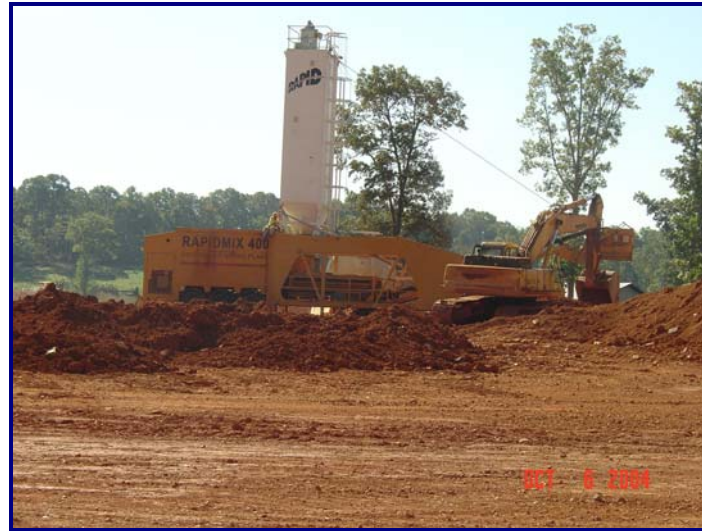
Fig. 2. Equipment Arrangement.

Despite concerns regarding the technical implementation of the bentonite blending operation, the admixture option appeared to be the best solution. Therefore, plans were made to proceed with this approach. (See Figure 2)

To blend the bentonite with the soil, the contractor selected to use a Rapidmix 400 pugmill with a vertical silo for bentonite storage. The Rapidmix 400 pugmill is a volumetric continuous mix plant that has an operator's control station containing a plant computer for controlling the proportions of the base soil, bentonite, and water. The mixing plant computer allows the operator to see rates and total volumes of any given component at any time and produces a ticket at the end of the day showing the amounts of base soil, bentonite, and water that were used in the mix.

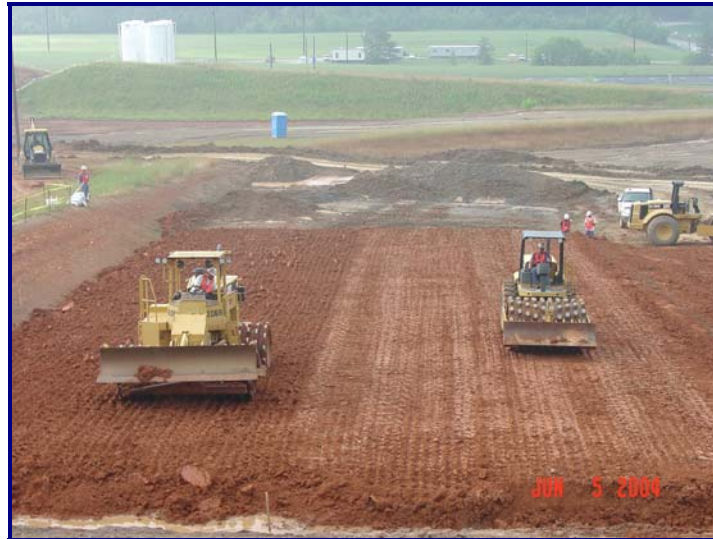
Fig. 3. Test Pad Construction and Testing.

Two adjacent test pads were constructed in the northeast corner of Cell 4 between Wednesday, May 26, 2004 and Saturday, June 5, 2004. (See Figure 3 above) The test pads were constructed and tested in accordance with the Test Pad Plan; a summary of the construction and testing, as well as the results and conclusions, were presented in the Test Pad Report.

The two pads were constructed to accommodate two types of compaction equipment. Lift thickness was controlled using global positioning systems with elevation controls mounted on a bulldozer. Lift thicknesses were also checked using manual survey.

Each test pad was constructed to be 25 ft wide by 130 ft long. Test pad dimensions were dictated by the spacing requirements of the Boutwell permeameters and by the number of Boutwell tests desired.

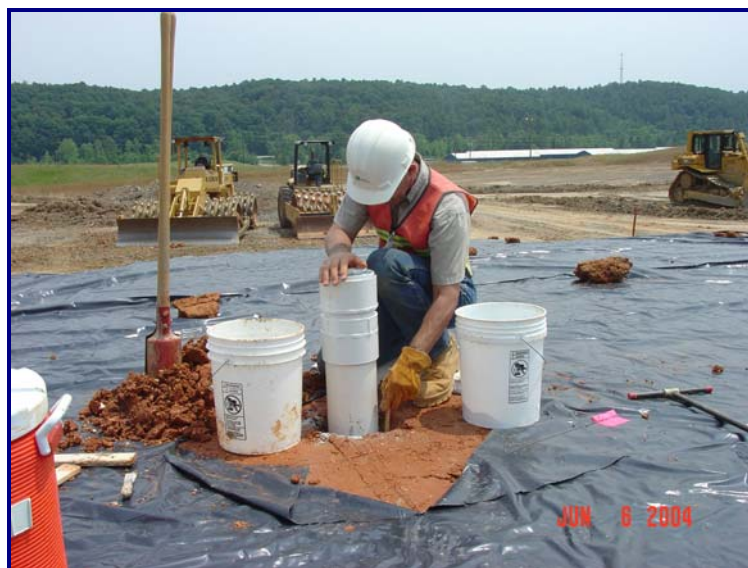
Fig. 4. Hydraulic Conductivity Testing.

Upon completion of the test pad construction, the in-situ hydraulic conductivity of the test pad was measured using the Two-Stage Borehole Permeameter (Boutwell) Method. (See Figure 4 above) A total of six six-inch diameter Boutwell permeameters were installed in each test pad. In addition, one Temperature Effect Gauge was installed between the third and fourth Boutwell permeameter in each test pad.

Each Boutwell permeameter was installed in accordance with ASTM D 6391. During the installation of Stage 1 of the Boutwell permeameters, two permeameters installed on the lane compacted using the Caterpillar 563 were found to be unable to hold water overnight. Attempts were made to reset or reconstruct those permeameters. After these rehabilitation attempts failed, it was decided that the permeameter tests were considered failures, and the tests were terminated. Since the acceptance criteria for each test pad included no more than one failing Boutwell, additional hydraulic conductivity testing on this test pad was not performed. Stage 1 testing for each Boutwell test in the test pad constructed using the Caterpillar 815 was completed without incident.

The Boutwell permeameter results indicated that the test pad constructed using the Caterpillar 563 did not meet the required standard for hydraulic conductivity. Excavation of the failed permeameters did not reveal any obvious defects within the soil mass to account for the high hydraulic conductivity. Based on a review of the manner of failure, it was concluded that the most likely cause of failure was the existence of horizontal planes built into the test pad.

Each Boutwell permeameter test performed in the test pad constructed by the Caterpillar 815 achieved a hydraulic conductivity less than the required 1×10^{-9} m/s. As the cleats of the Caterpillar 815 are sufficiently long to reach through the underlying lift, it was concluded that no horizontal layers were formed during construction of this test pad.
